A-Action

Home Inspection Group

Unit #111 PROPERTY INSPECTION REPORT

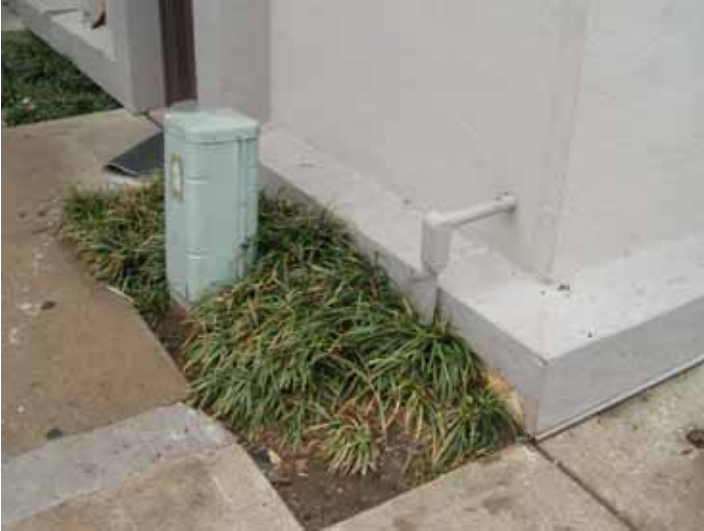
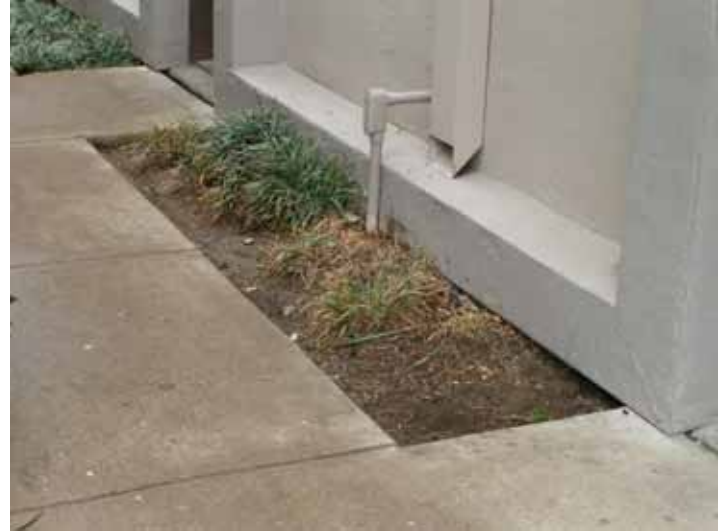
- The soil line is too high on the south side of the structure. Under current building standards there should be at least four (4) inches of foundation visible below masonry veneer and six (6) inches of foundation visible below wood veneer.

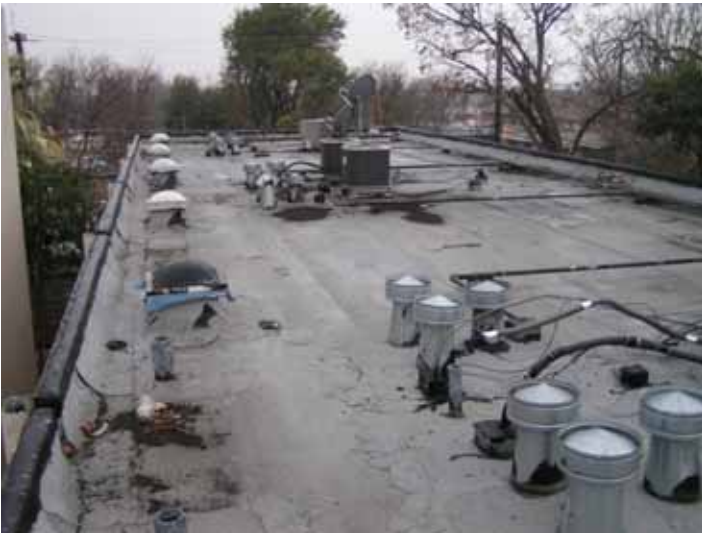
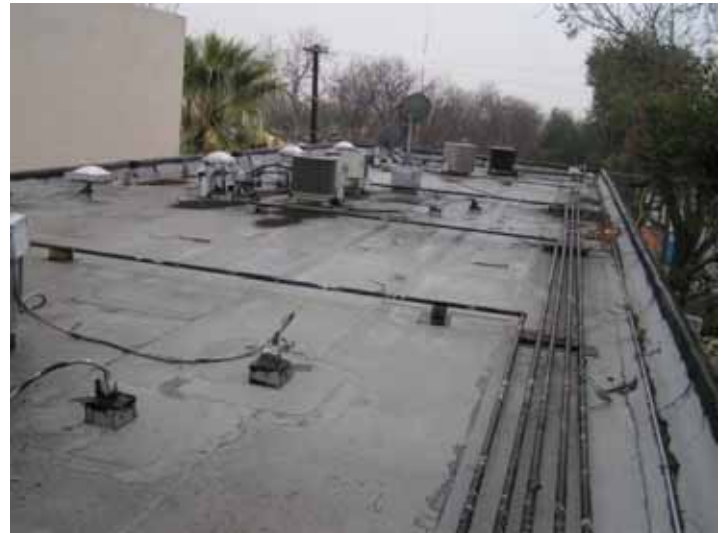
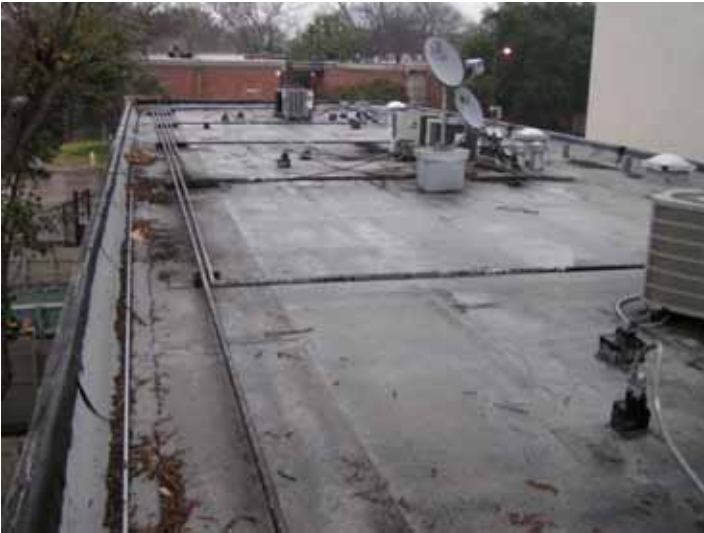
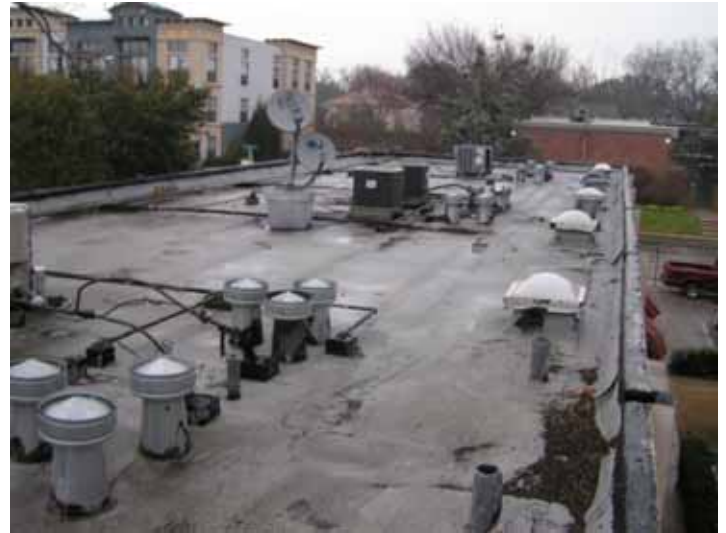
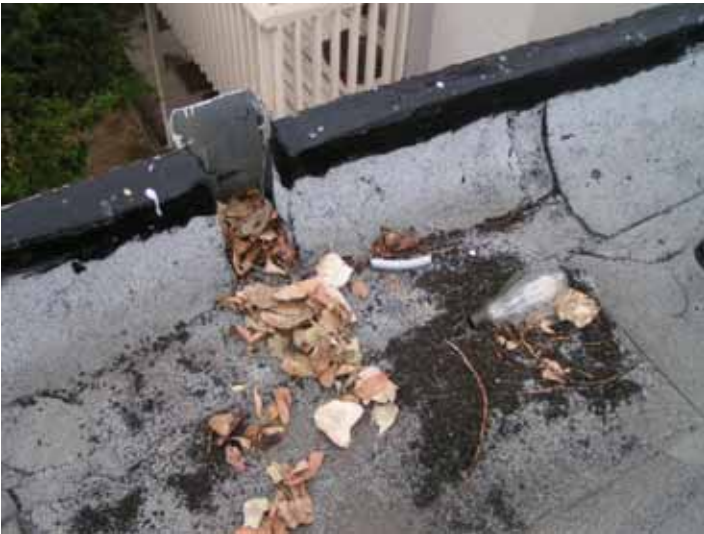
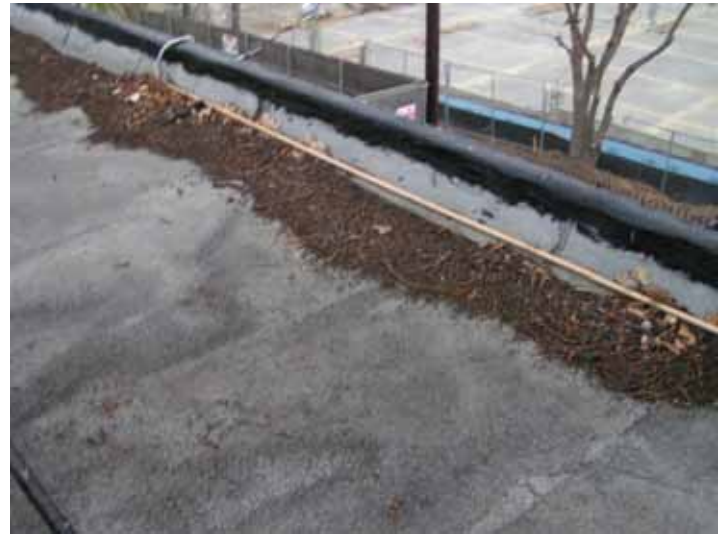
- The flat roof shows evidence of previous and current pooling and ponding. This condition should be closely monitored and improved as necessary.
- All debris needs to be removed from the roofing material.
- One of the roof drain screens is missing and should be replaced.
- Some minor granule loss observed at the time of this inspection.
- Tree and shrub branches need to be trimmed away from the roofing material at all times to help prevent damage to the roofing material. It is the opinion of this Inspector that there are some branches too close to the roofing material at this time and corrective measures are needed.

- The gutters require cleaning.

- The skylight shows signs of previous leakage. This would suggest that some water intrusion problems have been experienced in the past and should be closely monitored.

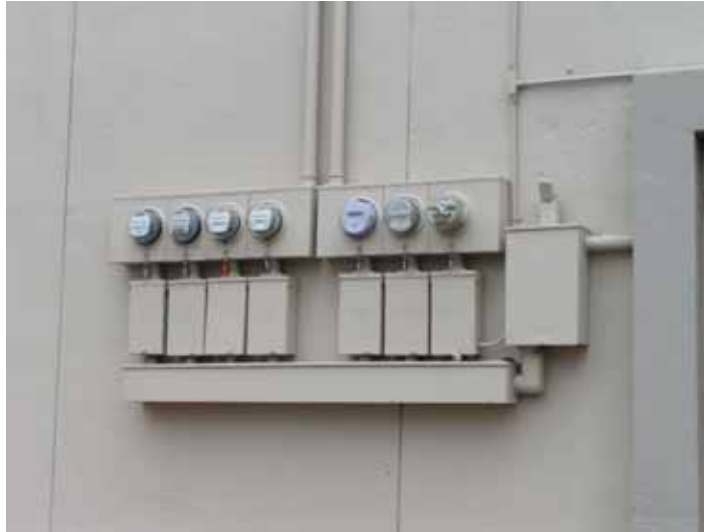
- The electrical service entrance and meter bases are located on the west exterior wall. All components appear to be in satisfactory condition at the time of this inspection.

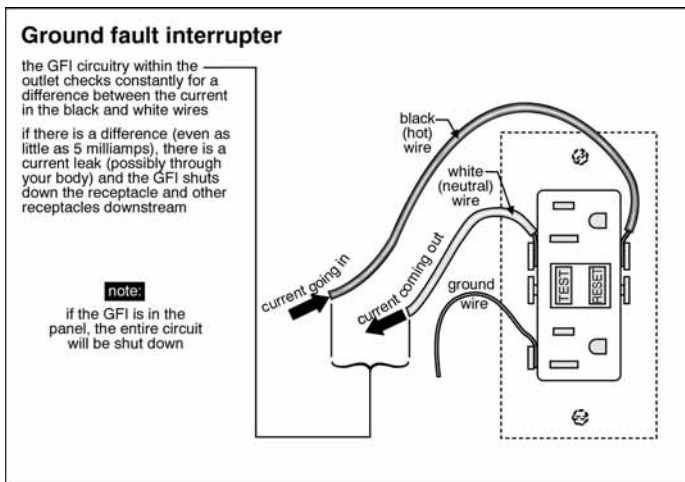
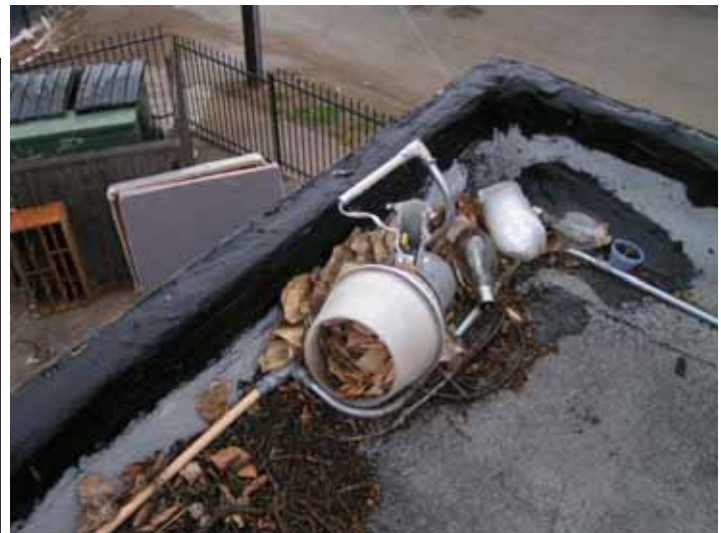
- The security light on the west exterior wall is damaged and appears to be inoperative.
- There is a security light lying on the northwest corner of the roof. The light is still wired at this time. This condition should be corrected for reasons of safety.

- The exterior receptacles do not appear to be connected to a ground fault circuit interrupter (GFCI) circuit. Under current electrical standards, all of the exterior receptacles should have GFCI protection. *The lack of this GFCI protection is a recognized hazard.*
- The exterior receptacles cover plates observed to be damaged and/or missing in one or more locations. Under current electrical standards all exterior receptacles should have weather tight covers in place. The missing cover plates should be replaced for reasons of safety.

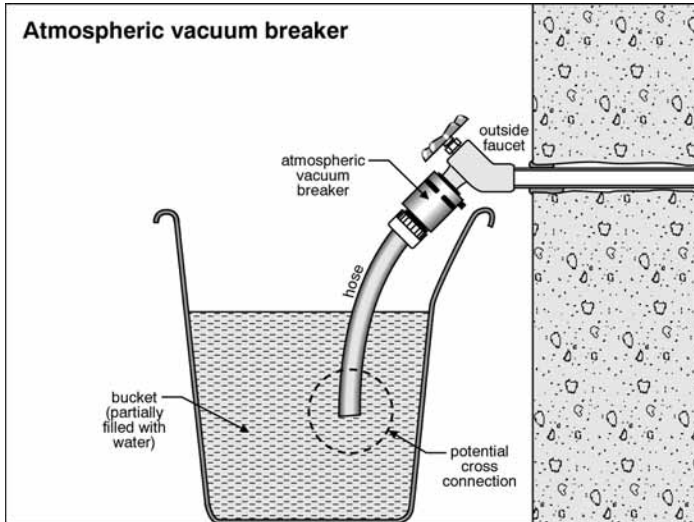
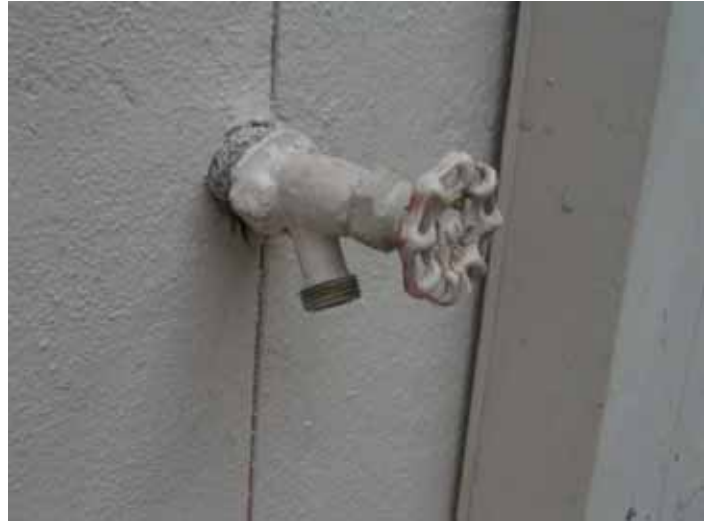
- There were no back-flow or anti-siphon devices (Vacuum Breakers) located at the outside water hose bibs (faucet).

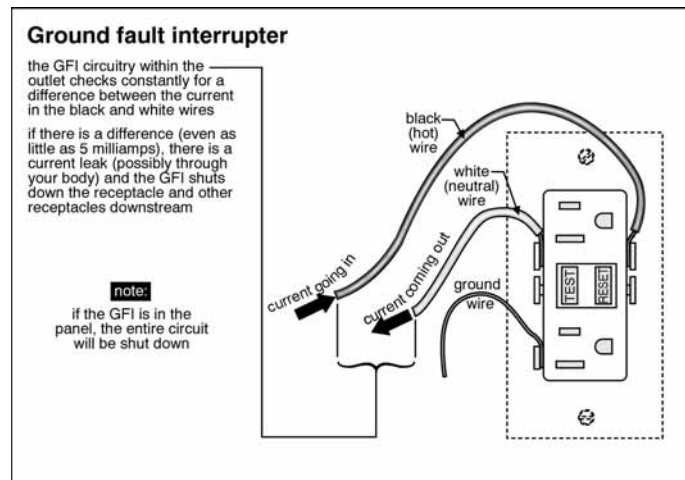
- Some of the receptacles in the home could not be reached for inspection due to personal effects, heavy storage and/or furniture.
- No ground fault circuit interrupter (GFCI) protection located in the wet/damp areas (i.e. all exterior receptacles, all kitchen counter top receptacles, bathroom receptacles). *The lack of this GFCI protection is a recognized hazard.*

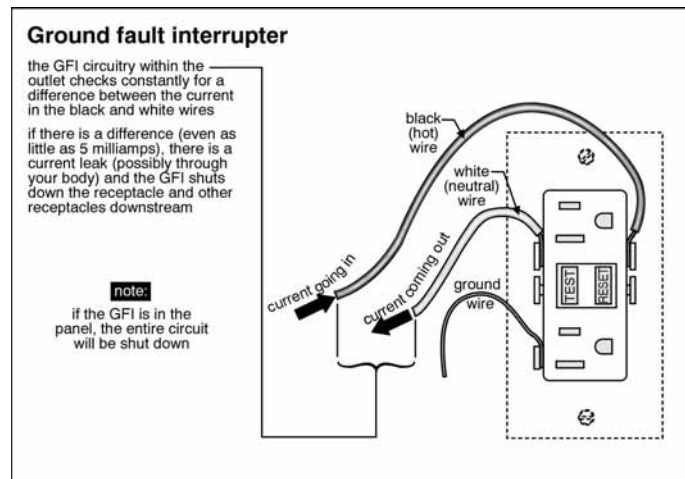
- Some of the receptacles in the home could not be reached for inspection due to personal effects, heavy storage and/or furniture.
- No ground fault circuit interrupter (GFCI) protection located in the wet/damp areas (i.e. all exterior receptacles, all kitchen counter top receptacles, bathroom receptacles). *The lack of this GFCI protection is a recognized hazard.*

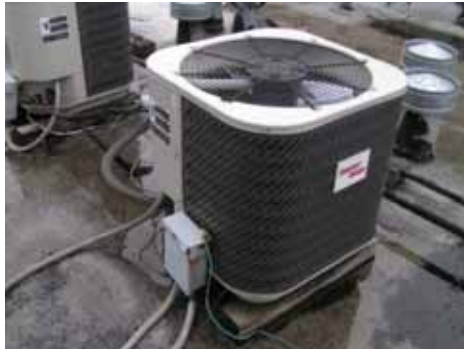
- Damaged and/or missing insulation on refrigerant lines should be repaired or replaced at the outside condenser.
- The condenser electrical conduit has pulled loose and needs to be re-secured.

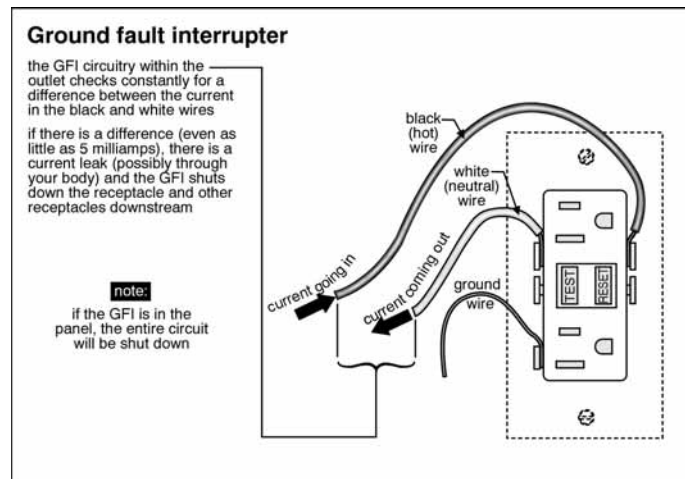
- Some of the receptacles in the home could not be reached for inspection due to personal effects, heavy storage and/or furniture.
- No ground fault circuit interrupter (GFCI) protection located in the wet/damp areas (i.e. all exterior receptacles, all kitchen counter top receptacles, bathroom receptacles). *The lack of this GFCI protection is a recognized hazard.*
