The A-Action Team
Your Consultant's For Life

I. STRUCTURAL SYSTEMS

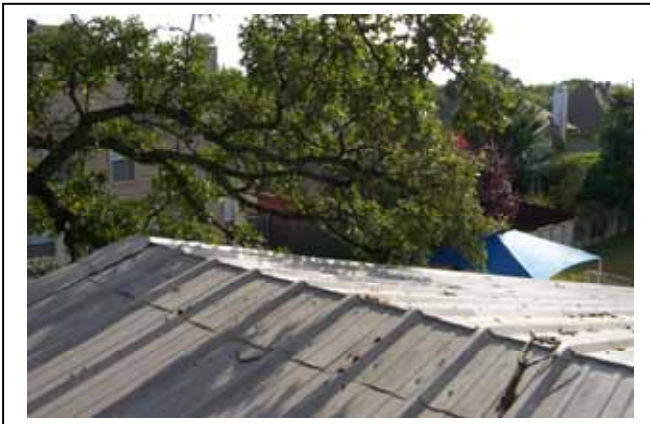
Trim back the trees.

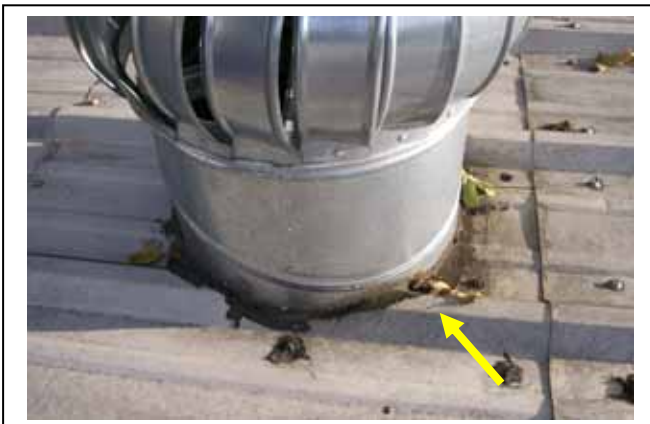
Prior Patching

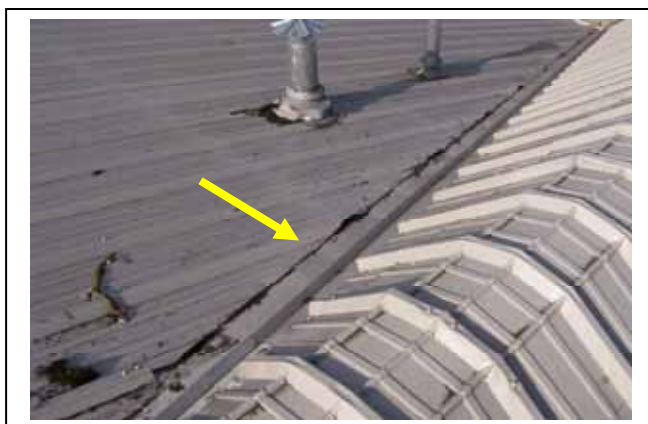
- There are two visible active water leaks at the time of this inspection. The north valley over the front northeast classroom and front lobby area is leaking and needs to be repaired. One of the roof penetrations of the southwest corner classroom restrooms is leaking and needs to be repaired.
- Prior repairs to the roofing material and/or flashing were observed. This would suggest that problems have been experienced in the past and should be monitored.
- Tree and shrub branches need to be trimmed away from the roofing material at all times to help prevent damage to the roofing material. It is the opinion of this Inspector that there are some branches too close to the roofing material at this time and corrective measures are needed.
- Debris should be removed from the roofing.

North Valley Leaking

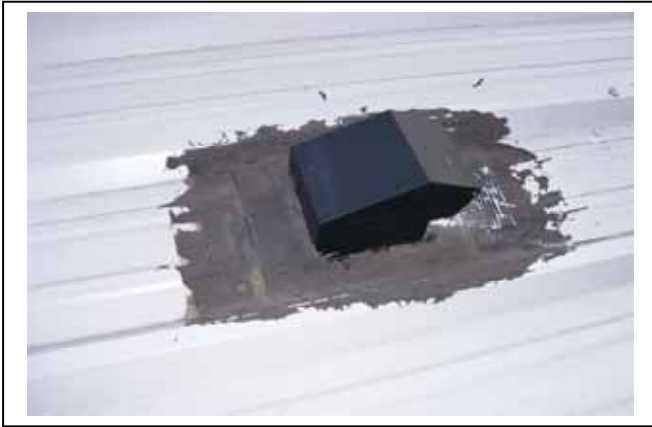
Improper roof jack installation.

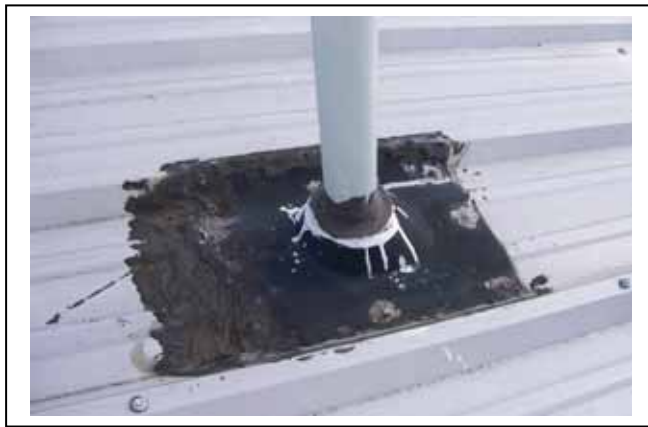
Improper roof jack installation.

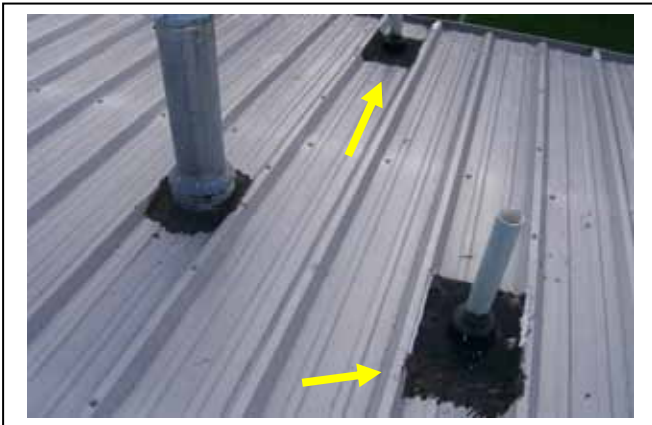
Improper roof jack installation and prior repairs

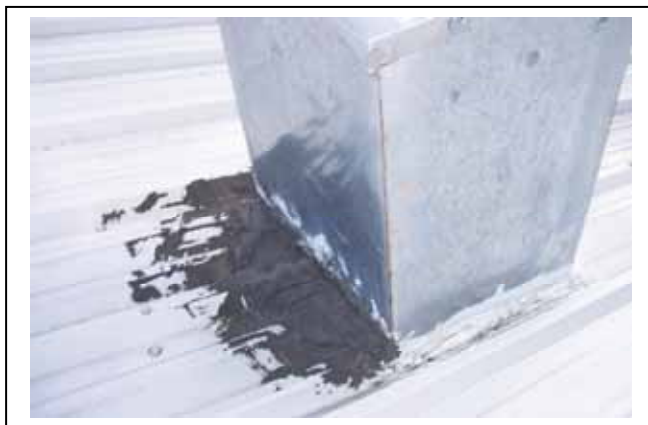
Prior Repairs

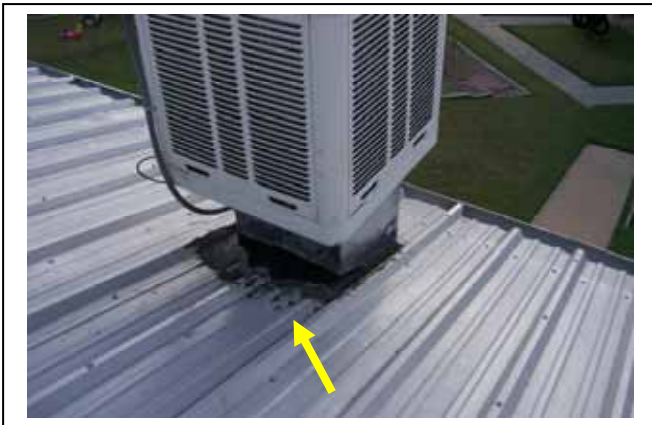
Prior Repairs

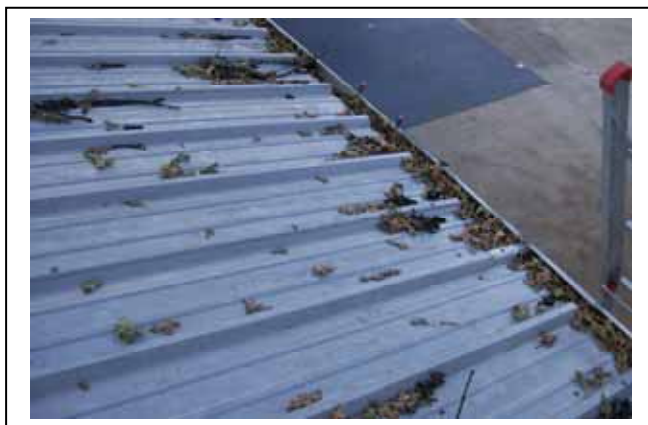
Gutters need to be cleaned.

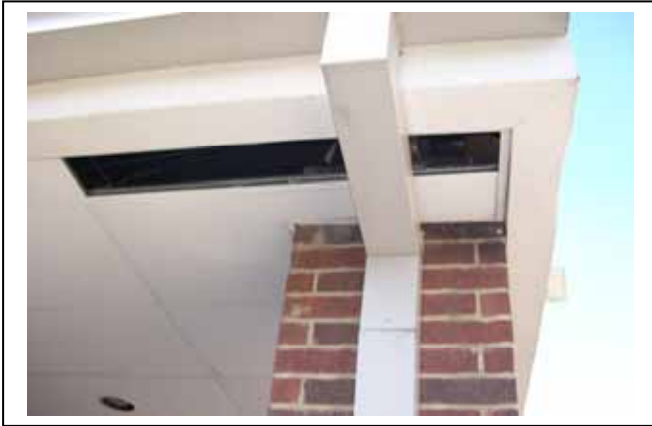
Carport soffit panel is missing.

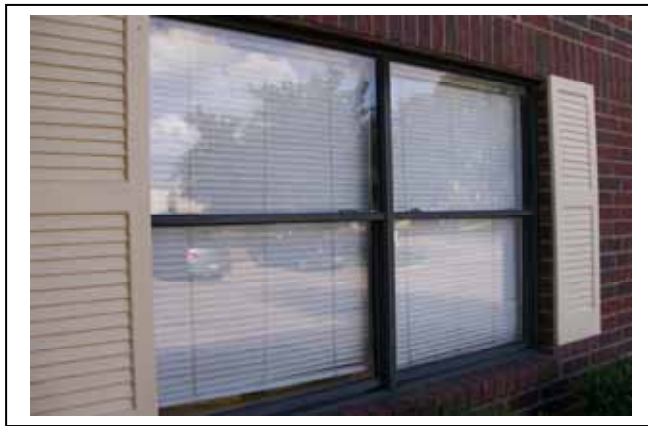
Window screens are missing.

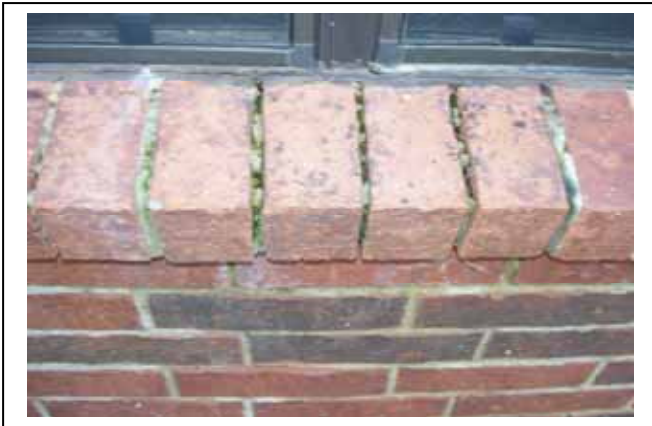
Window seat mortar needs to be improved on the north side of the structure.

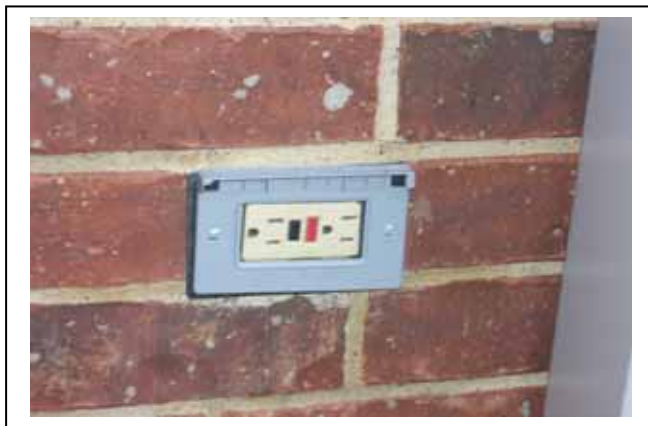
- All exterior receptacles should have weather tight covers. The receptacle cover plate is damaged and/or missing on the west exterior wall.
- The two exterior receptacles on the west exterior wall are inoperative at the time of this inspection. The cause and remedy should be further evaluated and corrected as necessary.

Receptacle weather cover is missing.

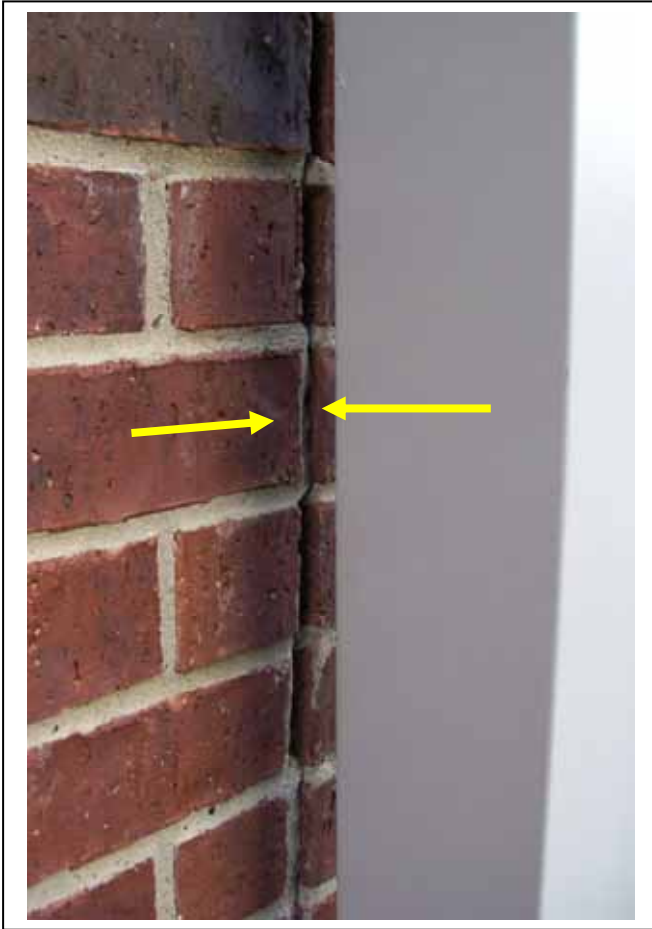
Expansion joint needs to be sealed.

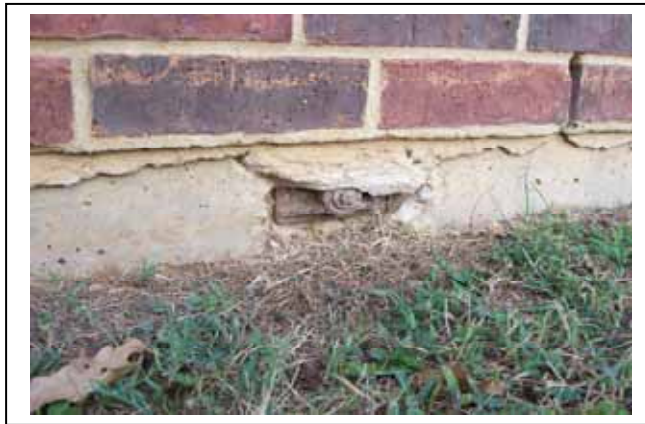
- One or more of the post tension cable ends are exposed and need to be properly sealed on the west side of the house.
- One or more of the foundation perimeter beam corners were observed to be sheared off (corner pop). This is a common condition in slab on grade foundations. This condition does not adversely affect the performance of the foundation. However, in some case, some cosmetic improvements may be necessary.
- Some deflection cracks in the exterior brick veneer were observed at the time of this inspection. This is not an uncommon condition to observe in a structure of this age and type of construction.

Exposed tension cable needs to be sealed.

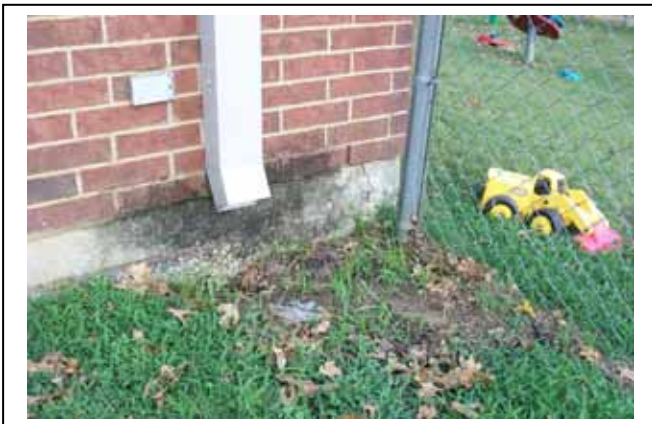
- The gutters require cleaning.
- The gutter seams are leaking and need to be resealed.
- The gutter downspouts on the west side of the structure are missing their splash blocks. This condition should be corrected to help prevent ground erosion near the foundation beam.

Downspout splash block is missing

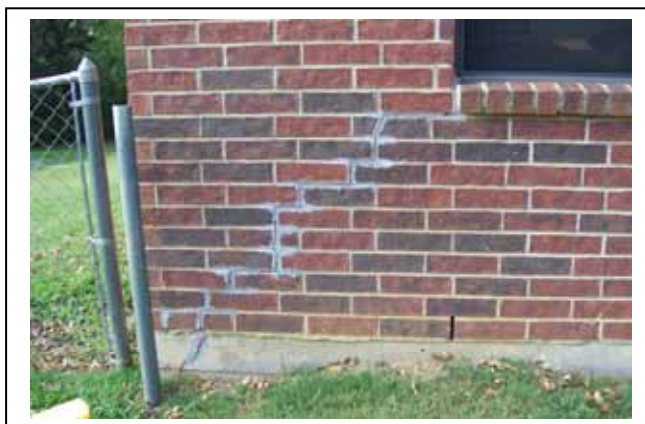
Prior mortar repairs on the north and south sides of the structure.

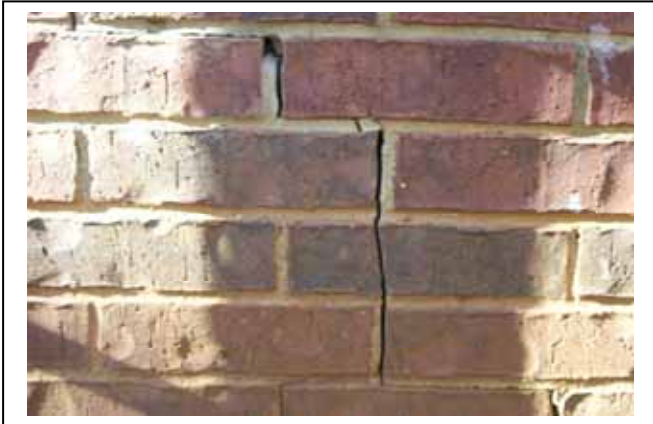
Mortar improvements are needed on the south side of the structure.

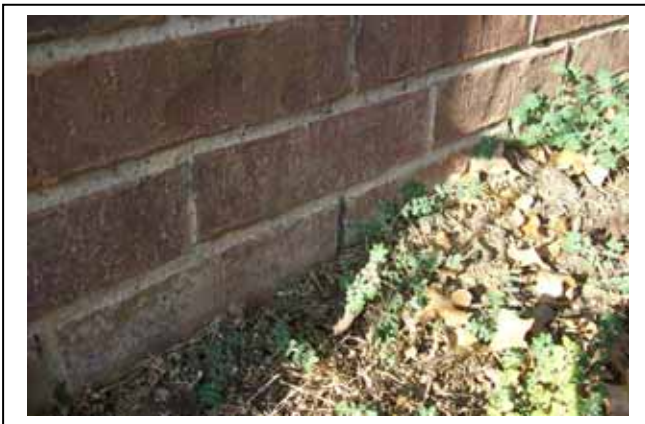
- The soil line is too high on the south side of the structure. Under today's building standards there should be at least four (4) inches of foundation visible below masonry veneer and six (6) inches of foundation visible below wood veneer.

High soil line on the south exterior wall.

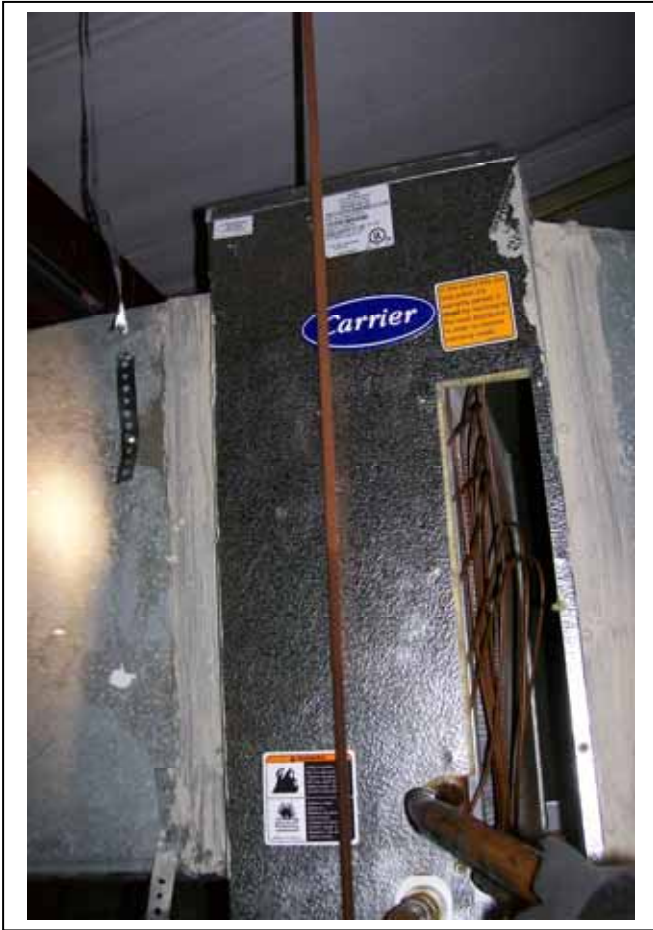
Coil service panel is missing to unit #2

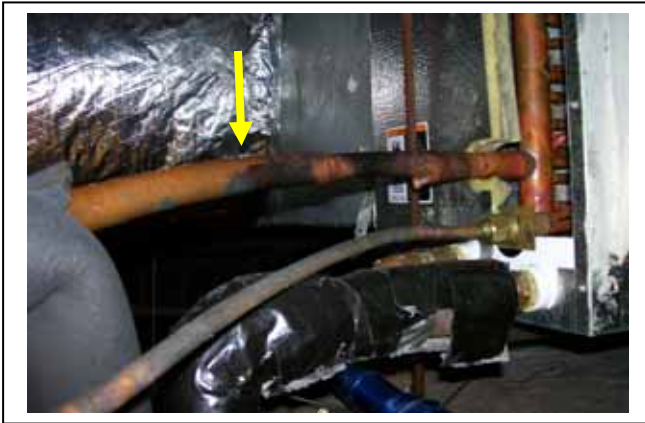
Insulation on the refrigeration lines needs to be replaced.

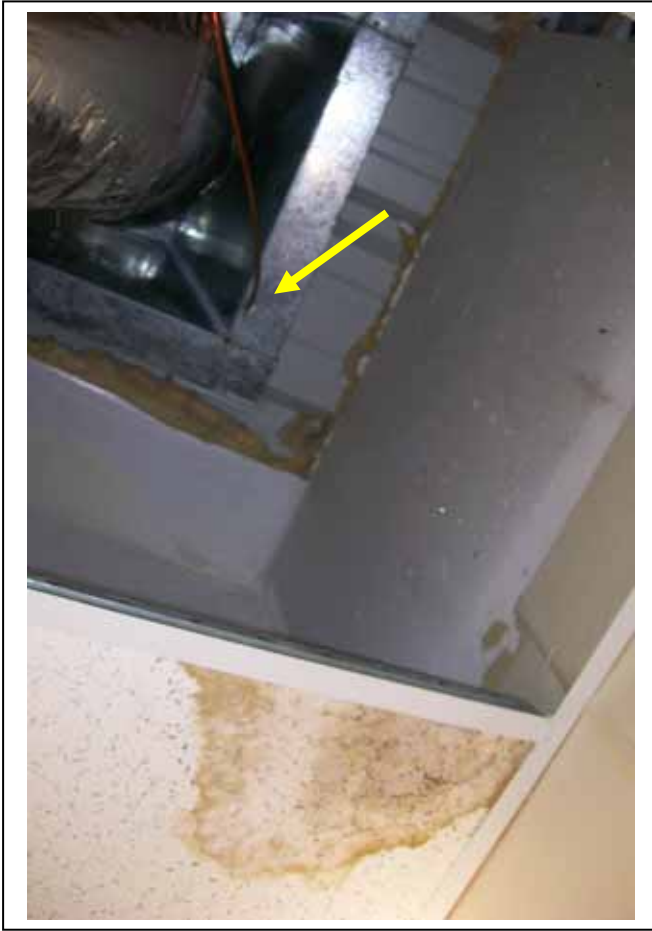
- Water stains observed on the drop ceiling tiles in the northeast classroom and southwest classroom restroom. The cause and remedy should be further evaluated and corrected as necessary. (Apparent roof leak in the north roof structure valley and west roof penetration.)
- The water stained drop ceiling tiles should be replaced in the northeast class room, southwest classroom and southwest classroom restroom area.

Roof leak over the southwest classroom restroom area.

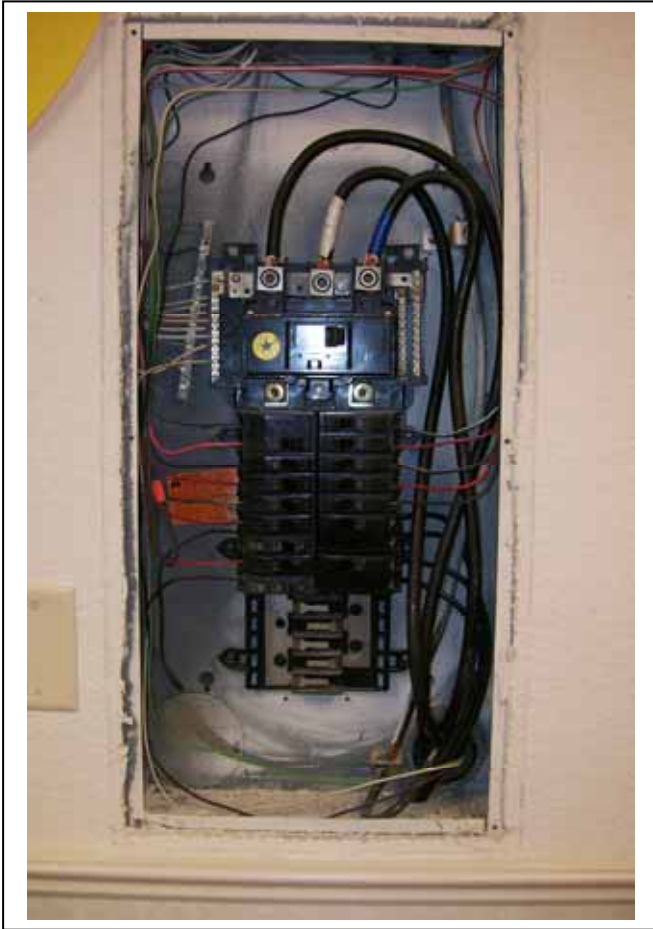
Panel #A OK

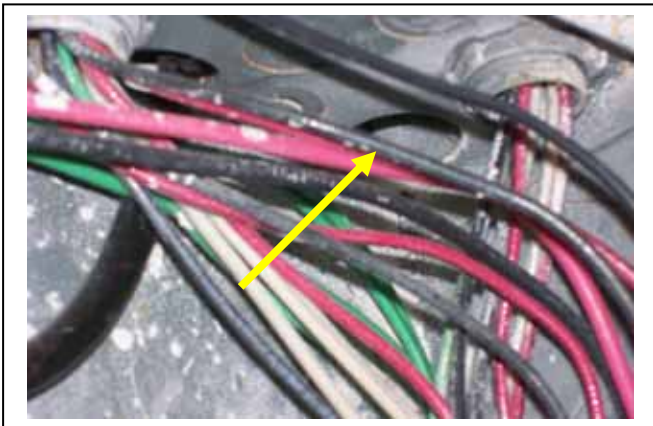
- All blank spaces in the panel box cabinet need fillers.

Open knockout in panel #B needs a filler.
