PROPERTY INSPECTION REPORT

Prepared For:	Clients Name Here	г. о
	(Name of C	lient)
Concerning:	Property Address Here	
	(Address or Other Identification	n of Inspected Property)
Ву:	Inspectors Name Here	Date of Inspection
-	(Name and License Number of Inspector)	(Date)
	(Name, License Number and Signature of Sponso	oring Inspector, if required)

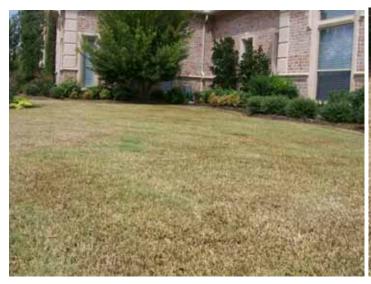
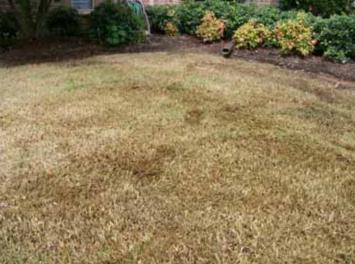
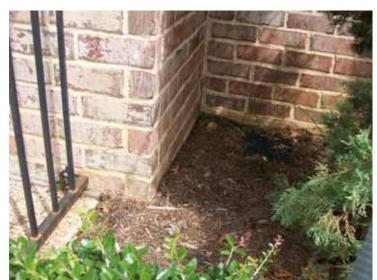
- Poor to negative site drainage was observed on the west side of the house. Proper drainage is needed to help prevent water from standing and/or ponding next to the foundation beam. Surface drainage should be diverted to a storm sewer conveyance or other approved point of collection so as to not create a hazard. Lots should be graded so as to drain surface water away from foundation walls. The grade away from foundation walls should fall a minimum of 6 inches within the first 10 feet.
- The soil line is marginally high on the west side of the house. Under current building standards there should be at least 4-inches of foundation visible below masonry veneer and 6inches of foundation visible below wood type veneer.

The gutters do not appear to have sufficient slope to drain properly on the west side of the
roof line at and/or around the garage window. If they do not perform as intended, the slope
should be adjusted.

Surface drainage shall be diverted to a storm sewer conveyance or other approved point of collection so as to not create a hazard. Lots shall be graded so as to drain surface water away from foundation walls. The grade away from foundation walls shall fall a minimum of 6 inches (152 mm) within the first 10 feet (3048 mm).

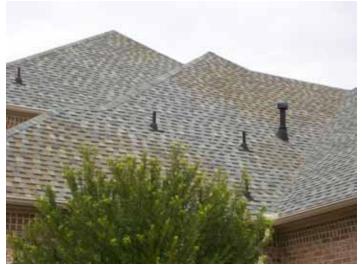
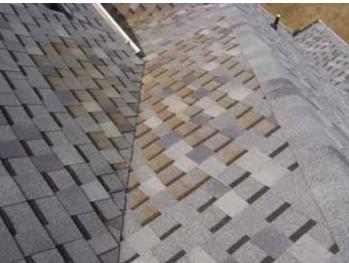
The roofing material has a discoloration that is not typically seen with this type of roofing material. This appears to be a manufacturer's defect that should be further investigated. You are strongly encouraged to contact the roofing material manufacturer to check on possible recalls for this type, make and/or batch of roofing material.

Roofing discoloration

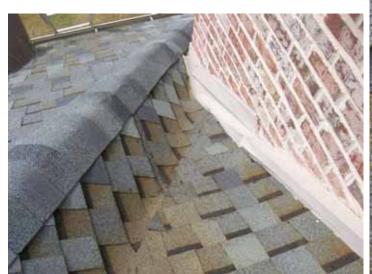
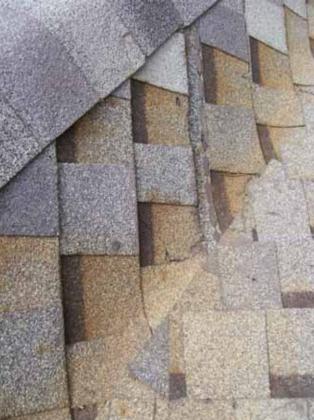
- Roof fasteners (nails and/or staples) observed to be exposed and should be properly sealed at the ridge caps and flashing areas.
- There appears to be a water leak through the roofing material over the guest bedroom. The water leak appears to be in the roof structure valley over the guest bedroom.
- The roof structure roofing material does not appear to be properly fastened in place and the shingles are sliding out of place at the valley over the guest bedroom.

Damaged shingle and shingles sliding out of place.

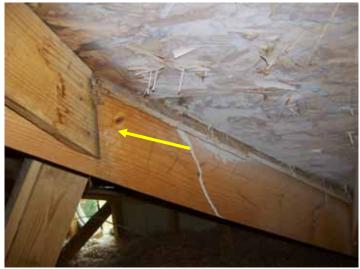
Water leaking into the attic area from the valley over the guest bedroom.

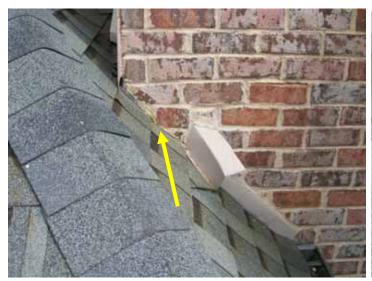
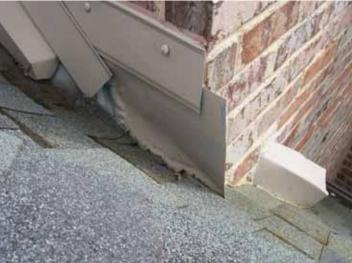
- The flashing needs to be checked, reset and/or repaired as necessary. The observations made to support the rendering of this opinion are listed but may not be limited to:
 - The sidewall flashing is missing counter flashing at the sidewall left of the front entry area and at the sidewall over the east side of the garage.
 - The condition and/or installation of the sidewall flashing is questionable at the sidewall over the master bathroom closet area. The counter flashing details are missing at the sidewall. There is visible evidence of water leakage into the attic space under the sidewall flashing details. This condition should be further evaluated and corrected as necessary.

Flashing details are missing.

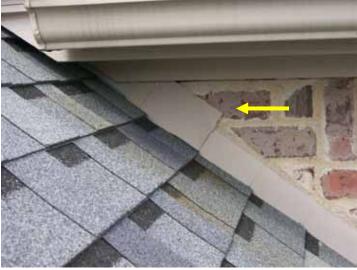
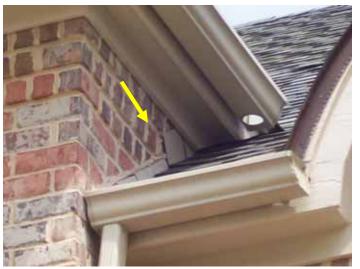
Missing counter flashing.

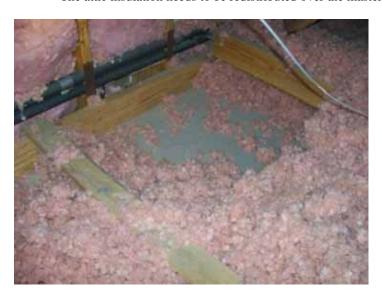
The attic insulation needs to be redistributed over the master bathroom closet.

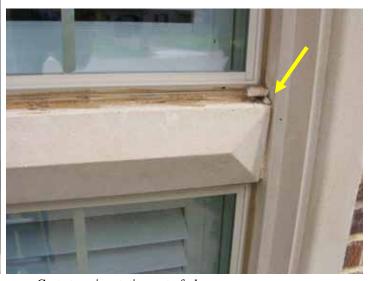
- The mortar at the cast stone at and around the front entry area is loose and/or missing. This condition should be further evaluated and corrected as necessary.

Mortar improvements are needed.

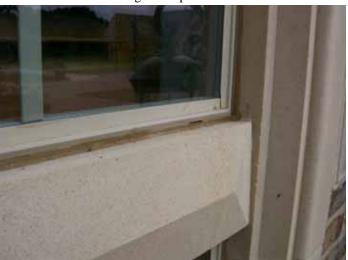
- The cast stone mortar needs to be improved at and around all of the west windows.
- The cast stone between the upper and lower windows of the dining area and study area window has a negative slope toward the windows. This has caused water intrusion at and around the windows. This condition should be further evaluated and corrected as necessary.

Mortar improvements are needed.

Negative slope on window cast stone.

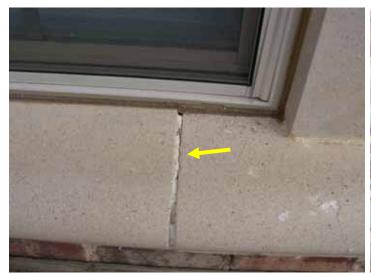
Mortar Improvements are needed.

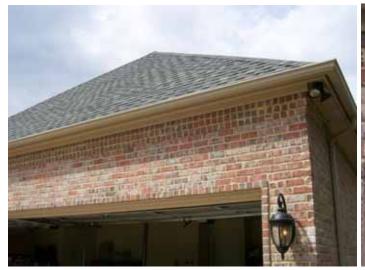
- There were no weepholes observed in the low course of the exterior masonry veneer over the window openings and garage overhead doorframe steel lintels.

No weepholes over the garage door and window steel lintels.

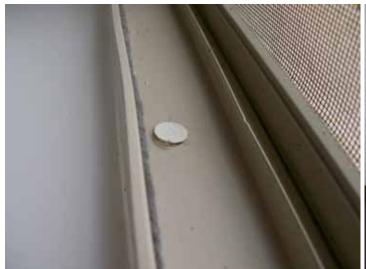
Security contacts need sealed.

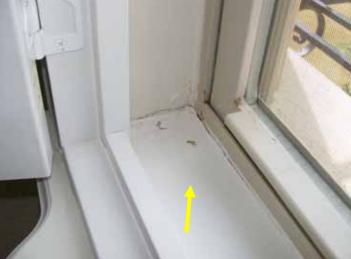
Water damage at bedroom #4 window.

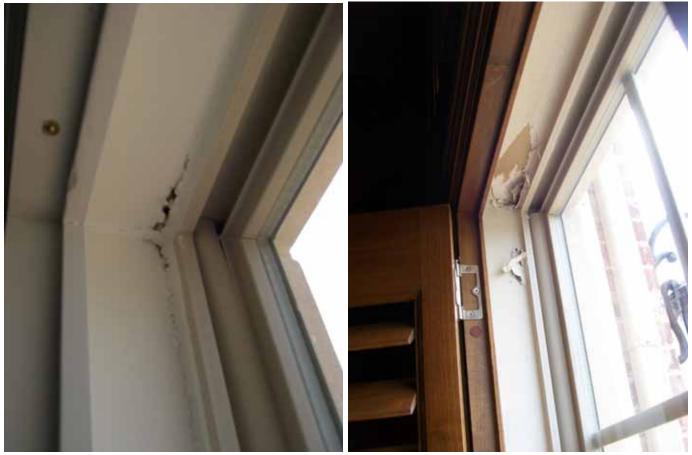
- Visible evidence of water intrusion observed at and/or around the window(s) in the dining room. The cause and remedy should be investigated and corrected as necessary.
- Visible evidence of water intrusion observed at and/or around the window(s) in the study area. The cause and remedy should be investigated and corrected as necessary.
- Visible evidence of water intrusion observed at and/or around the window(s) in the guest bedroom. The cause and remedy should be investigated and corrected as necessary.
- Visible evidence of water intrusion observed at and/or around the window(s) in bedroom #4. The cause and remedy should be investigated and corrected as necessary.
- The security contacts in the window frames need to be properly sealed so to help prevent water intrusion within the wall voids below the windows.

Water damage at dining area window.

Water damage at study area window.

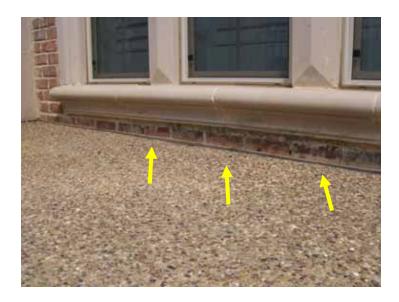
The patio at the front of the house is installed above the foundation/brick ledge. This type of
installation could cause water intrusion into the structure. This condition should be closely
monitored and corrected as necessary.

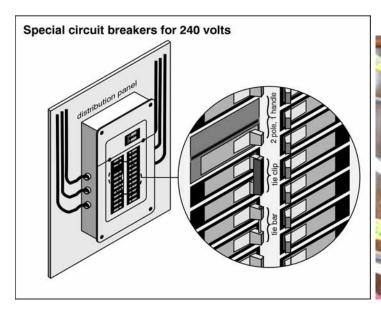
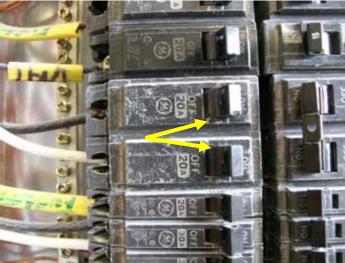
• A set of split 20-amp breaker's trip-ties are missing. The split overcurrent devices (breakers) servicing 240V appliances should be connected together by trip-ties.

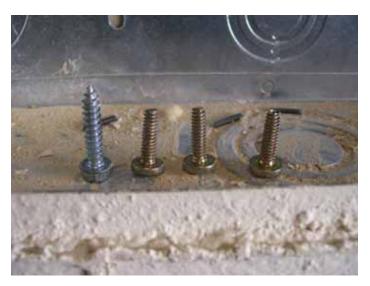
• Sub-panel box cover plate should be mounted with blunt tip screws and not sharp wood type screws for reasons of safety.

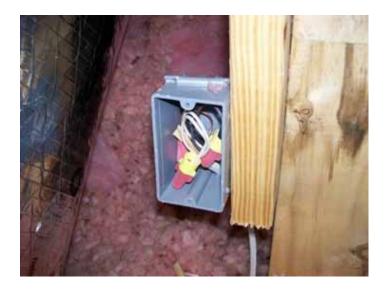
• There is an open electrical junction box in the attic area over the upstairs bedroom hallway. All open junction box(es) in the attic should be properly enclosed.

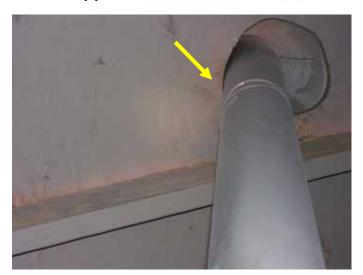
• The heating unit flue (vent pipe) has inadequate clearance from combustible materials. Double walled vent pipes should have at least one-inch (1") of clearance and single walled vent pipes should have at least six-inches (6") of clearance from combustible material.

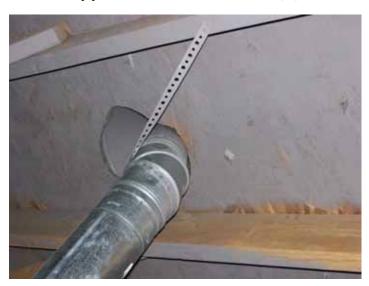
• The heating unit flue (vent pipe) has inadequate clearance from combustible materials. Double walled vent pipes should have at least one-inch (1") of clearance and single walled vent pipes should have at least six-inches (6") of clearance from combustible material.

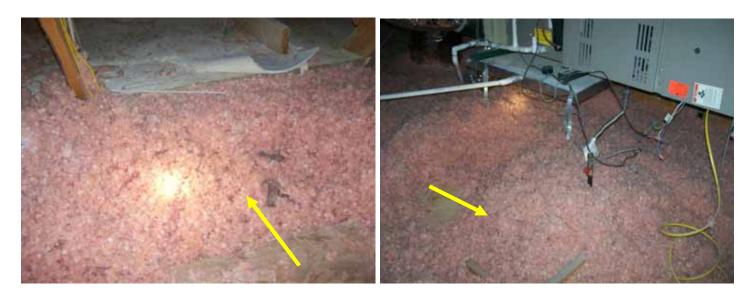
- There is an inadequate service passage to the attic mount equipment. Under current mechanical installation standards, all appliances (i.e. HVAC Equipment and/or Water Heaters) mounted in an attic space should be accessible with a passageway of continues solid flooring not less than 24-inches wide. A level service space at least 30-inches deep and 30-inches wide should be present along the side of the appliance where access is required.
- There is an inadequate service platform in front of the service side of the heater. There should be at least a 30 X 30 inch decked service space in front of the attic unit.

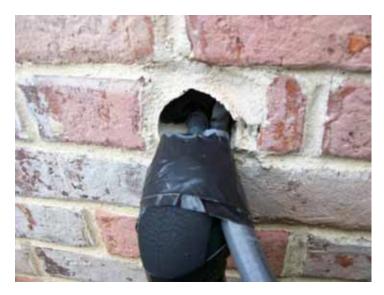
- Air leaks detected at and/or around the indoor coil housing. These air leaks should be corrected for improved efficiency.
- Damaged, deteriorated and/or missing insulation on the refrigerant lines should be repaired or replaced at the outside condenser.

- Damaged, deteriorated and/or missing insulation on the refrigerant lines in the attic area should be repaired or replaced as necessary.
- The emergency condensate drain pan under the coil housing should be free of all debris. The debris in the pan could clog the drain line and cause water to leak to the interior of the house.

- The outdoor unit of the air conditioning system is out of level. This should be improved.
- The electrical service disconnect is installed behind the condenser. This does not meet the
 clearance requirements of the National Electrical Code or the International Residential Code
 and should be corrected as necessary.

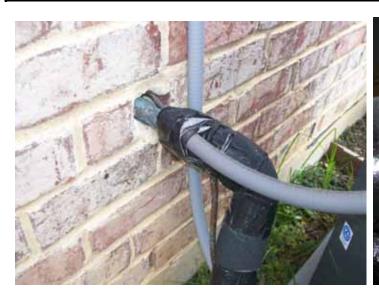
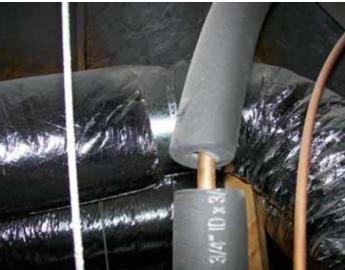
- Air leaks detected at and/or around the indoor coil housing. These air leaks should be corrected for improved efficiency.
- Damaged, deteriorated and/or missing insulation on the refrigerant lines should be repaired or replaced at the outside condenser.

- Damaged, deteriorated and/or missing insulation on the refrigerant lines should be repaired or replaced at the outside condenser.
- The secondary condensate drain line is not properly supported. The slope of the secondary condensate drain line appears to be insufficient. Under current mechanical standards, the secondary condensate drain line should have a minimum slope of 1/8-inch per foot.

- The emergency condensate drain pan under the coil housing should be free of all debris. The
 debris in the pan could clog the drain line and cause water to leak to the interior of the house.

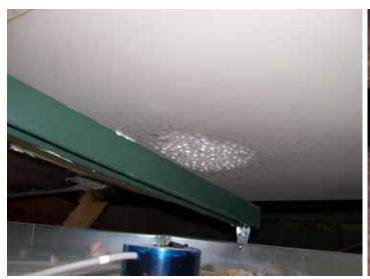
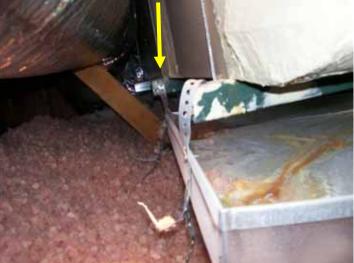
Cooling system needs to be checked and serviced by a Qualified Cooling Company. The observations made to support the rendering of this opinion are listed but not limited to the following:

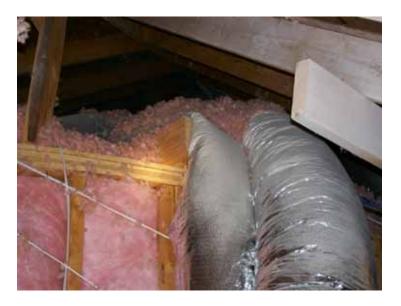
• Some of the ductwork in the attic area has been turned to sharply. This will restrict the airflow through the ducting system and effect the airflow balance in some areas of the house.

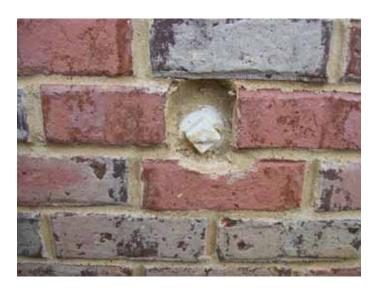
The masonry mortar covering the exterior wall cleanout cover on the north exterior wall should be removed.

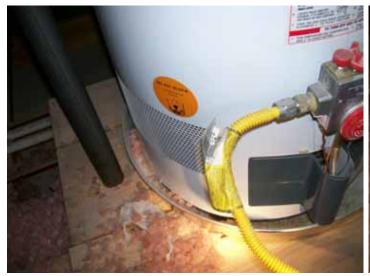
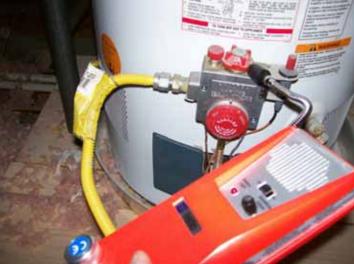
- There was a gas leak detected at the gas pilot assembly. The inspector used a TIFF 8800 gas leak detector to locate the leak.
- The debris in the water heater pan should be cleaned out to help prevent the pan drain line from being clogged.
- The fittings at the top of the water heater are made of dissimilar metals (galvanized steel
 connected to copper and/or brass). This condition is known to cause electrolysis and possibly
 shorten the lifespan of the water heater. It is recommended to replace the galvanized steel
 fitting with a brass or copper fitting or install a dielectric union between the two dissimilar
 metals to prevent electrolysis from occurring.

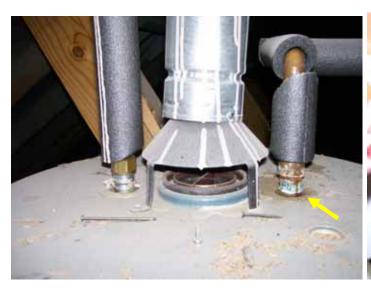
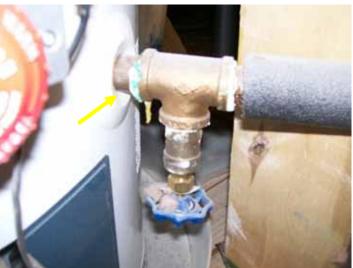
- There is a small water leak at the lower drain bib were the recirculation line is connected.
- Corrosion was observed at the water supply connections at the top of the water heater.
- The fittings at the top of the water heater are made of dissimilar metals (galvanized steel
 connected to copper and/or brass). This condition is known to cause electrolysis and possibly
 shorten the lifespan of the water heater. It is recommended to replace the galvanized steel
 fitting with a brass or copper fitting or install a dielectric union between the two dissimilar
 metals to prevent electrolysis from occurring.
- The debris in the water heater pan should be cleaned out to help prevent the pan drain line from being clogged.

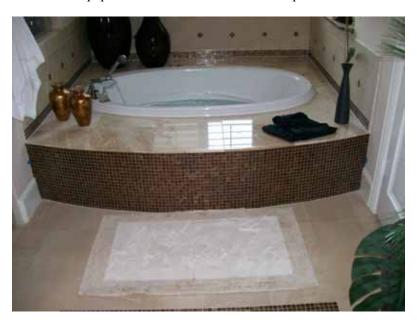
Note: The access to the hydrotherapy equipment motor is not readily accessible and inspection of the equipment lines and motor could not be performed.

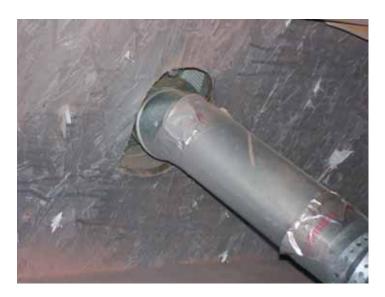
- The length of the clothes dryer flue is to long under current building standards.
- The dryer vent termination is not properly sealed on the attic side of the roof penetration. This is allowing dryer lint to fall back into the attic area and should be corrected as necessary.
- The dryer exhaust duct termination is not properly equipped with a backdraft damper at the time of this inspection.
- The dryer exhaust termination should not be screened. **Note**: Screening the dryer exhaust termination will cause the dryer duct to clog.

International Residential Code M1501.1 General. Dryer exhaust systems shall be independent of all other systems, shall convey the moisture to the outdoors and shall terminate on the outside of the building. Exhaust duct termination's shall be in accordance with the dryer manufacturer's installation instructions. Screens shall not be installed at the duct termination. Exhaust ducts shall not be connected with sheet-metal screws or fastening means which extend into the duct. Exhaust ducts shall be equipped with a backdraft damper. Exhaust ducts shall be constructed of minimum 0.016-inch-thick (0.406 mm) rigid metal ducts, having smooth interior surfaces with joints running in the direction of air flow. Flexible transition ducts used to connect the dryer to the exhaust duct system shall be limited to single lengths, not to exceed 8 feet (2438 mm) in length and shall be listed and labeled in accordance with UL 2158A. Transition ducts shall not be concealed within construction.

International Residential Code M1501.3 Length limitation. The maximum length of a clothes dryer exhaust duct shall not exceed 25 feet (7620 mm)from the dryer location to the wall or roof termination. The maximum length of the duct shall be reduced 2.5 feet (762 mm) for each 45-degree (0.79 rad) bend and 5 feet (1524 mm) for each 90-degree (1.6 rad) bend. The maximum length of the exhaust duct does not include the transition duct.
