PROPERTY INSPECTION REPORT

Prepared For: Client Name Here
(Name of Client)

Concerning: Address, City, TX 00000
(Address or Other Identification of Inspected Property)

By: Scott Lewis, Lic #10539 Date Here
(Name and License Number of Inspector) (Date)

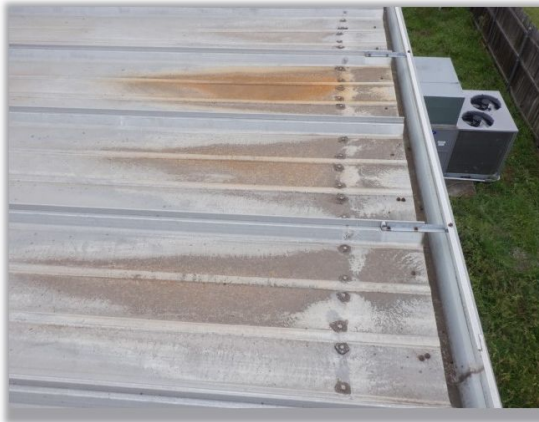
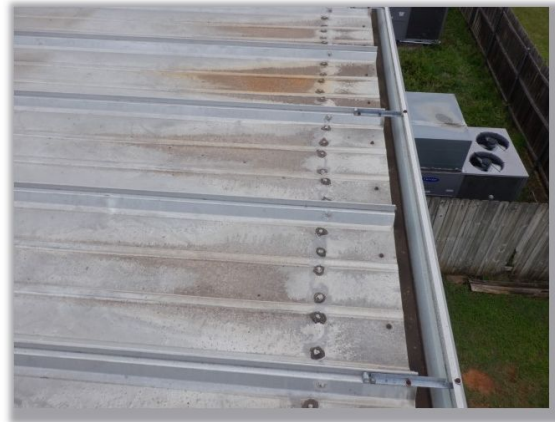
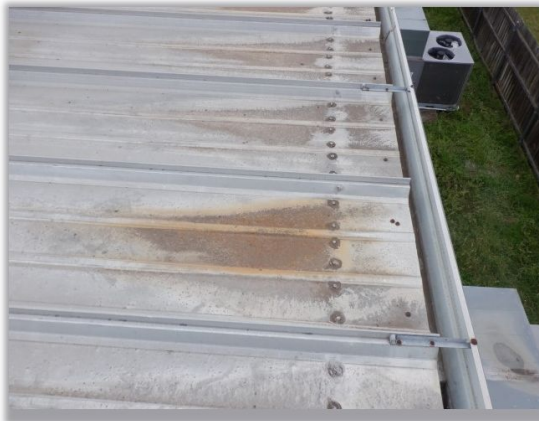
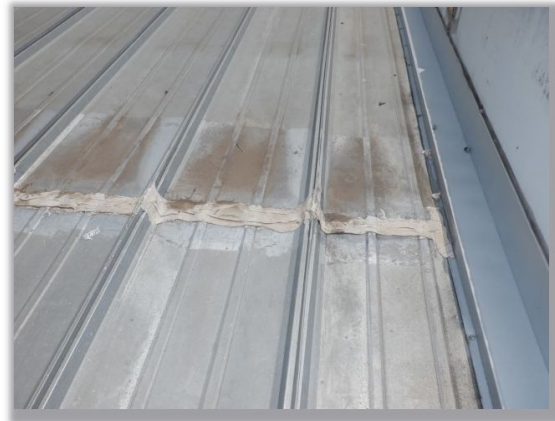
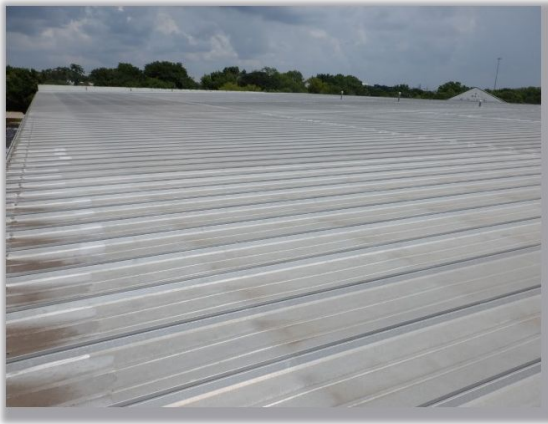
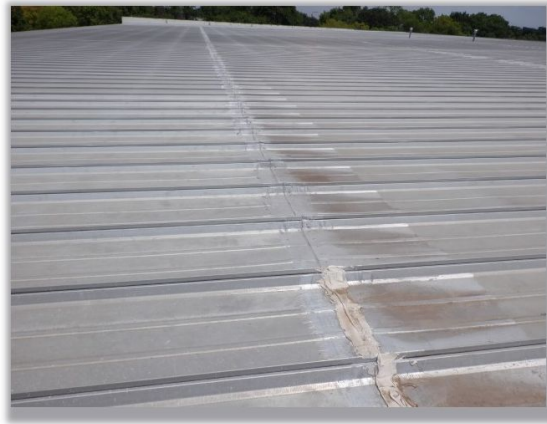
The overall condition of the roofing material is in fair condition. With regular maintenance, you should expect 15+ years of remaining life expectancy from the metal roofing material. There is visible evidence of previous repairs to the roofing material and the building owner stated her has had previous roof leaks that have been repaired.

- Rust was observed on the surface of the metal roofing material. This condition needs to be further evaluated as corrected as necessary. It is recommended to have the rusted surfaces cleaned and sealed to help extend the roofs life expectancy.

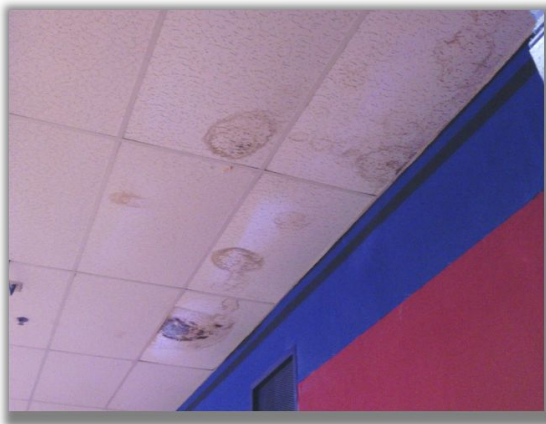
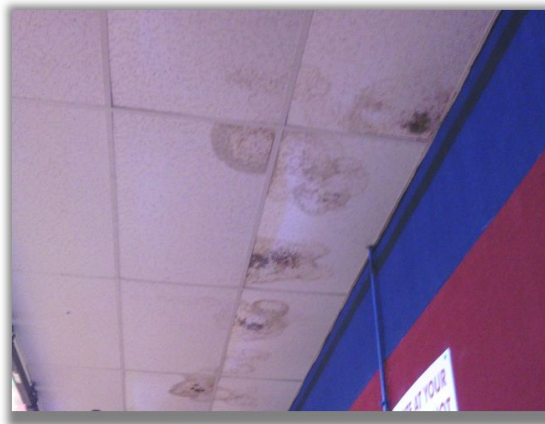
- The insulation under the metal roofing material was observed to be pulling loose and falling out of place along the east and west perimeter walls. This condition has caused condensation damage to the drop ceiling tiles. The drop ceiling tiles were observed to be water damaged under the loose insulation and suspended HVAC units above the drop ceiling tiles.

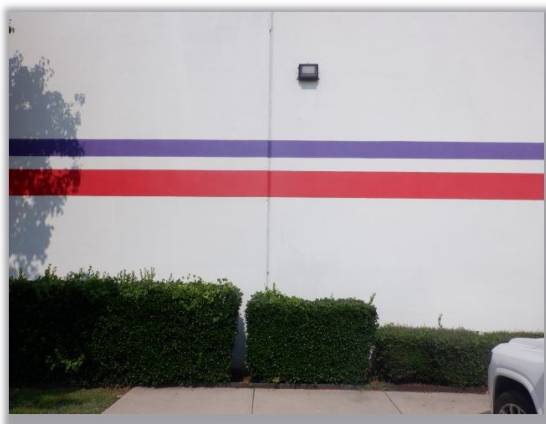
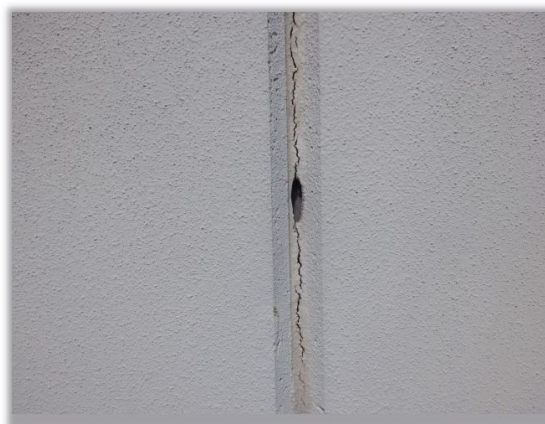
- The tilt wall expansion joints need to be properly sealed on the north, east, west and south sides of the structure. It is recommended to use an elastomeric caulking.

- The wood veneer trim and soffits has some deterioration or damage on the east side of the structure at the front entrance cover.
- The area between the exterior cladding / veneer and all of the wall penetrations / openings need to be properly sealed. Areas such as utility connections, downspouts, hose bibbs, lighting fixtures, receptacles etc. It is recommended to use an industry approved low-modulus elastomeric sealant.

- **Note:** Minor cracking of the concrete walls was observed on the west side of the structure. The is common to observe with the structure of this age and no repairs are recommended.

- **Note:** The concrete tile wall steel reinforcement was installed shallow and has caused some discoloration of the wall surface on the north and west sides of the structure.

- **Note:** Minor cracking of the concrete tilt walls were observed at and around the expansion joints. The is common to observe with the structure of this age and no repairs are recommended.

- **Note:** The heavy foliage growing on, over or around the exterior walls of the structure should be trimmed back at least 18-inches. The heavy foliage will limit the Inspectors visual observation of the exterior surfaces.

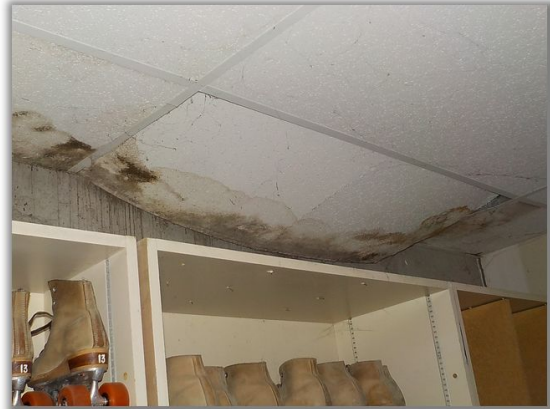
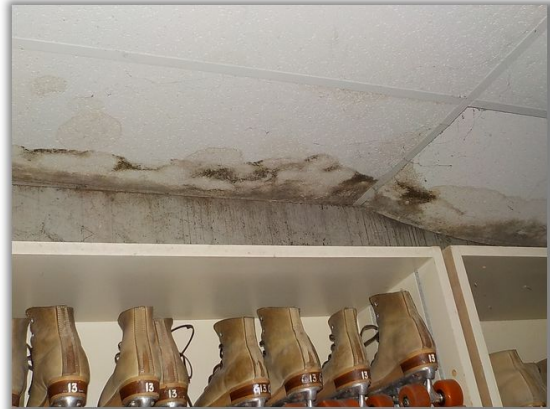
- The drop ceiling tiles were observed to be water stained and damaged in various locations. It is recommended to replace all damaged and stained tiles. It has rained in the last 24 hours and with the use of thermal imaging, there was no elevated moisture levels detected in the drop ceiling tiles at the time of this inspection.

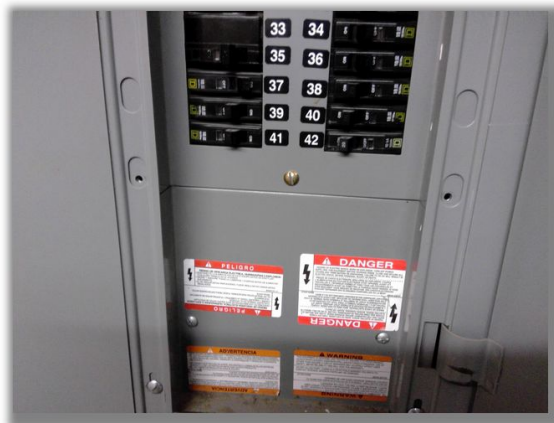
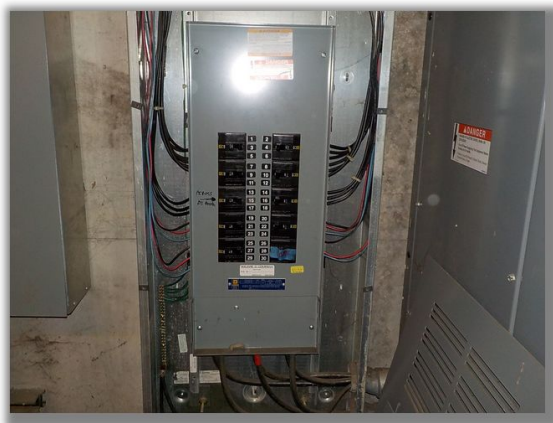
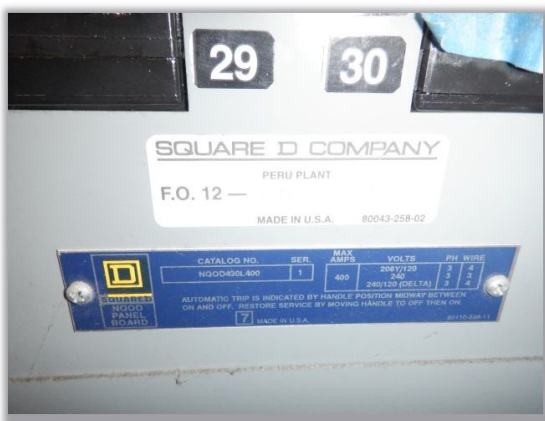
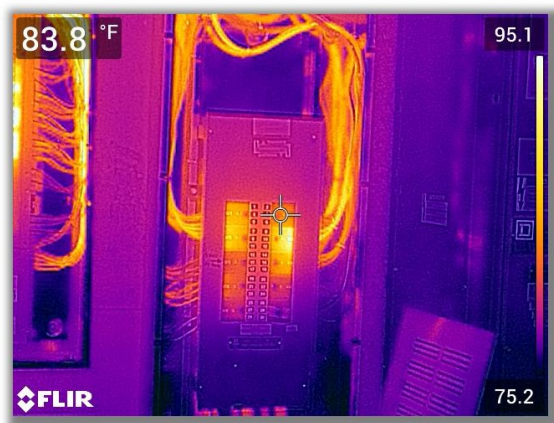
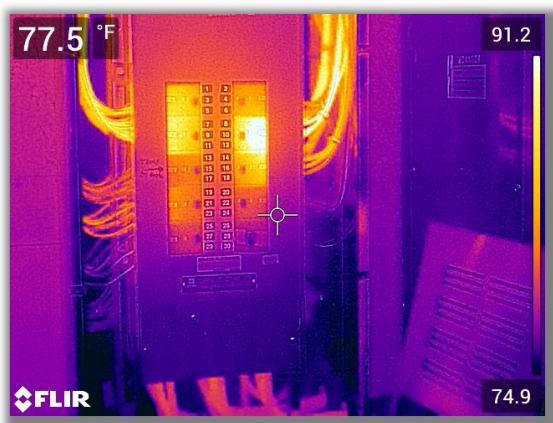
- The breakers (overcurrent devices) in the electrical panel are not properly labeled.
- One or more of the cabinet cover plate screws are missing and need to be replaced.

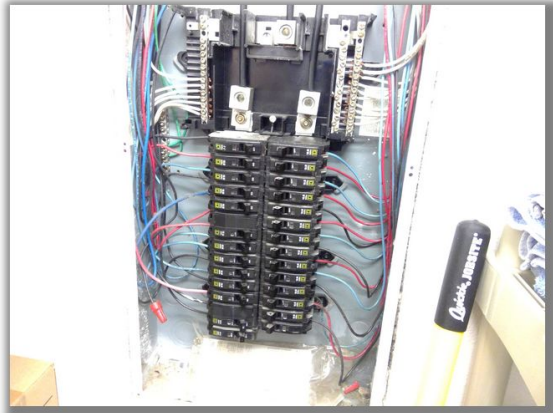
- The breakers (overcurrent devices) in the electrical panel are not properly labeled.
- One or more of the cabinet cover plate screws are missing and need to be replaced.
- The electrical cabinet cover plate door is missing. This should be corrected for reasons of safety.

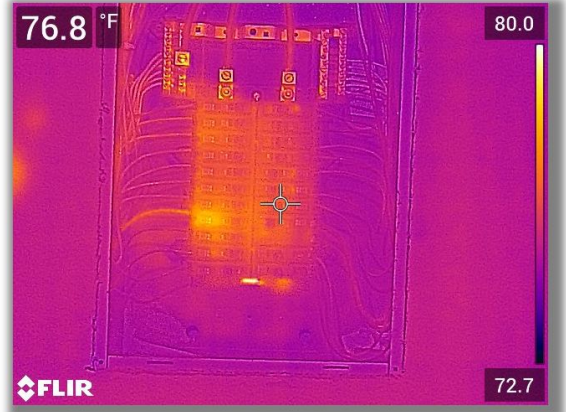
- The breakers (overcurrent devices) in the electrical panel are not properly labeled.

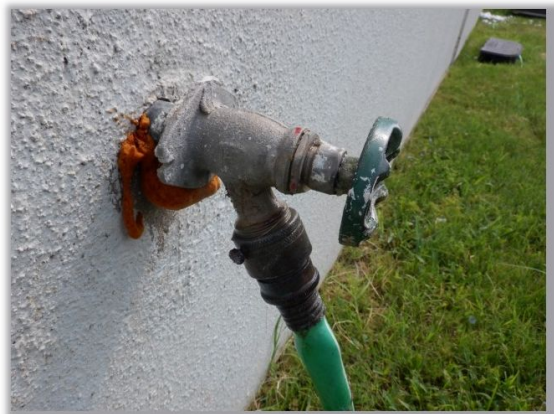
- The exterior water hose bibb (faucet) is leaking at the handle when in the off position on the south side of the structure.

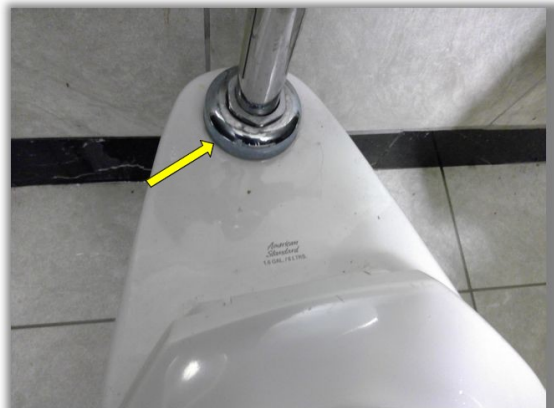
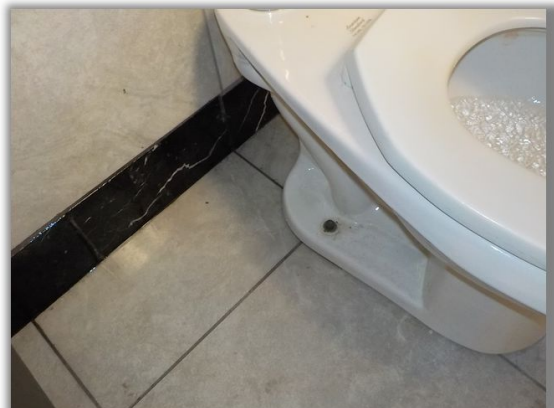
- The commode is inoperative. The cause and remedy should be further evaluated and corrected as necessary.

- The commode leaks between the bowl and tank when flushed. The cause and remedy should be further evaluated and corrected as necessary.

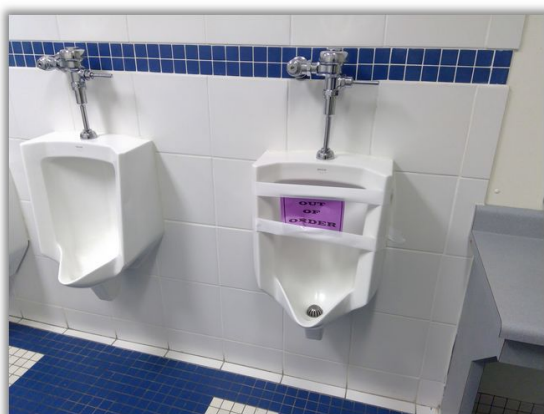
- The urinal is inoperative. The cause and remedy should be further evaluated and corrected as necessary.

- The commode leaks water onto the floor. The cause and remedy should be further evaluated and corrected as necessary.

- The faucet appears to have low water pressure on the hot and cold sides of the faucet when operated. The cause and remedy should be further evaluated and corrected as necessary.

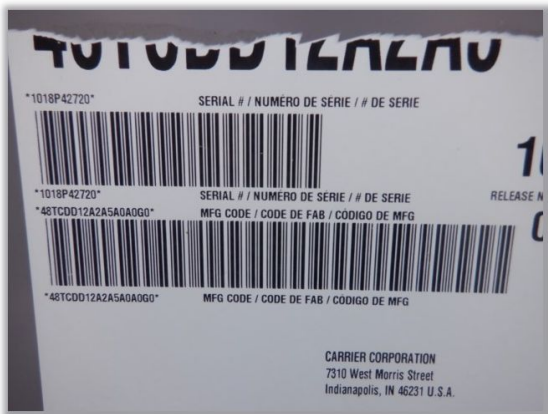
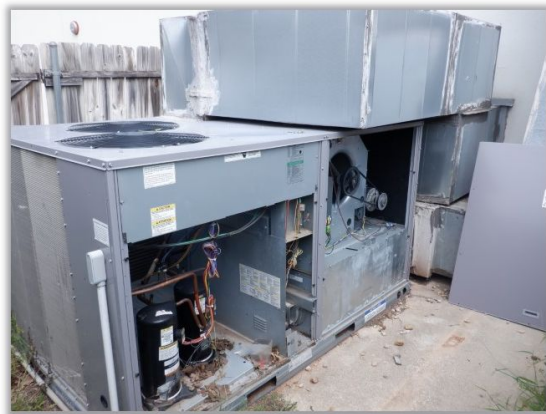
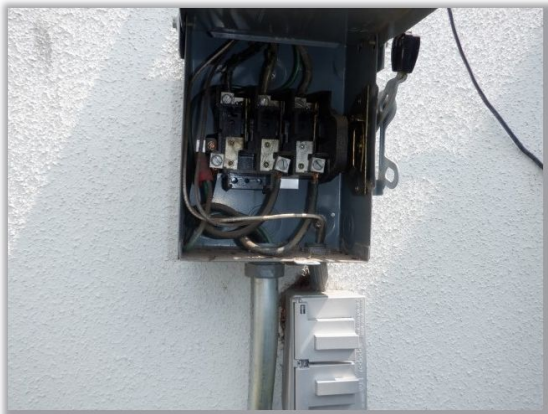
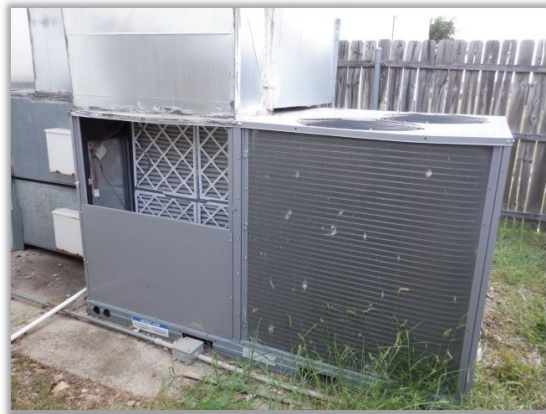
- The fins of the outdoor portion of the air conditioning system were observed to be damaged. This condition can reduce the efficiency of the system.

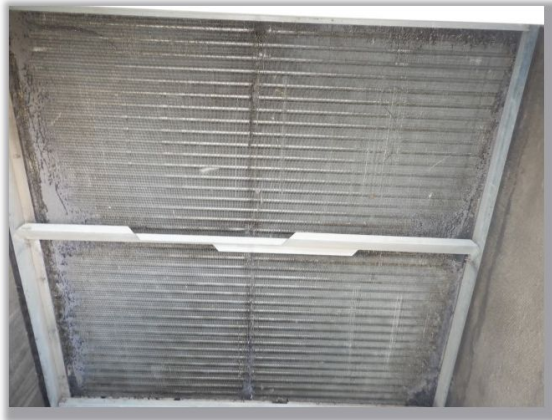
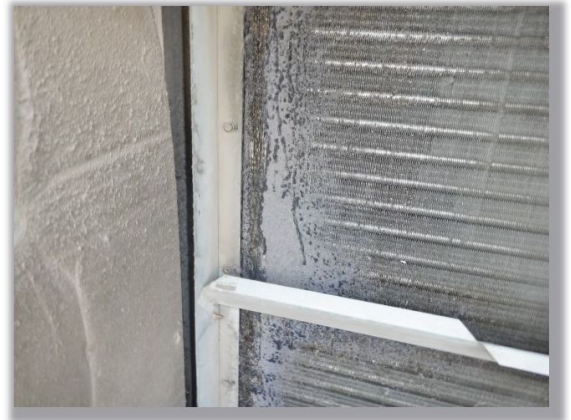
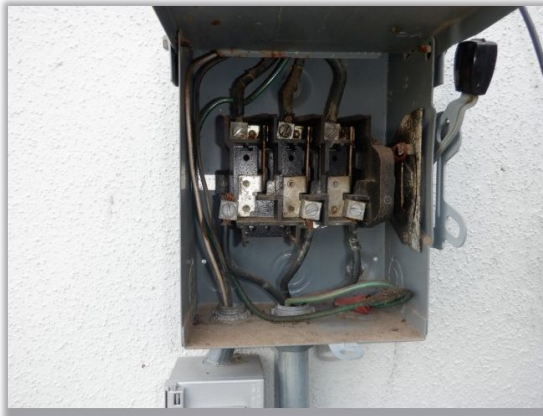
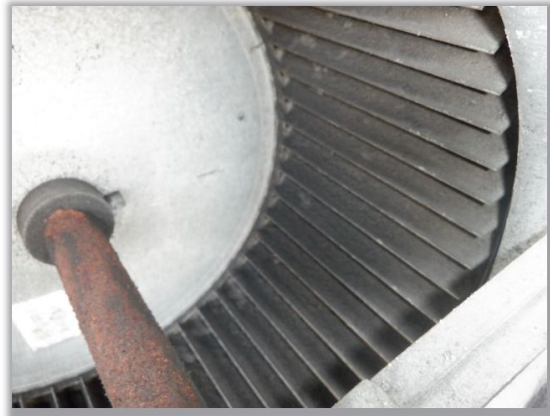
- The main blower belt was observed to be loose. The belt needs to be tightened to improve performance and air movement.
- The indoor blower observed to be dirty and should be cleaned to help improve the efficiency of the unit.
- The evaporator coils were observed to be dirty and require cleaning.
- The fins of the outdoor portion of the air conditioning system were observed to be damaged. This condition can reduce the efficiency of the system.

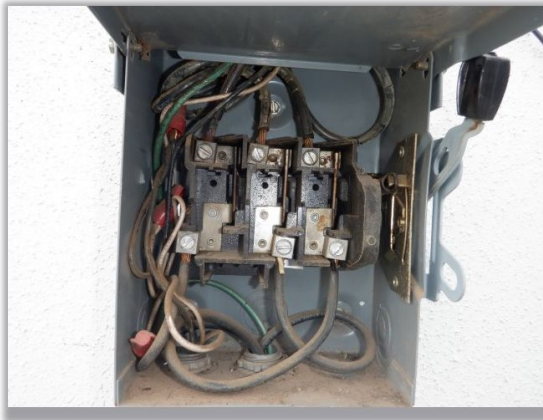
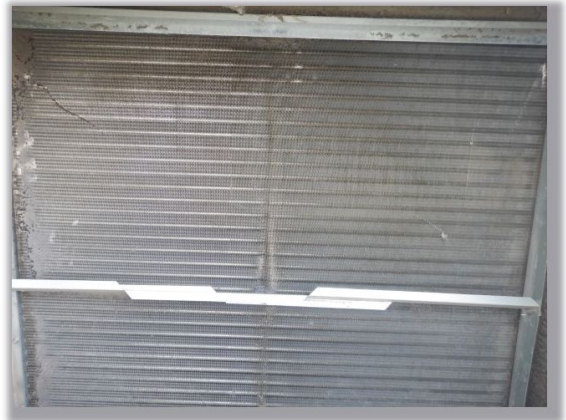
- The main blower belt was observed to be loose. The belt needs to be tightened to improve performance and air movement.

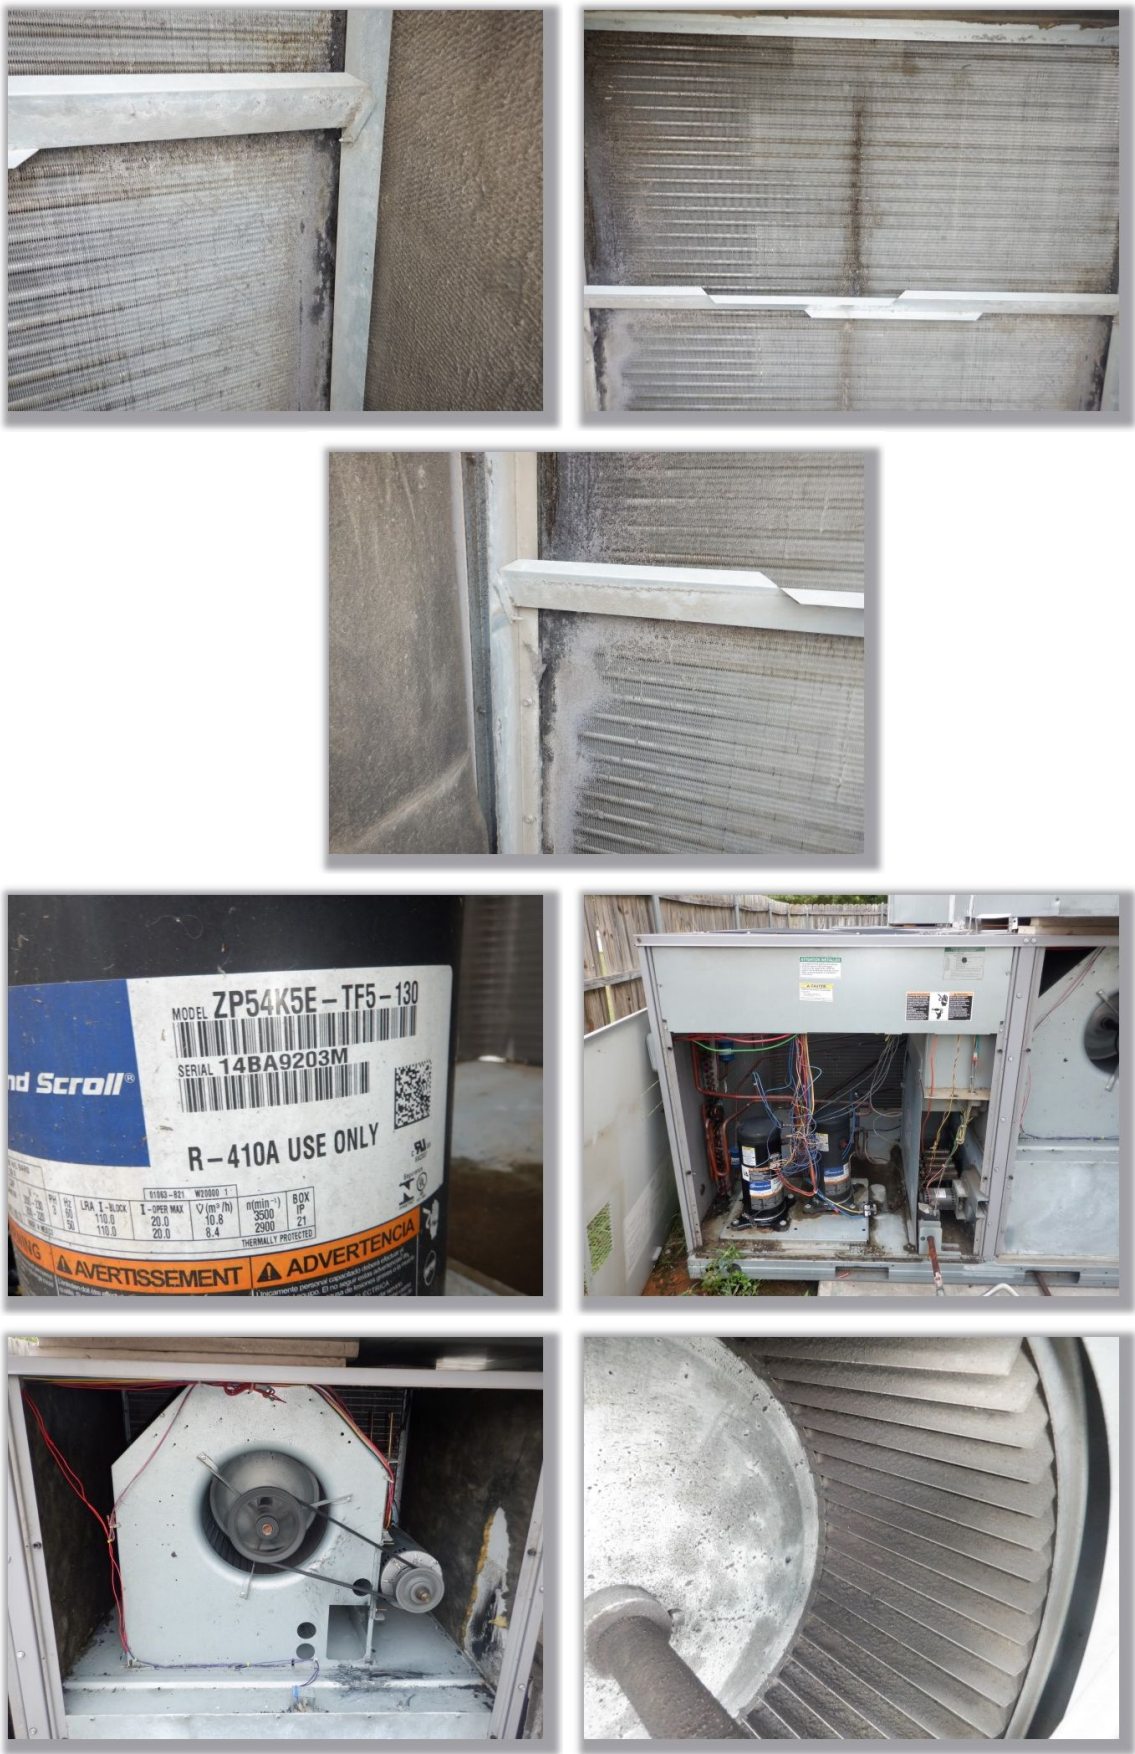
- **The temperature drop measured across the evaporative coils of the air conditioning system is lower than considered typical. The unit is not cooling properly and servicing is needed.**
- The evaporator coils were observed to be dirty and require cleaning.
- The indoor blower observed to be dirty and should be cleaned to help improve the efficiency of the unit.
- The fins of the outdoor portion of the air conditioning system were observed to be damaged. This condition can reduce the efficiency of the system.

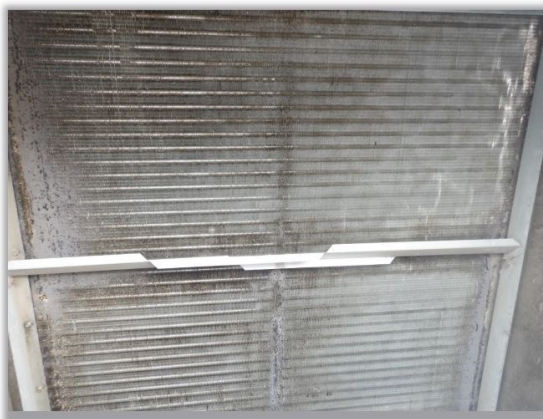
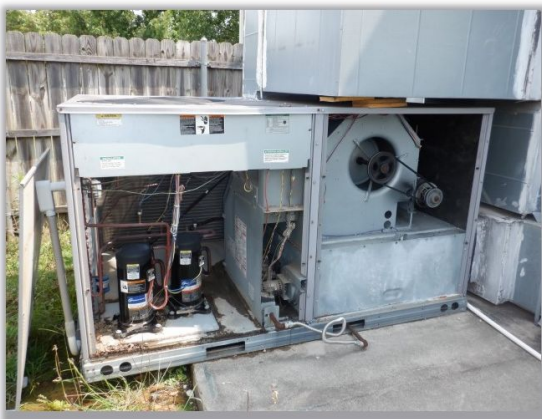
- The indoor blower observed to be dirty and should be cleaned to help improve the efficiency of the unit.
- The evaporator coils were observed to be dirty and require cleaning.
- There was no service disconnect observed within sight of the outside condenser/coils. The disconnect has been bypassed.
- The main blower belt was observed to be loose. The belt needs to be tightened to improve performance and air movement.
- The primary drain line is clogged and the interior of the housing is filling with water and leaking into the heater compartment. This condition needs to be corrected.

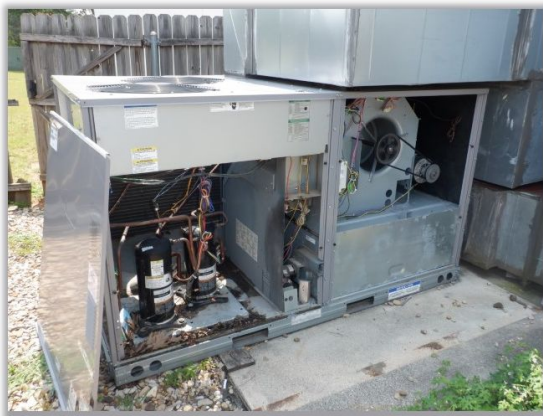
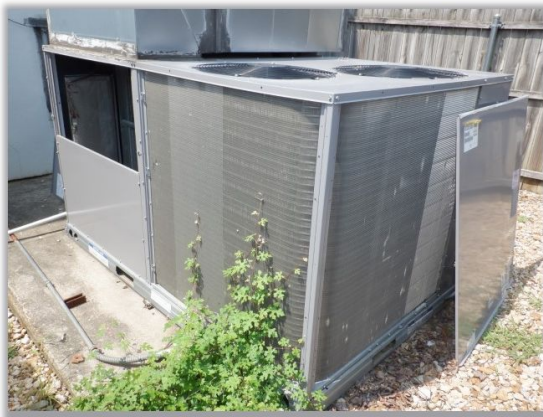
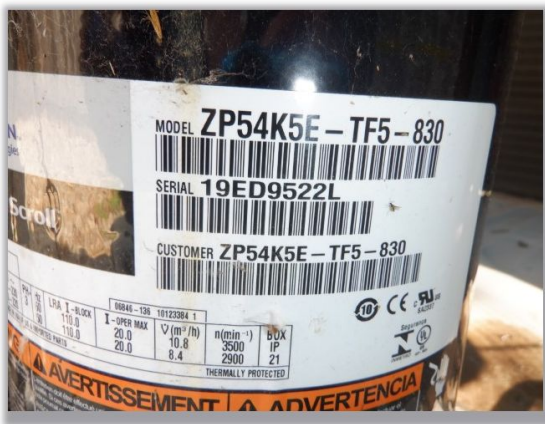
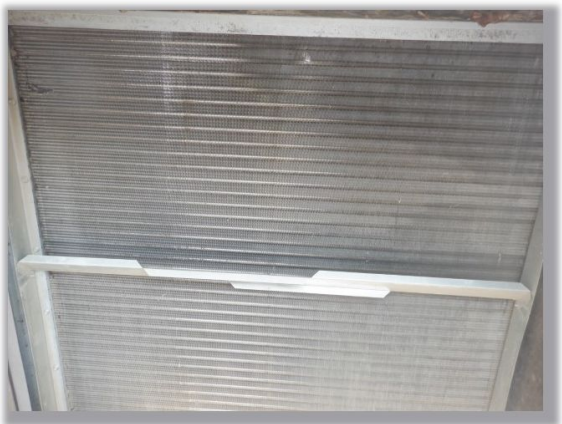
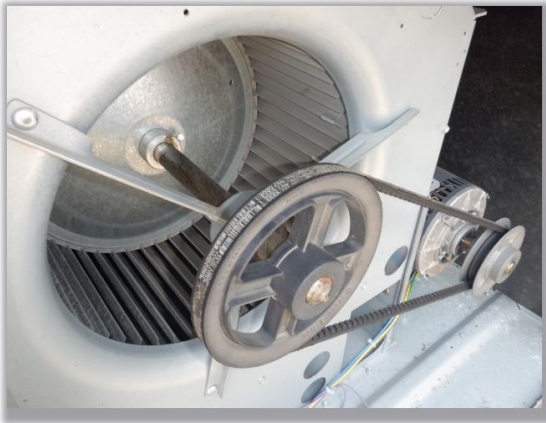
- **The temperature drop measured across the evaporative coils of the air conditioning system is lower than considered typical. The unit is not cooling properly and servicing is needed.**

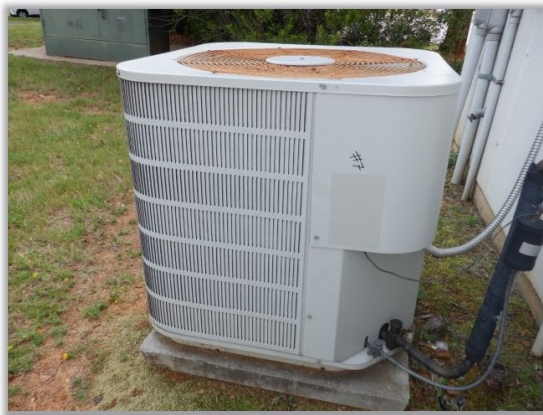
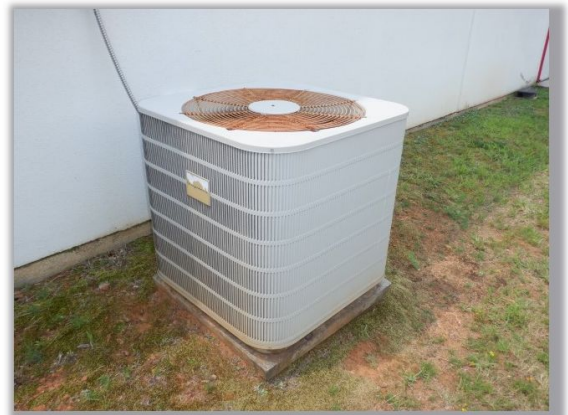
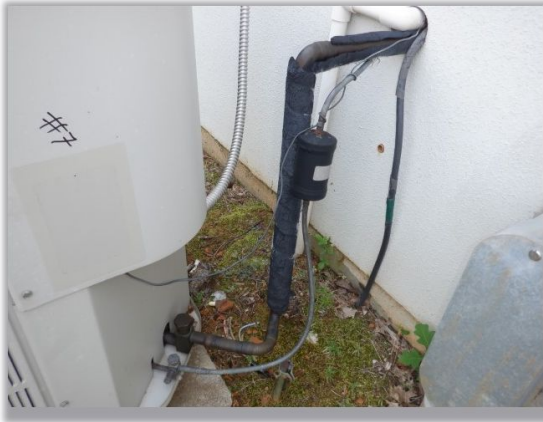
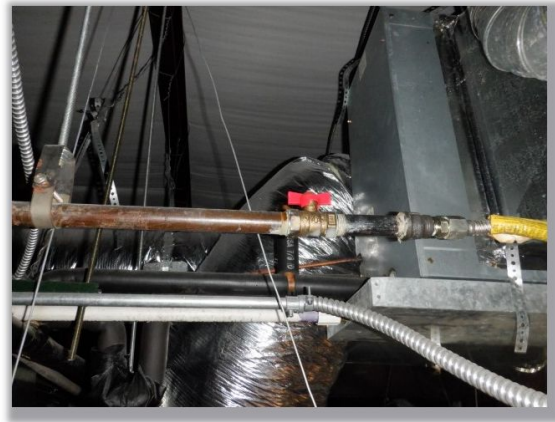
The HVAC system is older and replacement is necessary at this time. The approximate replacement cost for the HVAC system is \$10,000 to 12,500.

- The gas supply flex connector was observed to be passing through the heating unit cabinet. Under current mechanical installation standards, this is no longer an accepted practice. Only rigid black gas pipe is allowed to pass through the heating unit cabinet.
- The front cover panel plastic retention clips are damaged and the cover does not fasten in place / securely properly.
- Damaged, deteriorated (aged) and/or missing insulation on the refrigerant lines in the space above the drop ceiling tiles should be repaired or replaced as necessary. The old insulation is allowing condensation to drip onto the drop ceiling tiles causing water stains and damage.
- The indoor blower observed to be dirty and should be cleaned to help improve the efficiency of the unit.
- The evaporator coils were observed to be dirty and require cleaning.
- The dirty air filter should be replaced.

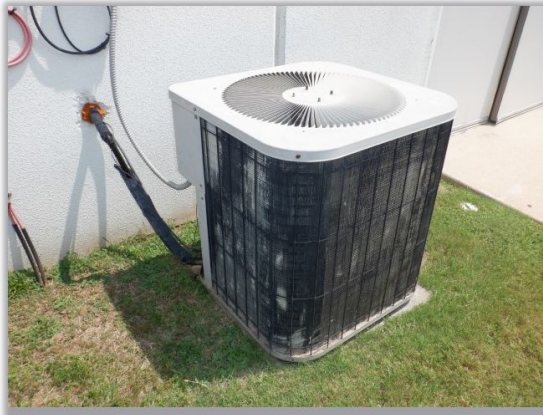
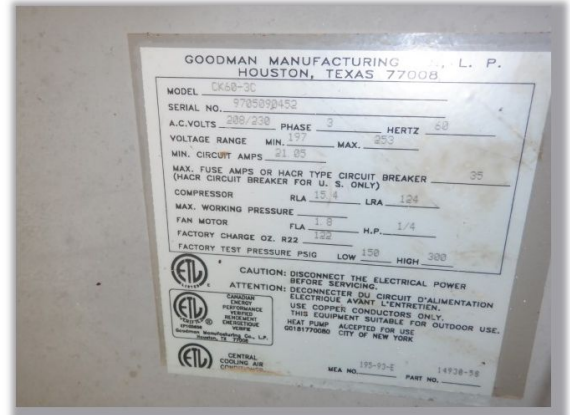
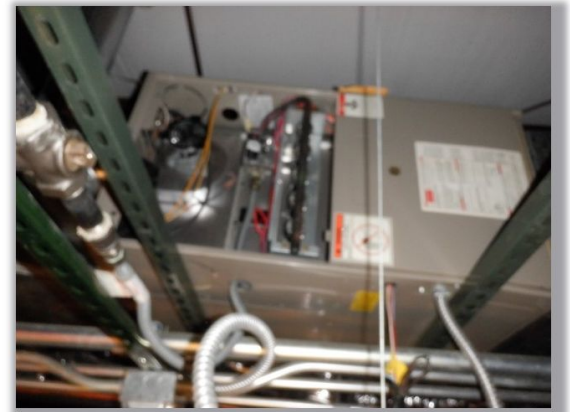
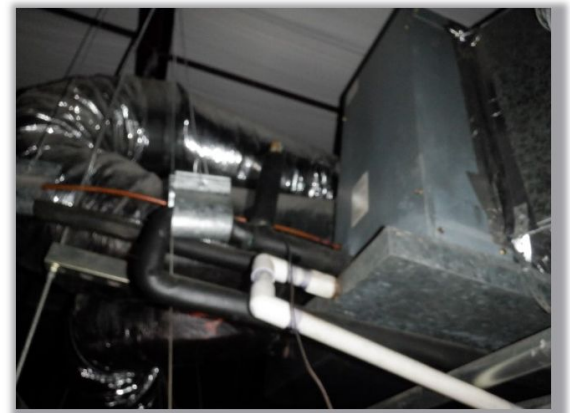
The HVAC system is older and replacement is necessary at this time. The approximate replacement cost for the HVAC system is \$10,000 to 12,500.

- The gas supply flex connector was observed to be passing through the heating unit cabinet. Under current mechanical installation standards, this is no longer an accepted practice. Only rigid black gas pipe is allowed to pass through the heating unit cabinet.

- The front cover panel plastic retention clips are damaged and the cover does not fasten in place / securely properly.
- Damaged, deteriorated (aged) and/or missing insulation on the refrigerant lines in the space above the drop ceiling tiles should be repaired or replaced as necessary. The old insulation is allowing condensation to drip onto the drop ceiling tiles causing water stains and damage.

- The evaporator coils were observed to be dirty and require cleaning.
- The indoor blower observed to be dirty and should be cleaned to help improve the efficiency of the unit.

- The dirty air filter should be replaced.
- There is a Teflon coated brass gas appliance connector in use for the heating equipment. Brass is no longer an acceptable material to be used as a gas supply connector and should be replaced with an approved gas appliance flexible connector.

- Damaged, deteriorated and/or missing insulation on the refrigerant lines should be repaired or replaced at the outside condenser.
- The fins of the outdoor portion of the air conditioning system were observed to be damaged. This condition can reduce the efficiency of the system.
