# PROPERTY INSPECTION REPORT FORM

Client Name Here	Date Here
Name of Client	Date of Inspection
Address HereCity, TX 00000	
Address of Inspected Property	
Brian Murphy	3948
Name of Inspector	TREC License #

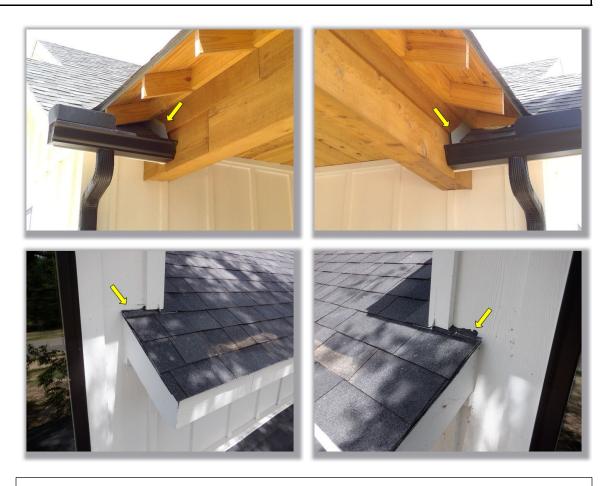
- There was no kickout flashing details observed at the lower bottom edge of the roof line interface and the sidewall that continues past the edge of the roof. The lack of this kickout flashing will allow water to penetrate at these points.
- The sidewall flashing details were observed to be missing on the west side of the structure.
- Counter flashing details were observed to be missing on the west side of the roof structure. This condition could allow water penetration at this point.

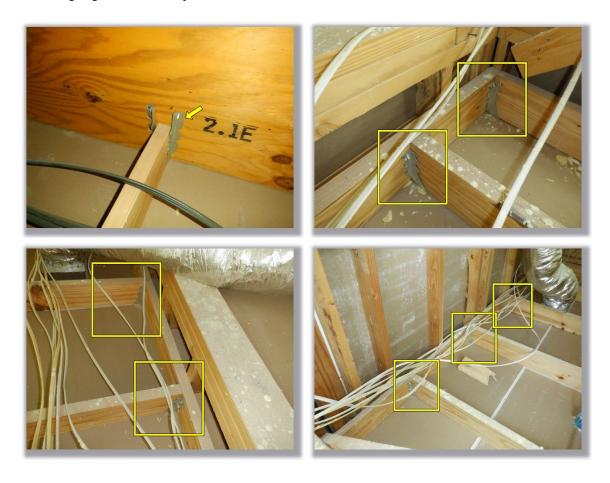
• The ceiling joist hangers are missing fasteners (nails) in various locations over the living area dining area, garage and and front porch.

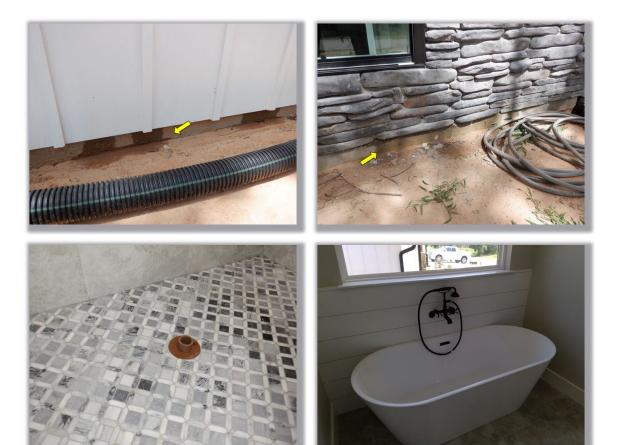
- The tub is not secured in place.
- The bathtub was observed to drain slowly, suggesting that an obstruction may exist.
