## **PROPERTY CONDITION REPORT**

### **Code Compliance Inspection**

**Concerning:** Address, City, TX 00000  
(Address of Inspected Property)

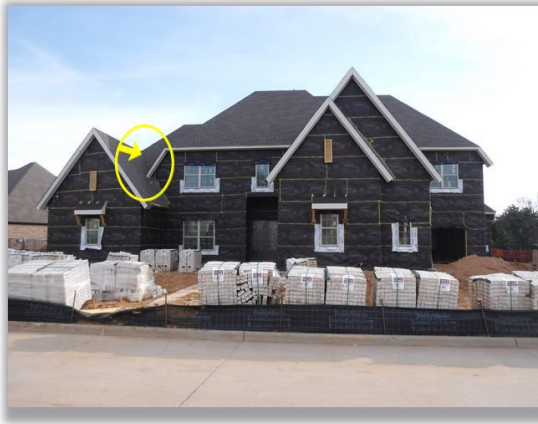
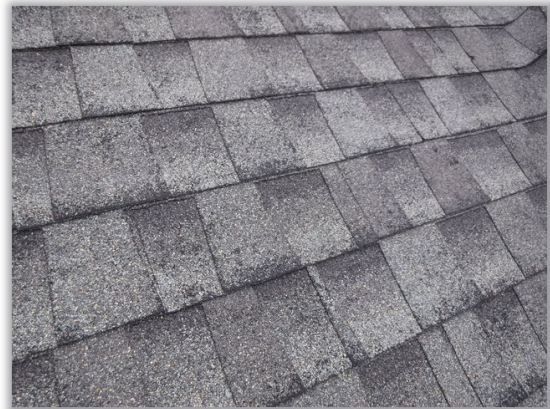
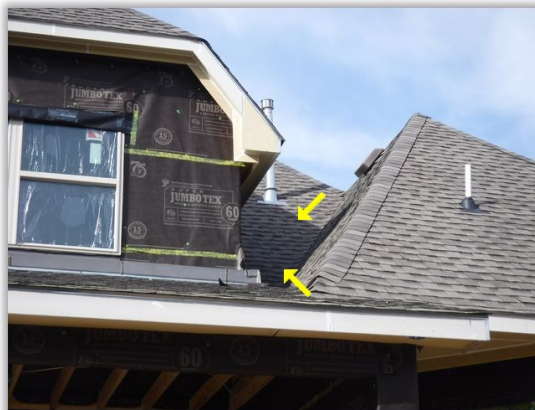
- There is a lot of foot traffic bruising and/or damage to the roofing material on the front and back sides of the roof structure.

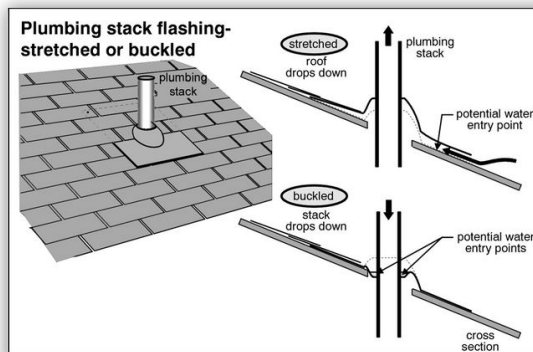
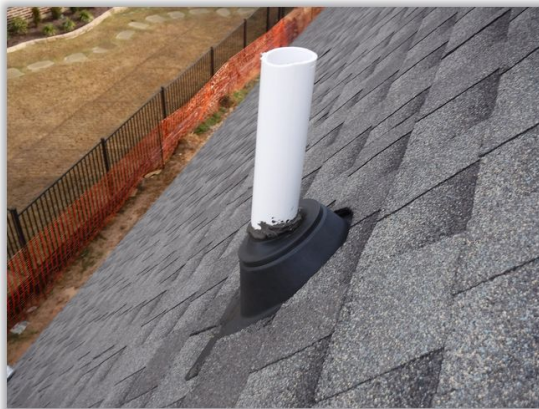
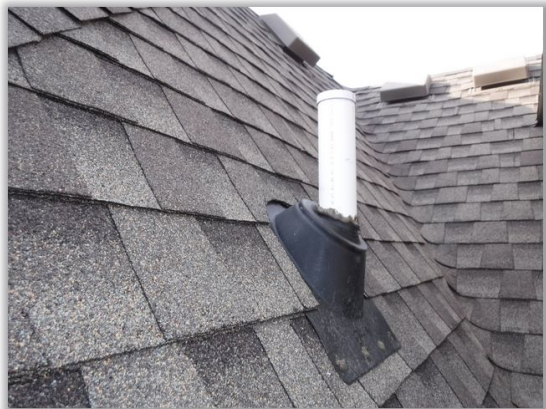
- One or more of the roof level plumbing vent stack flashing details are buckled downward around the plumbing stack. This condition could allow water penetration at this point and corrective measures are recommended.

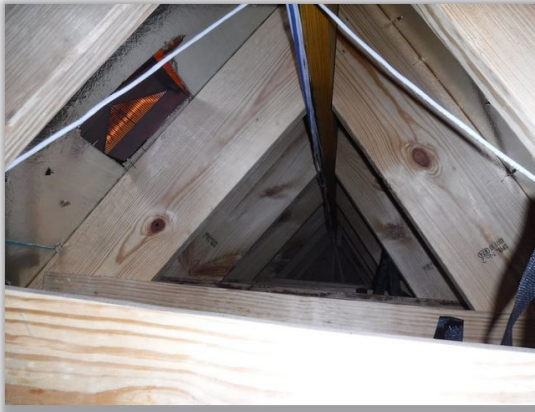
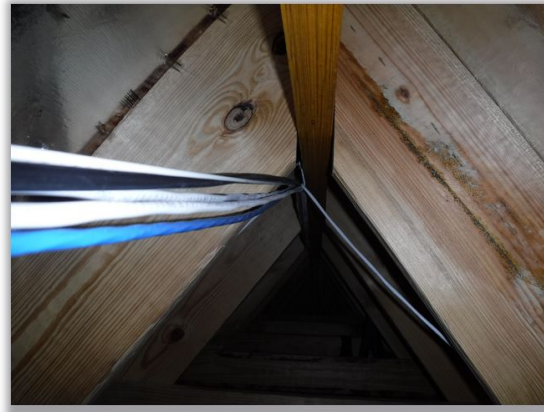
- The top ridge board is not properly sized to the cut end of the rafter over the media room. Ridge boards shall be at least 1-inch nominal thickness and not less in depth than the cut end of the rafter.

**R802.3 Framing details.** Rafters shall be framed to ridge board or to each other with a gusset plate as a tie. Ridge board shall be at least 1-inch (25 mm) nominal thickness and not less in depth than the cut end of the rafter. At all valleys and hips there shall be a valley or hip rafter not less than 2-inch (51 mm) nominal thickness and not less in depth than the cut end of the rafter. Hip and valley rafters shall be supported at the ridge by a brace to a bearing partition or be designed to carry and distribute the specific load at that point. Where the roof pitch is less than three units vertical in 12 units horizontal (25-percent slope), structural members that support rafters and ceiling joists, such as ridge beams, hips and valleys, shall be designed as beams.

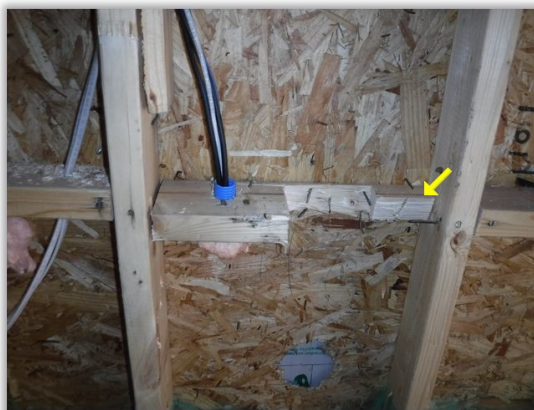
- The wall blocking is damaged in the single car garage right of the electrical panels. The block will need to be replaced.

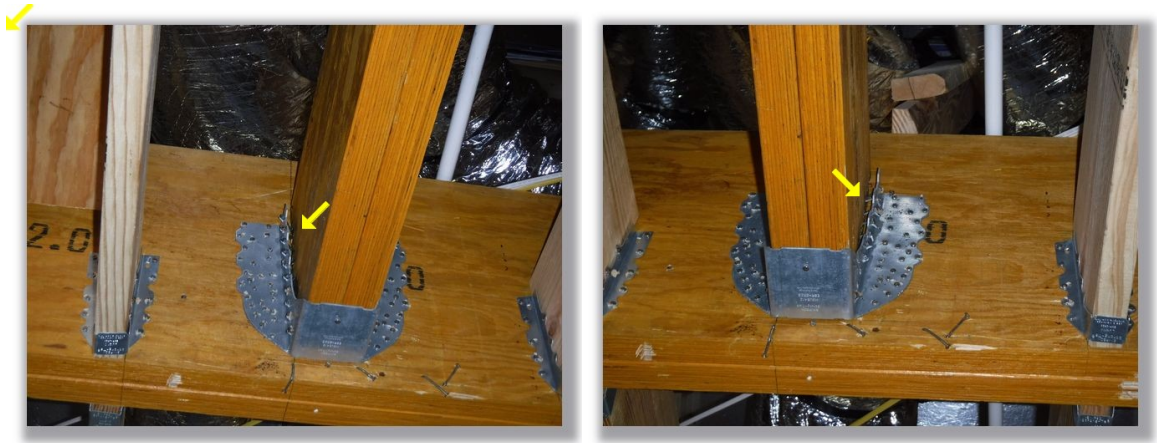
- The joist hanger over the gameroom is not properly fastened in place. There are larger gaps on both sides of the joist and the fasteners to not secure the joist.

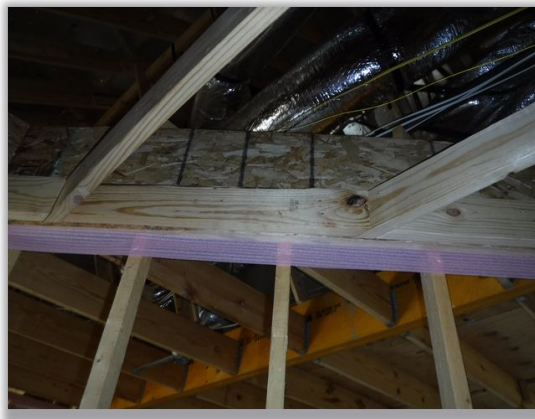
- One or more joist hanger(s) were observed to be missing over the media room wet bar area.

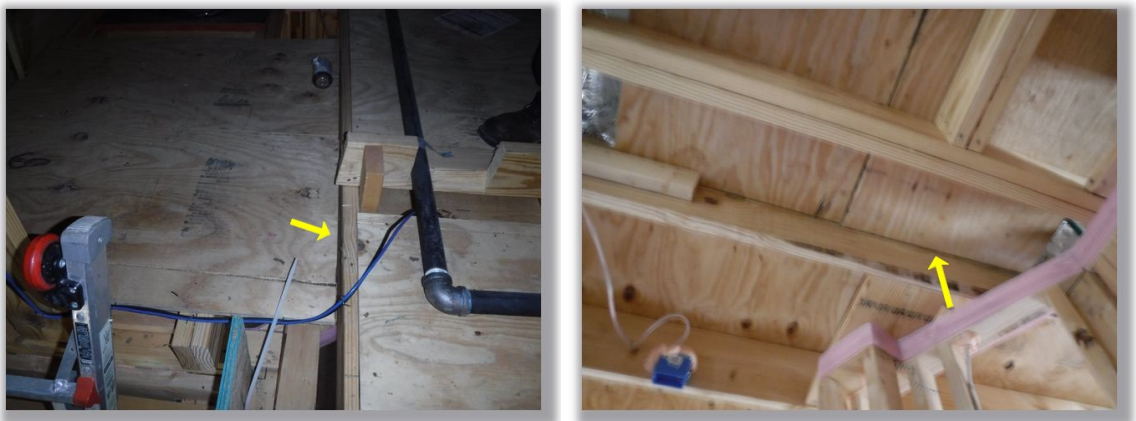
- The platform in front of the upstairs attic access needs to be better blocked to prevent someone from damaging ceiling finishes.

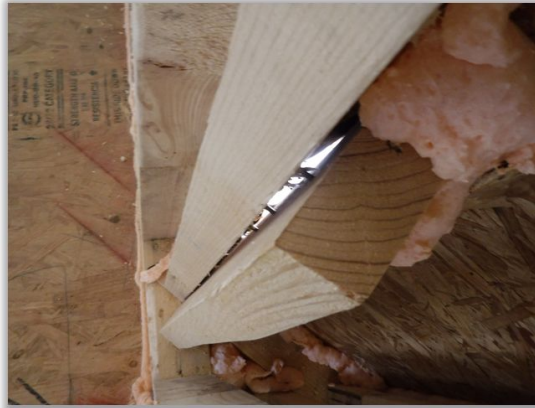
- There is daylight visible through the exterior sheathing in the upstairs northeast bedroom adjacent to the

bathroom. This area needs to be properly sealed.

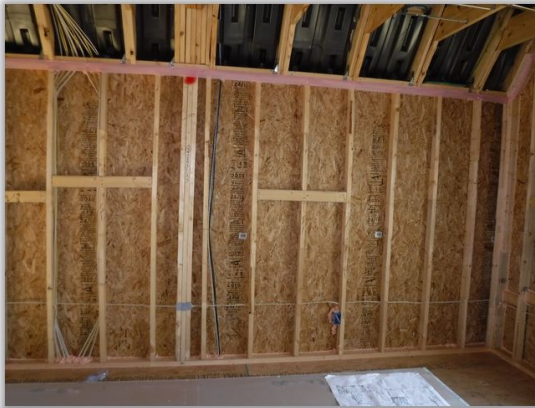
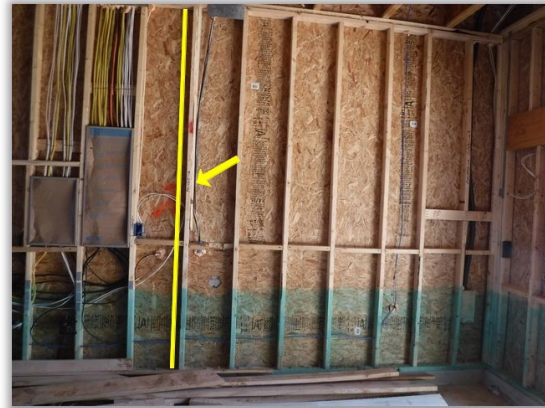
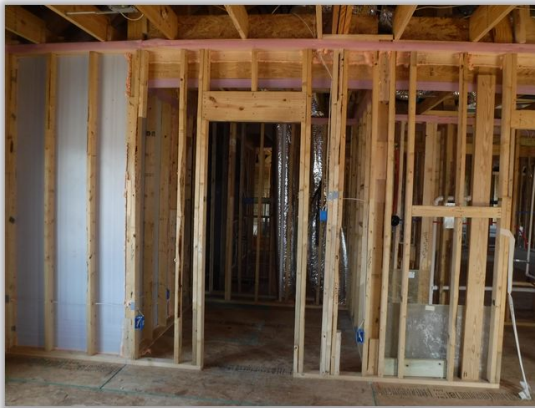
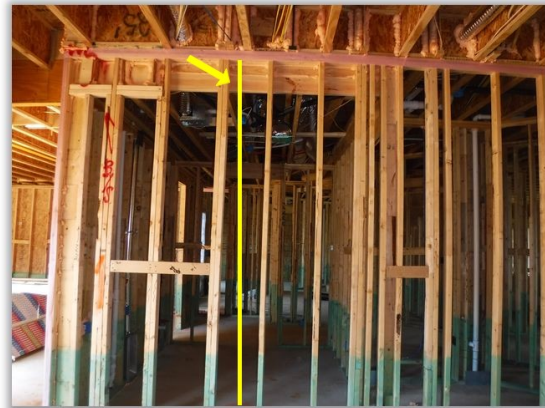
- The are doubled / tripled upped studs missing in the single car garage to line up below the load baring supports in the bedroom above it. It is recommended to ad additional stubs to help with transferring the load to the foundation.

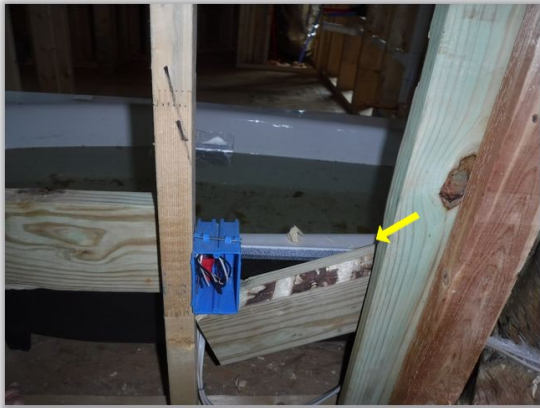
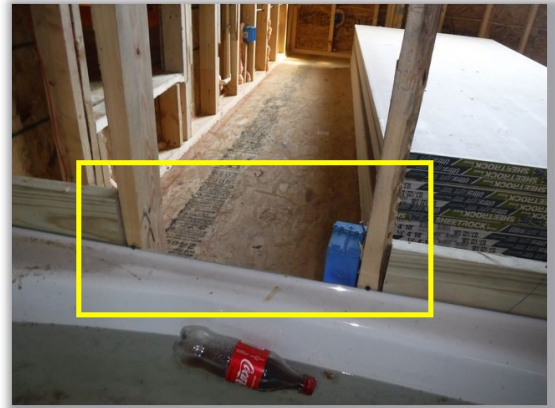
- The bathtub blockouts are missing / damaged at and around the tubs in the upstairs northeast bathroom and upstairs northwest bathroom.

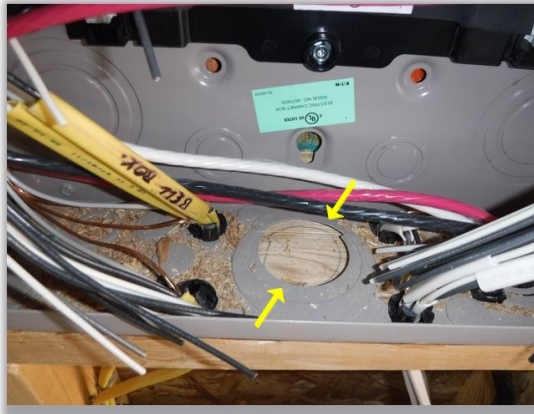
- The open unused knockouts in the bottom of the subpanel cabinet needs to be properly closed.

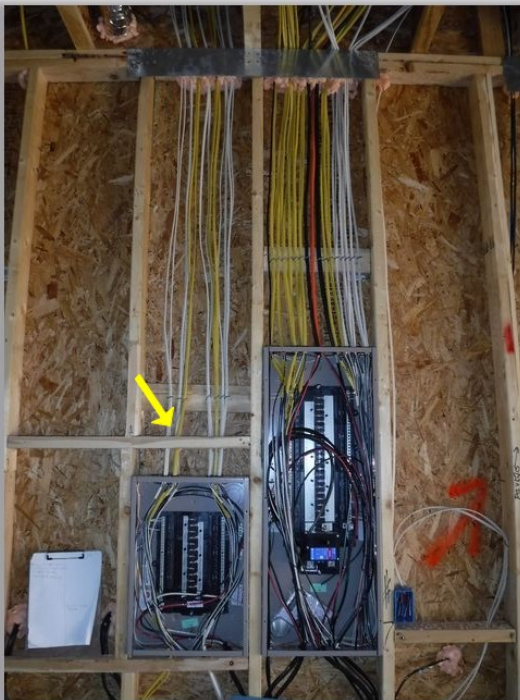
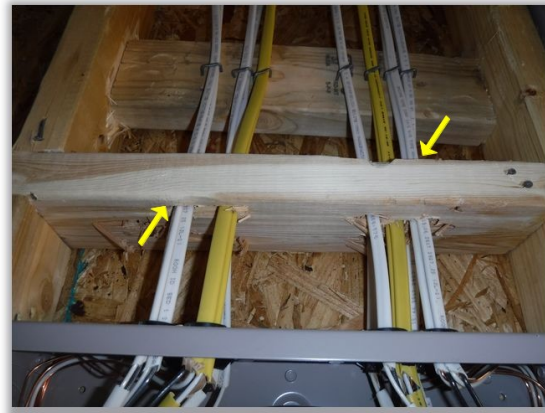
- Striker plates are needed to help protect the electrical branch circuit wiring from fastener (nail or screw) damage in various locations throughout the structure. Bored holes in framing members for wiring shall be located not less than 1 ¼ inches from the edge of the framing member or shall be protected with a minimum 0.0625-inch steel plate or sleeve, a listed steel plate or other physical protection. The striker plates are needed at the holes through the wood over the sub-panel.

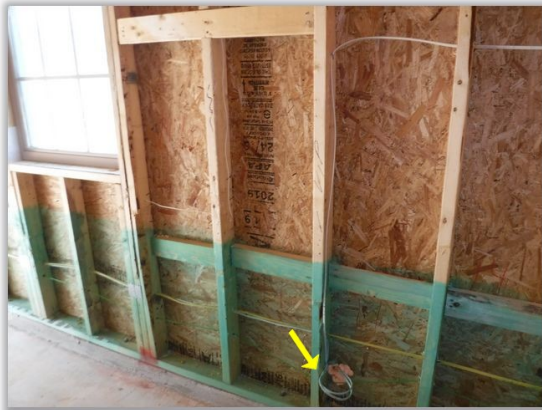
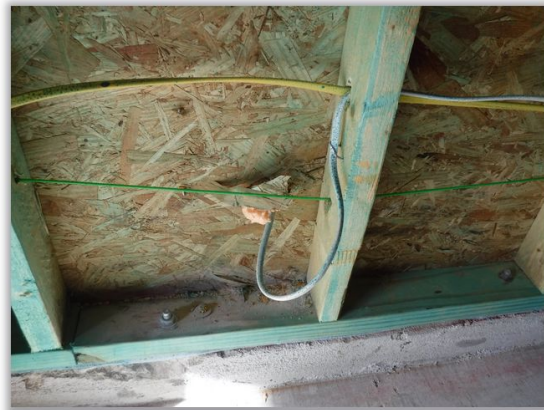
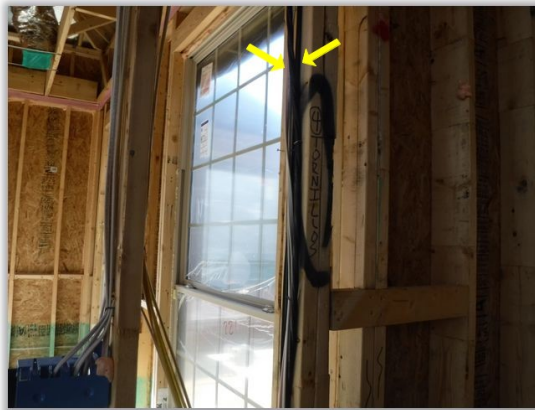
- The wires are not properly secured in place to hole the wires 1 1/2-inch from the edge of the stud face. The wires that need to be secured are located in the garage, family room and study.

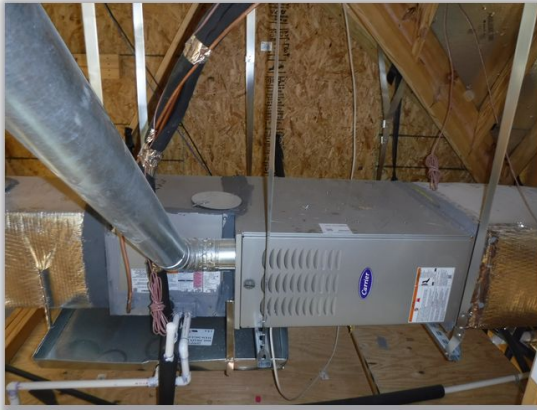
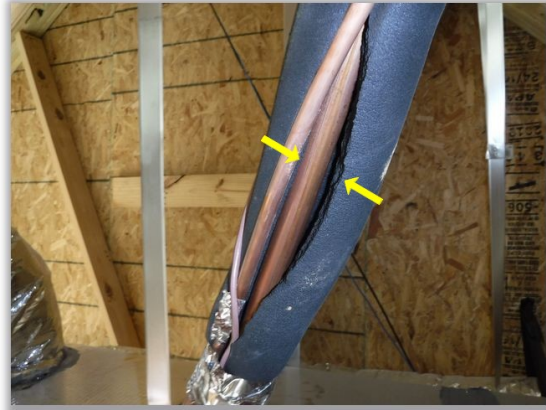
- The insulation is separating on the refrigerant lines in the attic area should be repaired or replaced as necessary at the HVAC unit over the cabana room.

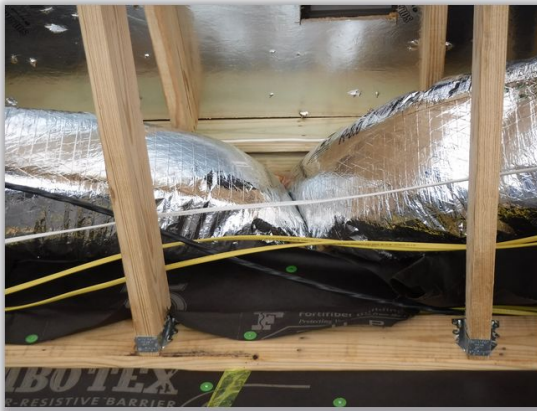
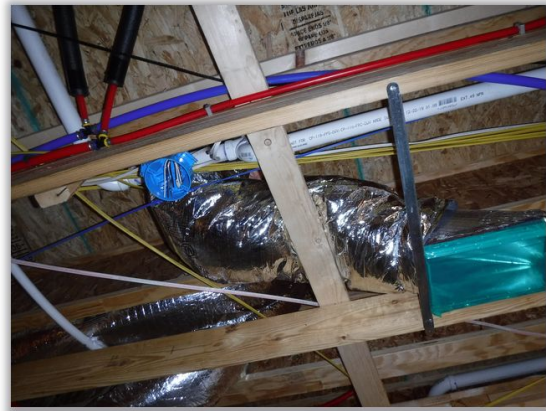
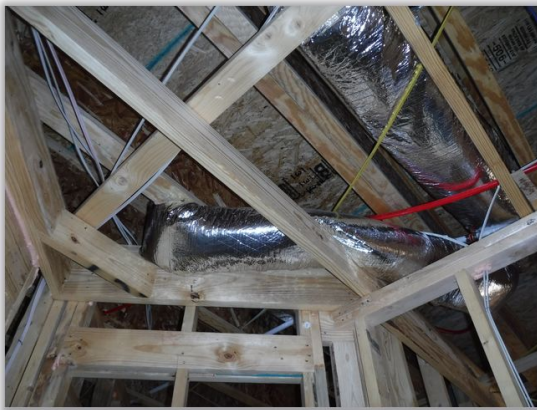
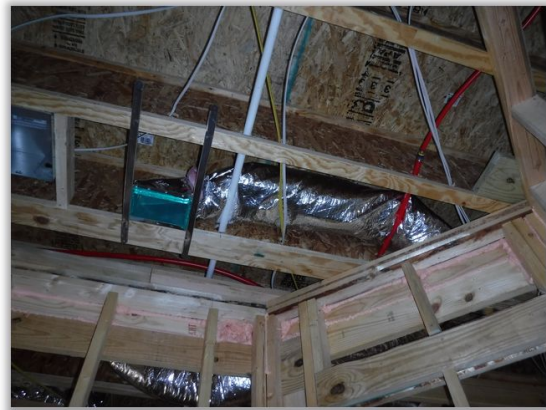
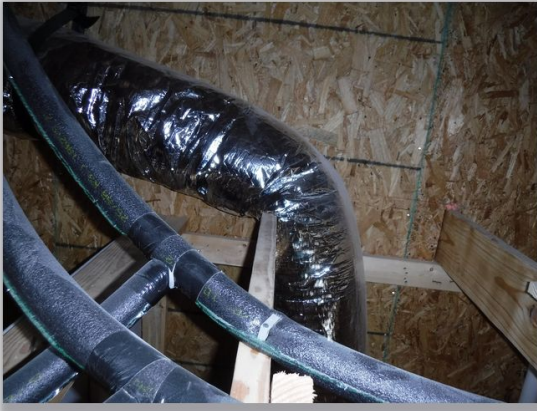
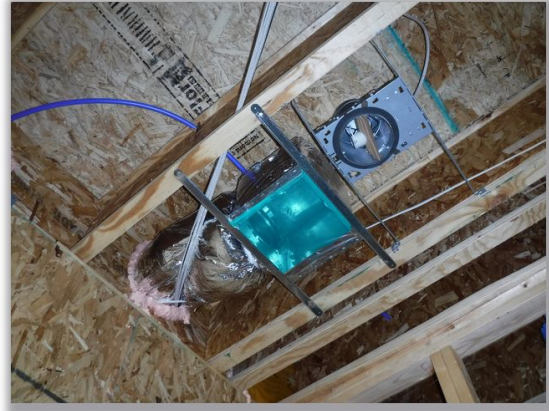
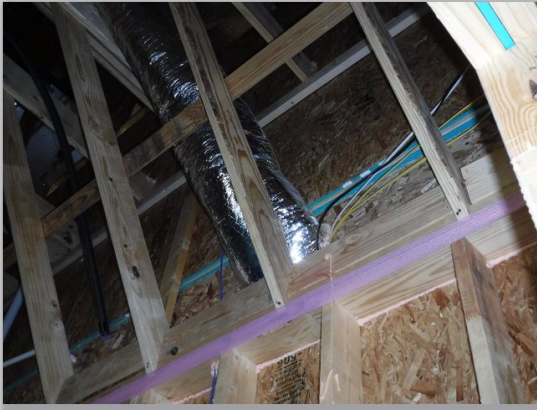
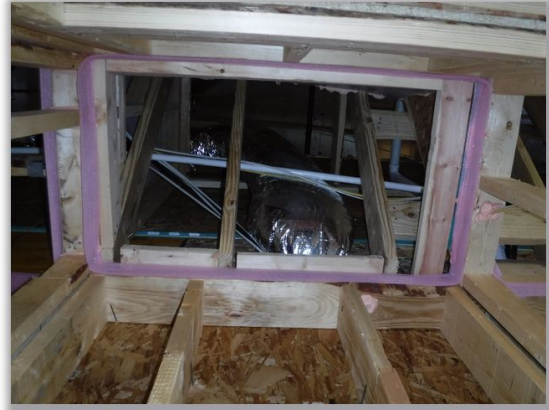
- The flex ducts are turned sharply in the attic space over the back porch, over the master bathroom traveling to study, laundry room and downstairs half bathroom. This condition does not meet current manufacturers installation standards. This condition should be corrected to help improve proper air balance and flow to the different areas of the structure.

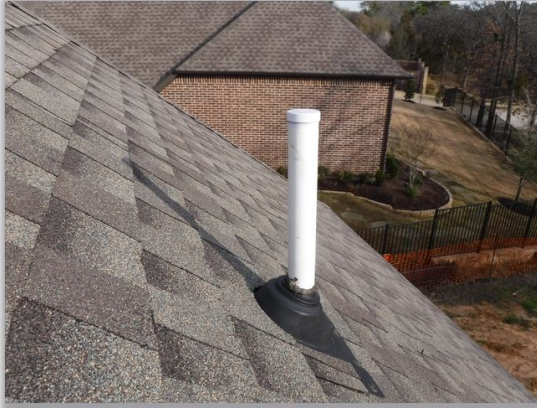
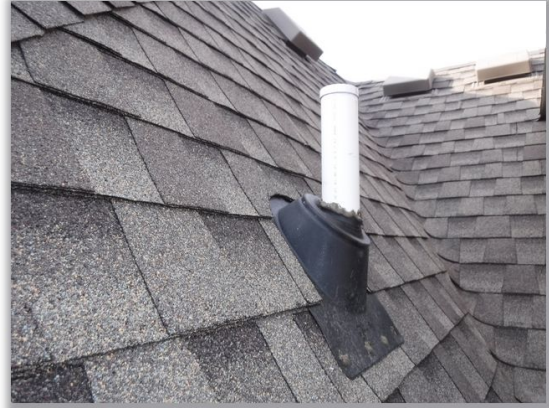
- The roof level vent stacks need to be painted to help protect them from UV breakdown.
- Several of the plumbing stacks are capped at the roof level termination.

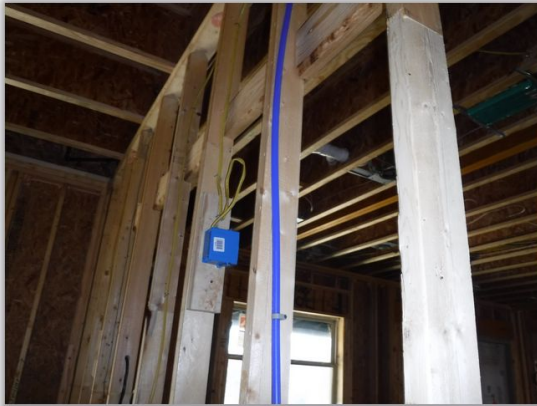
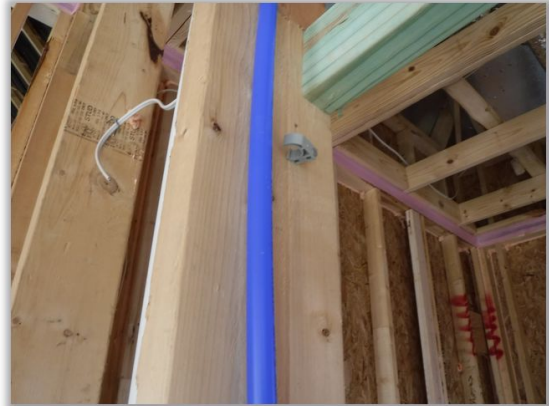
- The plumbing water lines need to be better secured with the wall cavity in the cabana room pool bath. This will help prevent hammering and water line knocking.

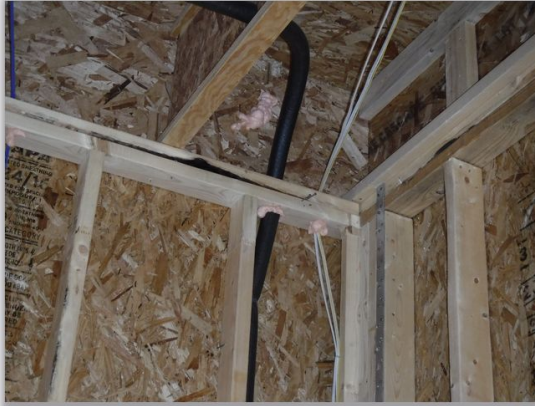
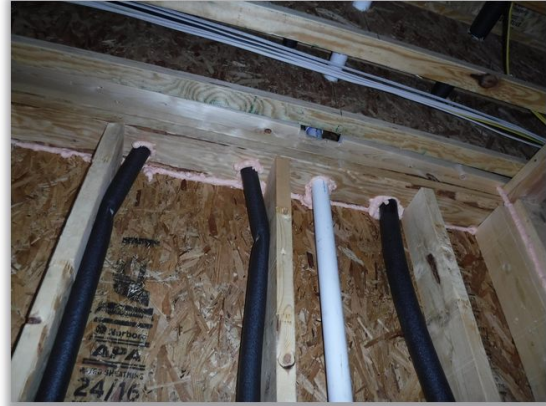
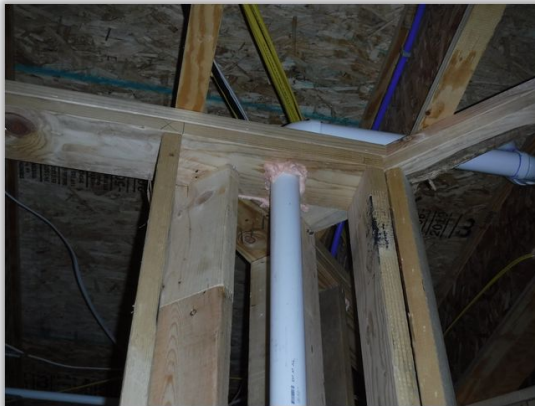
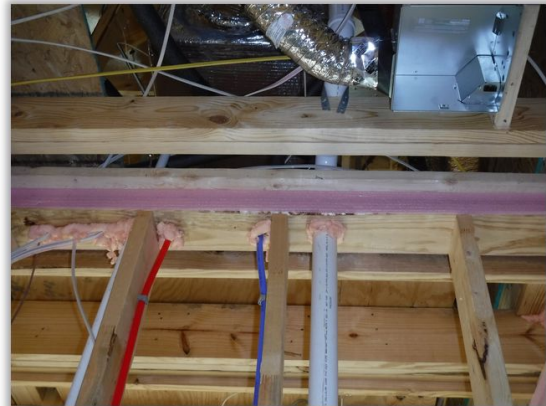
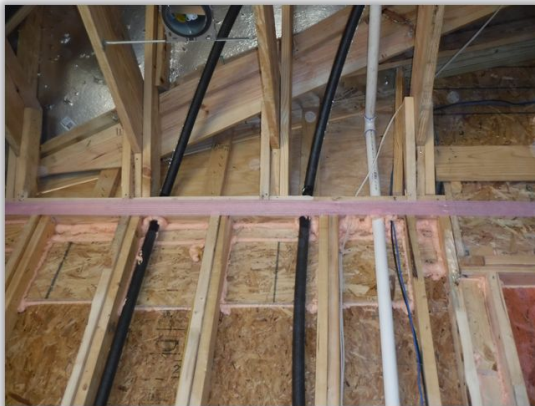
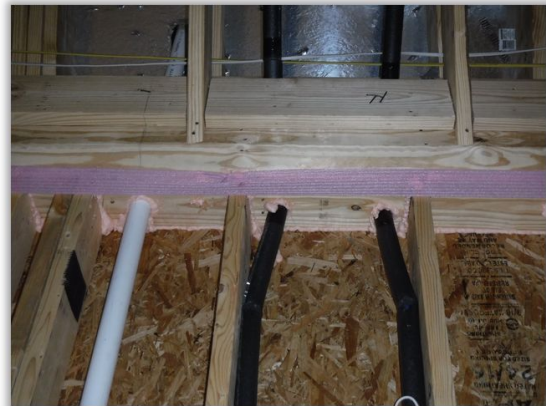
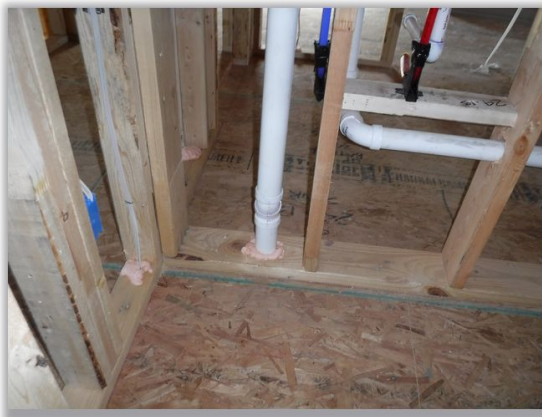
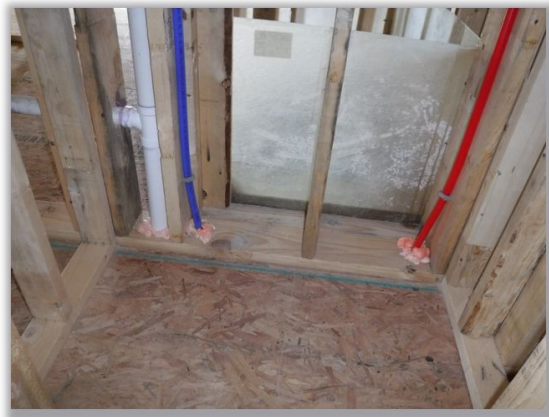
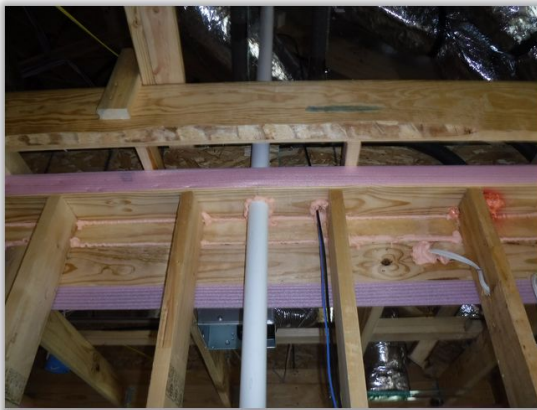
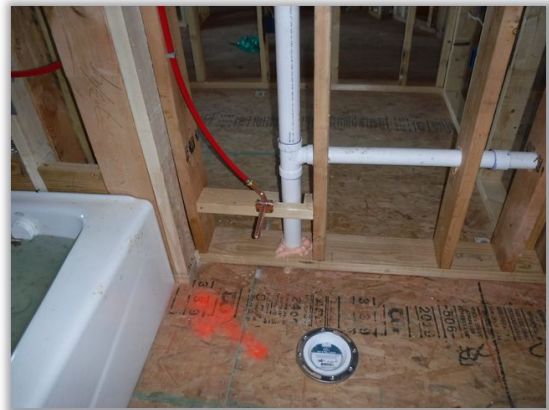
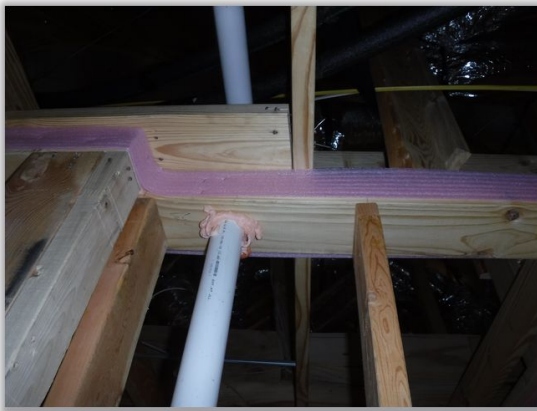
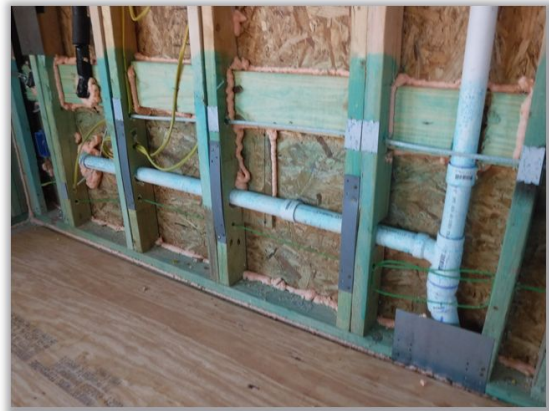
- The plumbing waste pipes that pass through the top plate and/or bottom plate should be protected with shield plates that extend not less than 2-inches above the bottom plates and/or below top plates to help prevent possible damage from fasteners (nails). Shield plates need to be installed to help prevent damage in the pool bath in cabana room, laundry room, garage wall adjacent to laundry room, southwest corner bedroom bathroom, both north bedrooms, garage, laundry room, master bedroom and master bathroom.

**P2603.2.1 Protection against physical damage.** In concealed locations, where piping, other than cast-iron or galvanized steel, is installed through holes or notches in studs, joists, rafters or similar members less than 1¼ inches (31.8 mm) from the nearest edge of the member, the pipe shall be protected by steel shield plates. Such shield plates shall have a thickness of not less than 0.0575 inch (1.463 mm) (No. 16 Gage). Such plates shall cover the area of the pipe where the member is notched or bored, and shall extend not less than 2 inches (51 mm) above sole plates and below top plates.

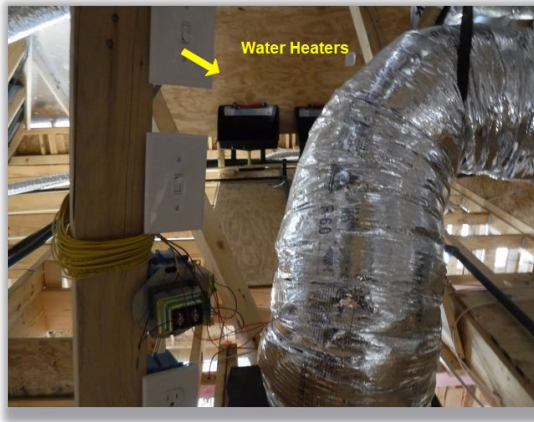
- There is not a clear and unobstructed passage to access the attic water heaters. This condition does not meet current building codes.

*Attics* containing *appliances* shall be provided with an opening and a clear and unobstructed passageway large enough to allow removal of the largest *appliance*, but not less than 30 inches (762 mm) high and 22 inches (559 mm) wide and not more than 20 feet (6096 mm) long measured along the centerline of the passageway from the opening to the *appliance*. The passageway shall have continuous solid flooring in accordance with Chapter 5 not less than 24 inches (610 mm) wide. A level service space not less than 30 inches (762 mm) deep and 30 inches (762 mm) wide shall be present along all sides of the *appliance* where access is required. The clear access opening dimensions shall be not less than of 20 inches by 30 inches (508 mm by 762 mm), and large enough to allow removal of the largest appliance.
