April 11, 2022

PROPERTY INSPECTION REPORT FORM

Client Name Here	04/11/2022
<i>Name of Client</i>	<i>Date of Inspection</i>
AddressCity, TX 00000	
<i>Address of Inspected Property</i>	
Brian Murphy	3948
<i>Name of Inspector</i>	<i>TREC License #</i>

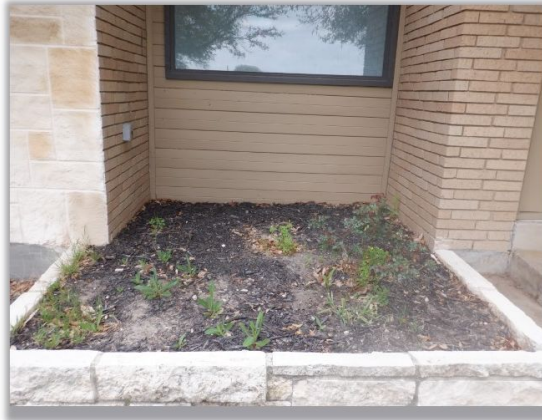
Grading & Drainage

- Marginal site drainage was observed on the north, east, west and south sides of the structure. Proper drainage is needed to help prevent water from standing and/or ponding next to the foundation beam. Corrective measures may be needed if the water stands within 10-feet of the foundation perimeter beam for more than 24-hours.
- The soil line is too high on the north, east and west sides of the structure. Under current building standards there should be at least 4-inches of foundation visible below masonry veneer and 6-inches of foundation visible below wood type veneer.

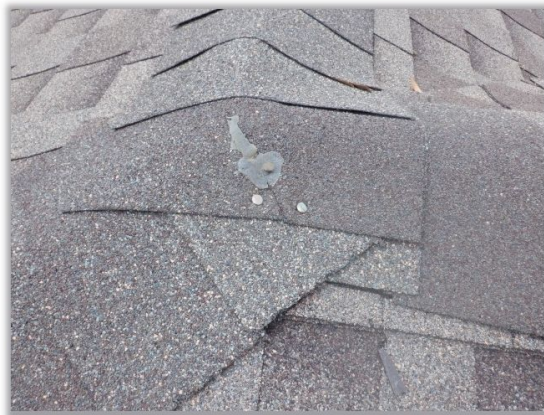
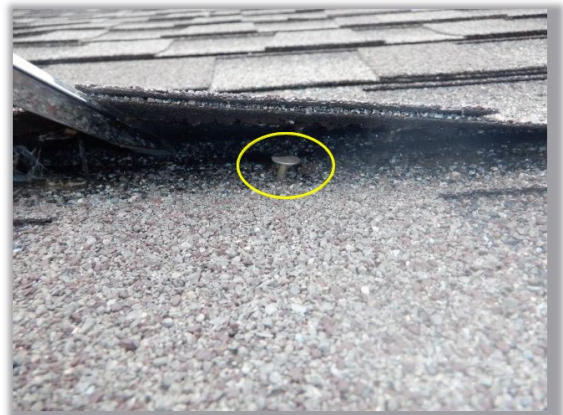
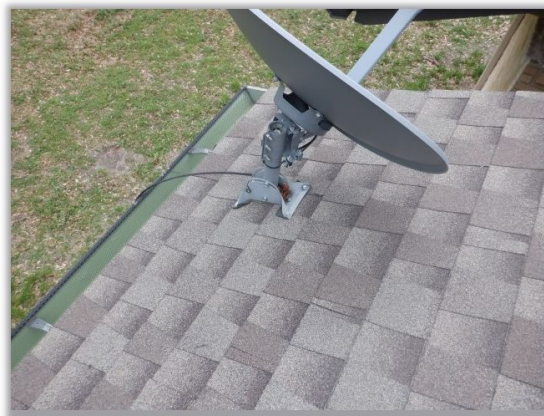
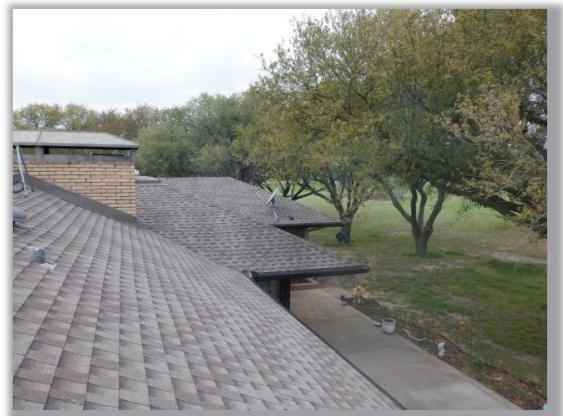
Additional Observations and/or Comments:

- **Note:** Roof fasteners (nails and/or staples) were observed to be exposed and should be properly sealed at the ridge caps and flashing areas.
- **Note:** High shingle fasteners (staples and/or nails) were observed in various locations.
- **Note:** The tree and shrub branches should be trimmed away from the roofing material at all times.
- **Note:** All debris, such as leaf's and branches, should be removed from the roof structure.
- The fasteners at the satellite dish mount need to be sealed to help prevent water leakage at this point.

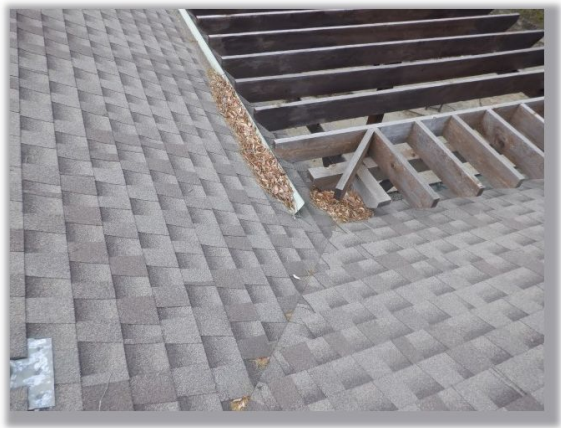
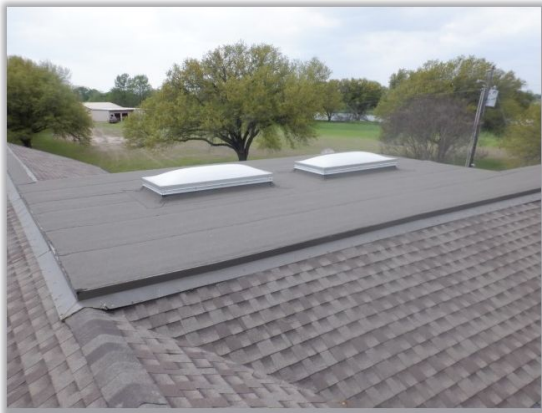
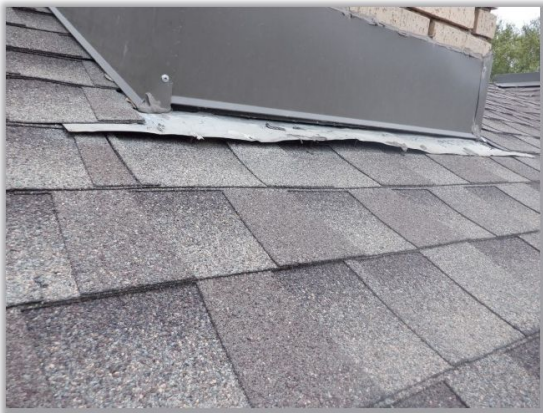
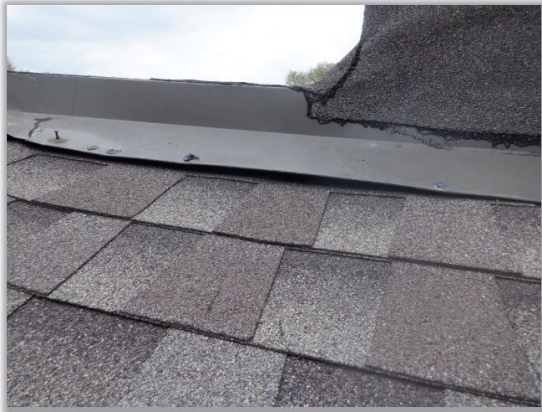
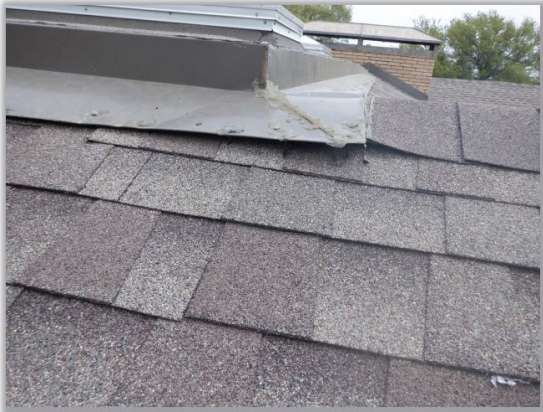
Flashing Details

- The flashing is lifting and/or pulling loose and should be re-secured at the roof line transitions.

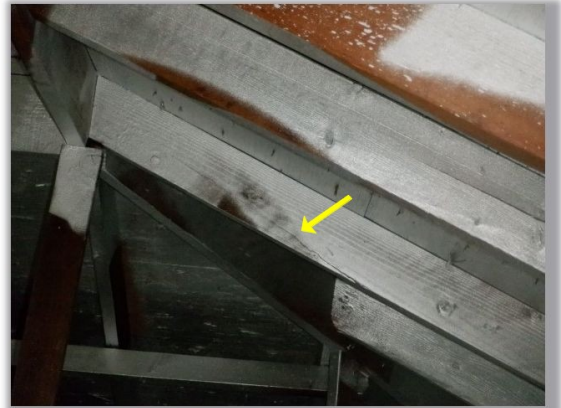
Roof Structure

- Split rafter(s) were observed in the attic area over master bedroom, master bathroom the area(s).
- **Note:** Visible evidence of rodent activity was observed in the attic area. It is recommended to have a Certified Pest Control Operator further evaluate this condition and make corrections as necessary.

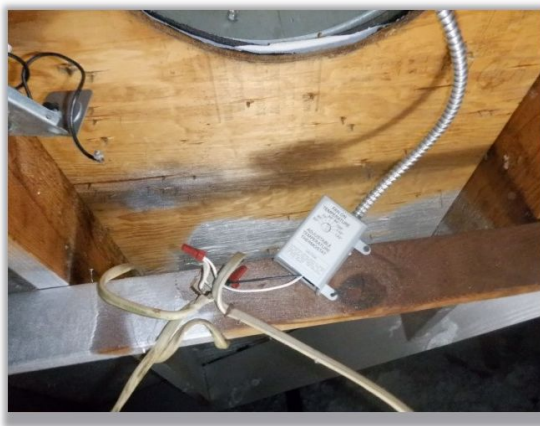
Attic Power Vents

- The spliced wires at the attic power ventilator(s) needs to be properly enclosed in a junction box(es).

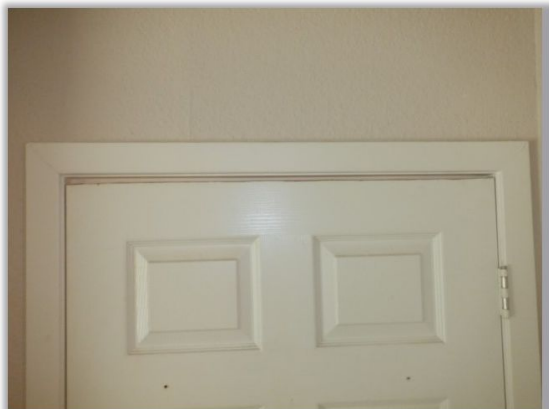
Interior Doors

- Some of the interior doors are out of square and have been shaven at the top to help them fit the opening. This may be due to adverse foundation performance.
- The door is not latching properly to the front corner bedroom closet.
- The door is sticking to the Jack and Jill bathroom.

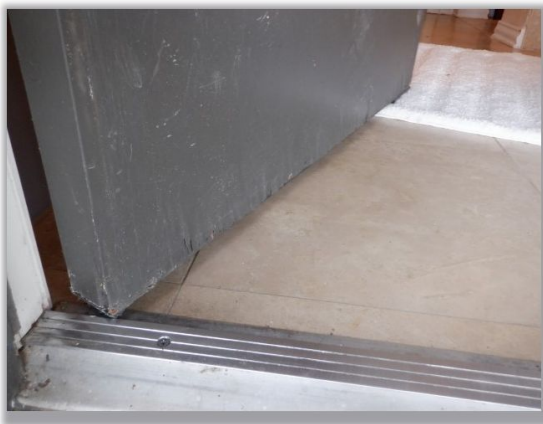
Exterior Doors

- The door is loose at the hinges to the exterior mechanical closet.
- The door has some surface damage to the Jack and Jill bathroom.
- The door is not latching properly to the garage exterior door.
- The door is sticking to the front entry door.

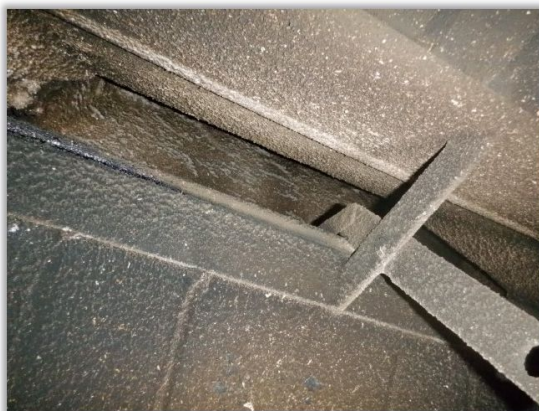
- The chimney flue needs to be cleaned by a Qualified Chimney Sweep. A creosote / soot build-up was observed in the visible flue area.
- Firebox brick mortar needs to be improved.
- **Note:** The floor of the firebox is dirty and needs to be cleaned. I was unable to view the floor of the firebox at the time of this inspection.

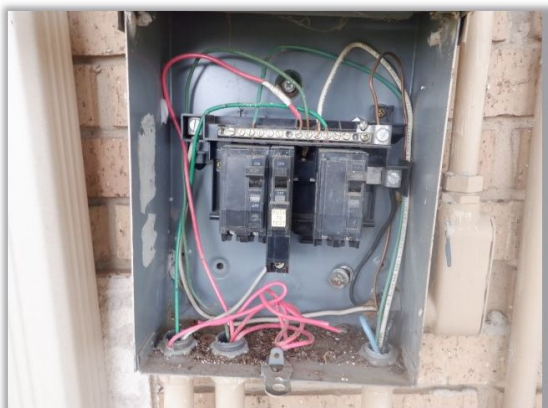
- All openings (missing knockouts) in the electrical cabinet cover plate (dead front) and /or cabinet need to have fillers.
- The sub-panel does not appear to have a four-wire service feed. Although the sub-panel is functional, it does not meet current National Electrical Code standards. This is an “as-built” condition but Per TREC standards of practice we are required to report this condition as a deficiency.

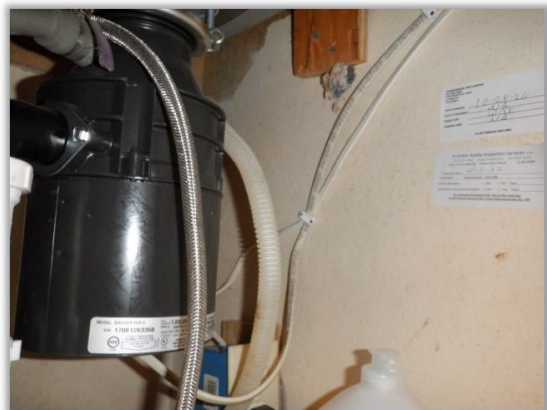
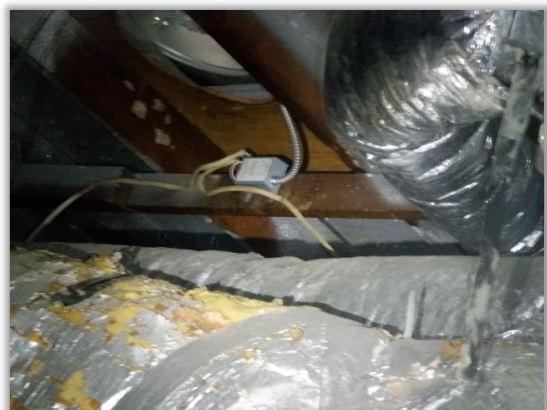
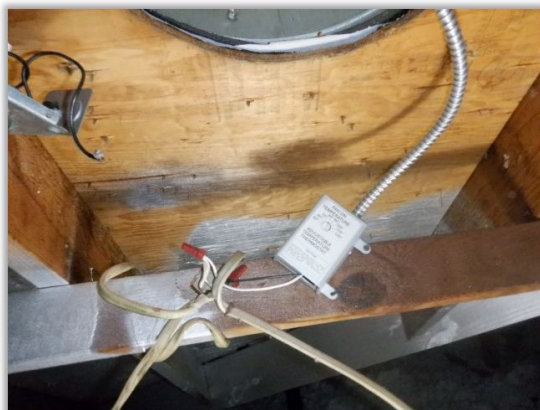
Distribution Wiring

- Spliced electrical wires were observed in the attic area. Spliced wires in the attic should be properly enclosed in junction box(es) and secured to the ceiling joist. Spliced wires were located over the bedroom hallway, master bedroom and master bathroom.
- Open end wires were observed master bedroom and master bathroom. The open ended wires need to be properly enclosed in an electrical junction box for reasons of safety.
- All exposed distribution wiring should be properly enclosed in conduit. Exposed wiring was observed in the kitchen cabinet below the sink.

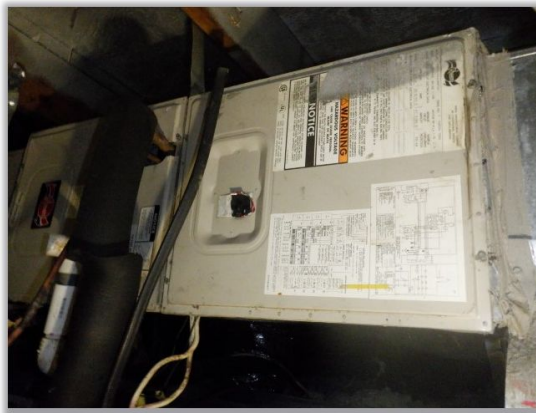
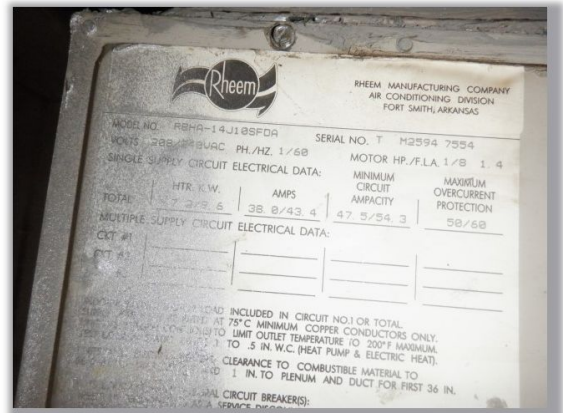
- **Note:** There is a heat pump thermostat in place, it should be noted that there is no heat pump equipment in place at the time of this inspection.

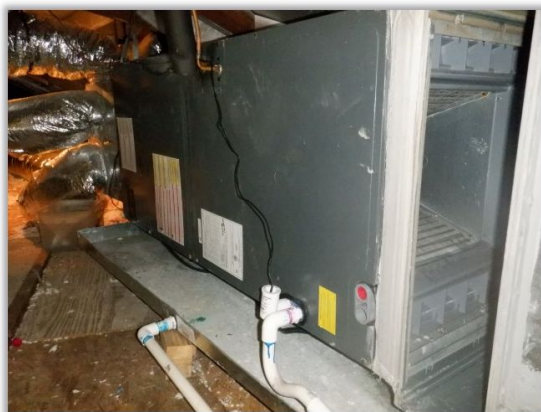
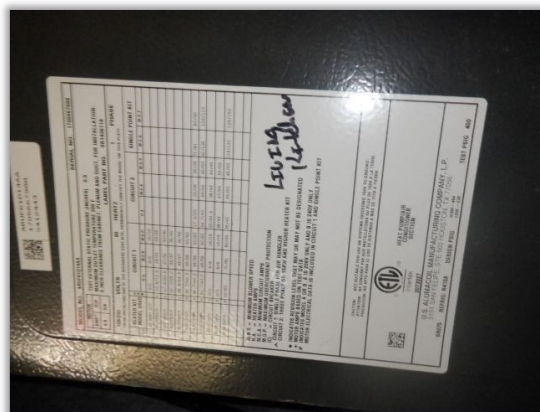
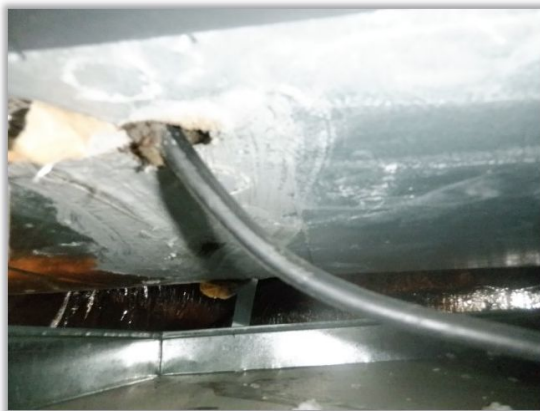
- The electrical branch wires are not properly secured to the heater housing.

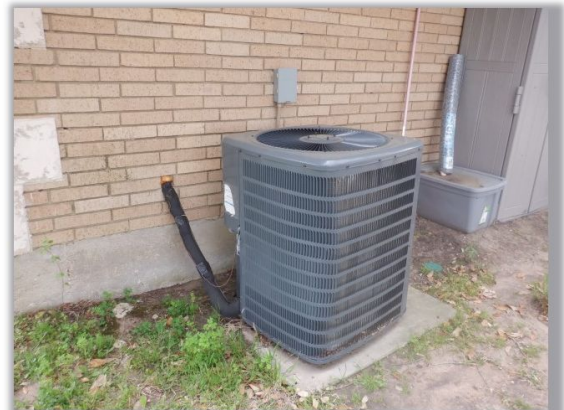
- Air leaks were detected at and around the indoor coil housing. The air leaks should be corrected for improved efficiency.
- Damaged, deteriorated and/or missing insulation on the refrigerant lines should be repaired or replaced in the HVAC closet compartment.

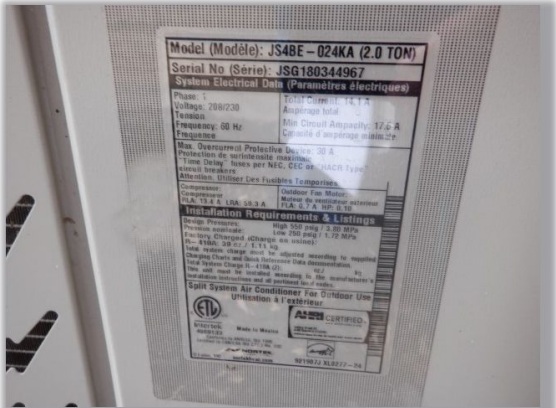
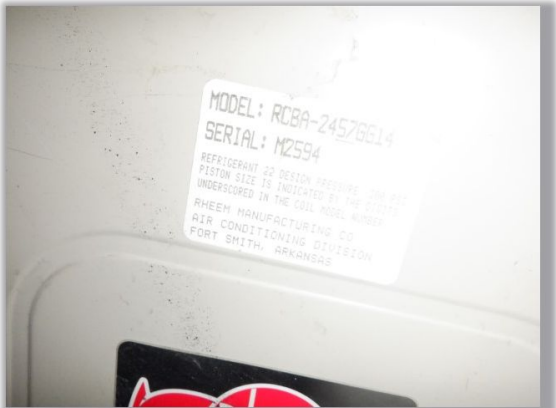
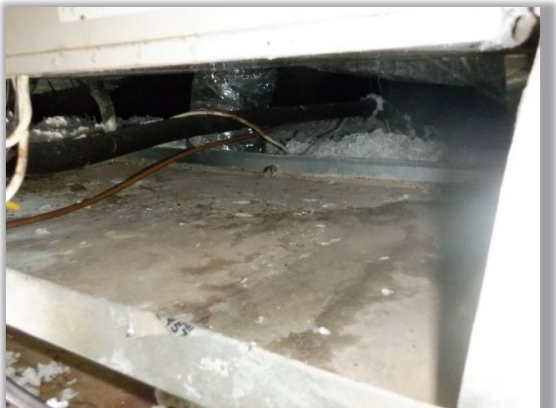
- **Note:** Previous water leakage was observed from around the base of the indoor coil housing. This condition should be closely monitored.
- **Note:** The auxiliary/secondary drain pan under the coil housing has some water staining and/or a rust build-up. This would indicate that the pan has held water in the past and should be closely monitored.

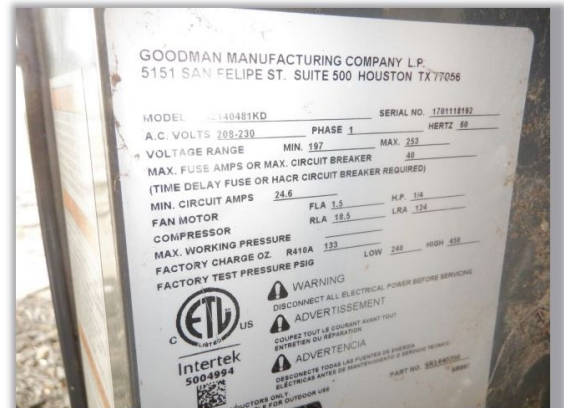
- **Note:** Previous water leakage was observed from around the base of the indoor coil housing. This condition should be closely monitored.
- **Note:** The auxiliary/secondary drain pan under the coil housing has some water staining and/or a rust build-up. This would indicate that the pan has held water in the past and should be closely monitored.

- **Note:** The auxiliary/secondary drain pan under the coil housing should be free of all debris. The debris in the pan could clog the drain line and cause water to leak to the interior of the house.

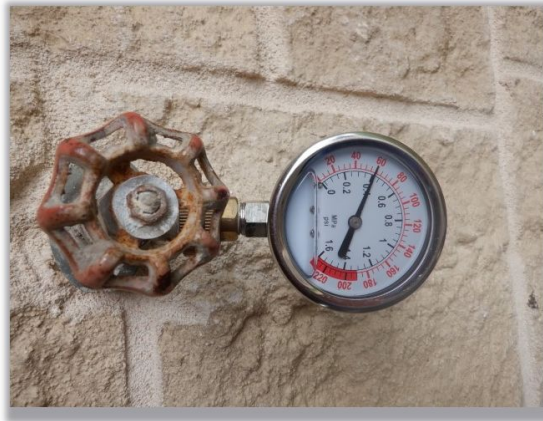
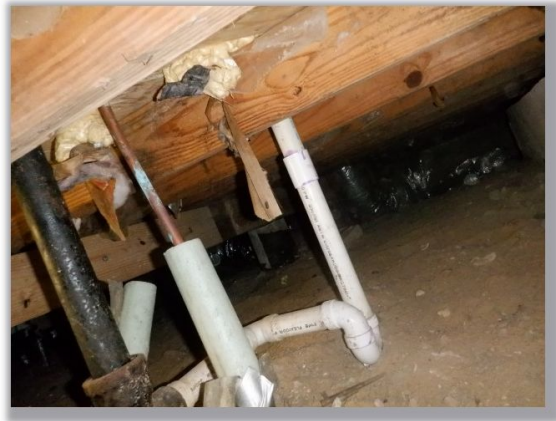
Water Supply System

- All exposed water supply lines in the crawl space area should be insulated to help protect them from possible freeze damage.

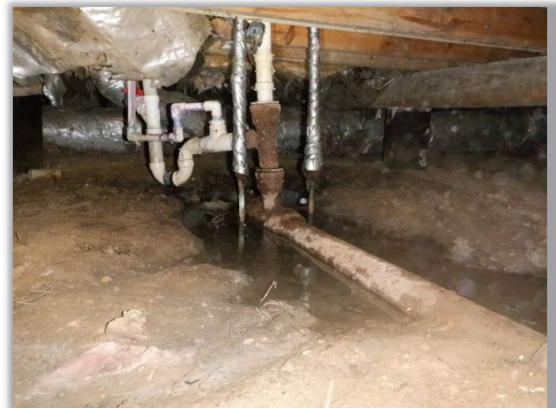
- The cast iron plumbing system has visible rust and corrosion on the exterior surfaces of the piping system. This is a good indicator that failures may occur in the near future. Further evaluation of the cast iron plumbing system is recommended.

- Cast iron material was observed to be present in the drains, wastes and vents system. Full evaluation of the integrity of this type of material is beyond the scope of this inspection. Due to the known latent defects that are associated with this type of older material, it is recommended to have the integrity of the drain system further evaluated by a qualified plumber. It is recommended to have a hydrostatic test and to have the inaccessible and buried pipes scoped with a camera as part of this evaluation. This evaluation should occur prior to the expiration of any time limitations such as option or warranty periods.

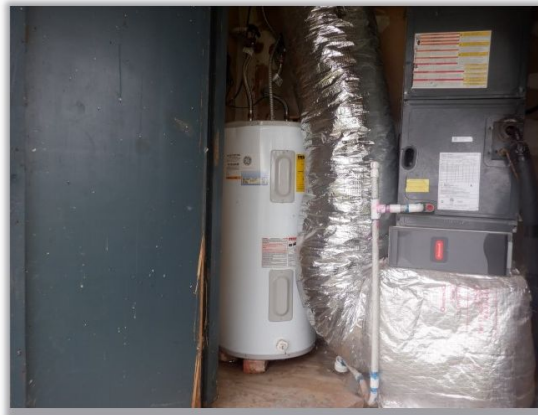
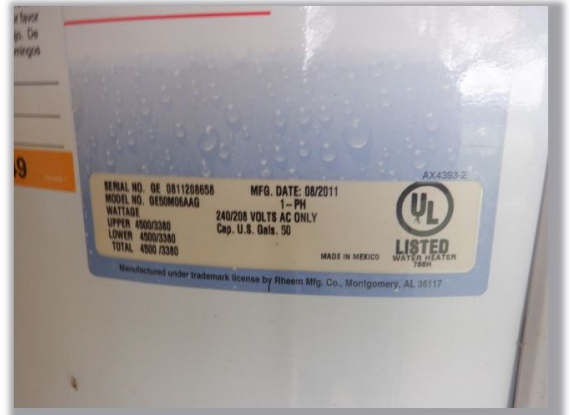
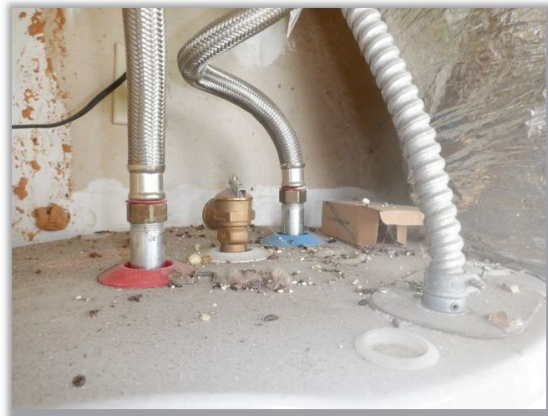
- There is no temperature and pressure relief valve (TPR) discharge pipe in place at the time of this inspection. For safety reasons, it is recommended that a TPR valve discharge pipe be installed. Under current building standards, the discharge pipe should run downward to the exterior of the structure, turn downward, and terminate within 6-inches of the ground.
- The floor under the water heater was observed to be water damaged and/or sagging. This condition should be further evaluated and corrected as necessary.

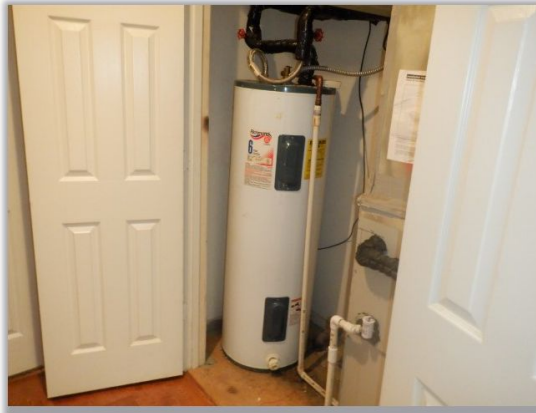
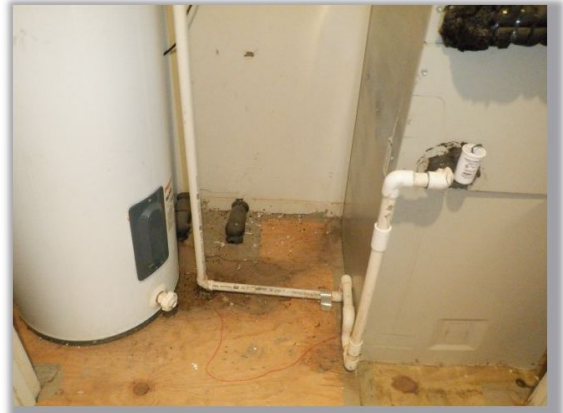
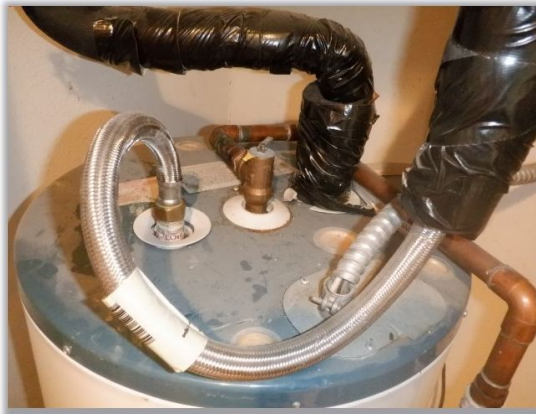
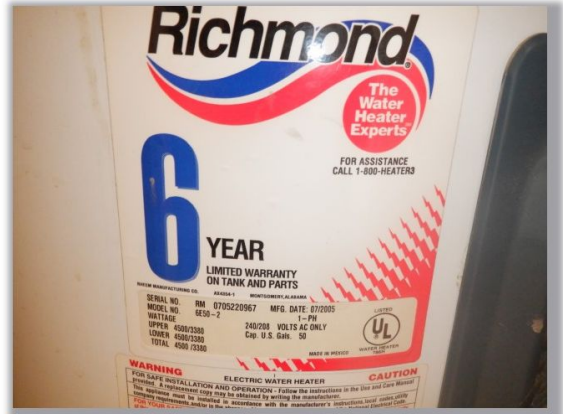
- Some corrosion was observed at the water supply connections at the top of the water heater.
- There is no pan installed under the water heater.
- The floor under the water heater was observed to be water damaged and/or sagging. This condition should be further evaluated and corrected as necessary.
- The electrical wiring conduit has pulled loose at the top of the water heater.
- The temperature and pressure relief (TPR) valve discharge pipe is connected to the HVAC discharge pipe. This condition does not meet current mechanical installation standards. This is an “as-built” condition but Per TREC standards of practice we are required to report this condition as a deficiency.

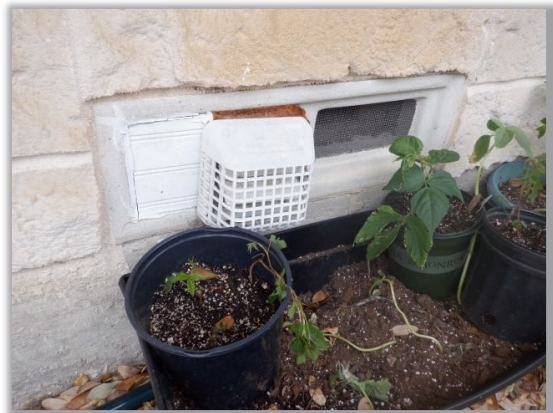
- The dryer duct termination was observed to be screened. Screening the termination is not permitted under current installation standards. **Note:** Screening the dryer termination will cause the dryer duct to clog and will not allow the dryer to operate efficiently.
