INSPECTED FOR  
**Client Name Here**  
**Address**  
**City, TX 00000**  
**Date Here**

## PROPERTY INSPECTION REPORT FORM

<b>Client Name Here</b> <i>Name of Client</i>	<b>Date Here</b> <i>Date of Inspection</i>
<b>Address</b> City, TX 00000 <i>Address of Inspected Property</i>	
<b>Brian Murphy</b> <i>Name of Inspector</i>	<b>3948</b> <i>TREC License #</i>

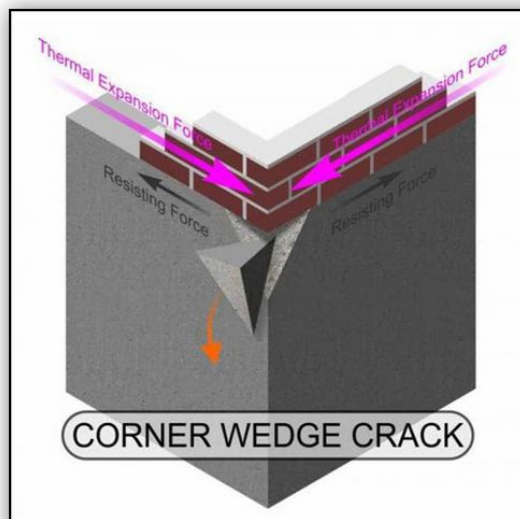
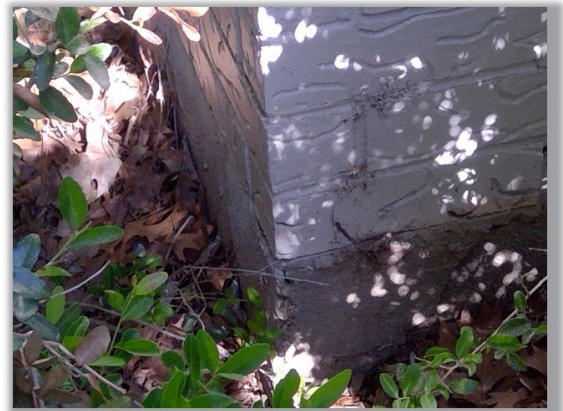
- One or more of the foundation perimeter beam corners were observed to be sheared off (corner pop). This is a common condition to observe and is do to thermal expansion and contraction of the different building materials. This condition does not adversely affect the foundation performance. However, in some cases, some cosmetic improvements may be necessary.

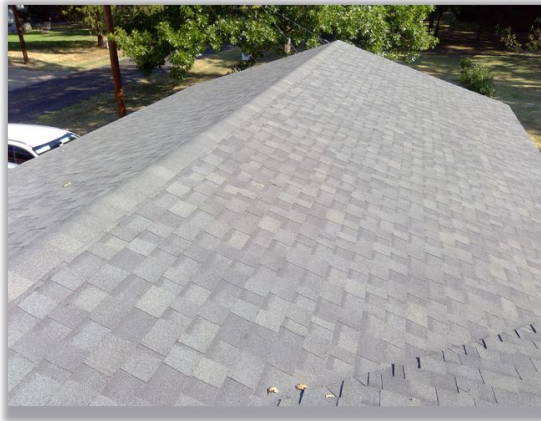
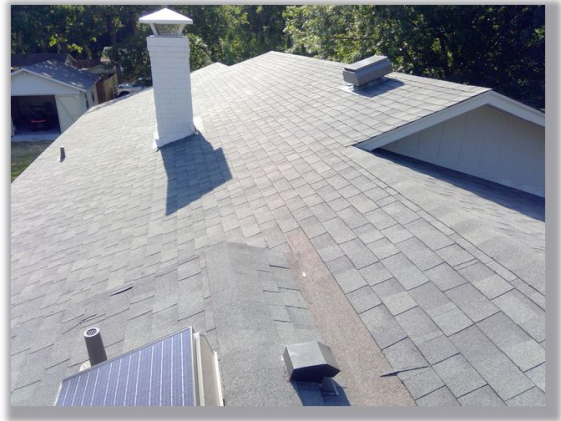
- **Note:** The tree and shrub branches should be trimmed away from the roofing material at all times.

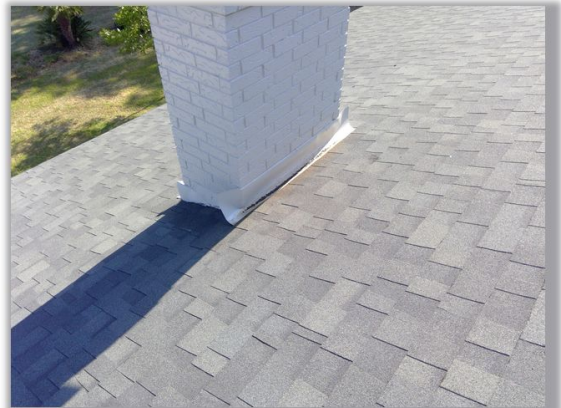
- There was no kickout flashing details observed at the lower bottom edge of the roof line interface and the sidewall that continues past the edge of the roof. The lack of this kickout flashing will allow water to penetrate at these points.
- There is no cricket / saddle in place behind the roof level chimney structure. Under current building standards, there should be a cricket or saddle installed behind the ridge side of any chimney greater than 30-inches wide.

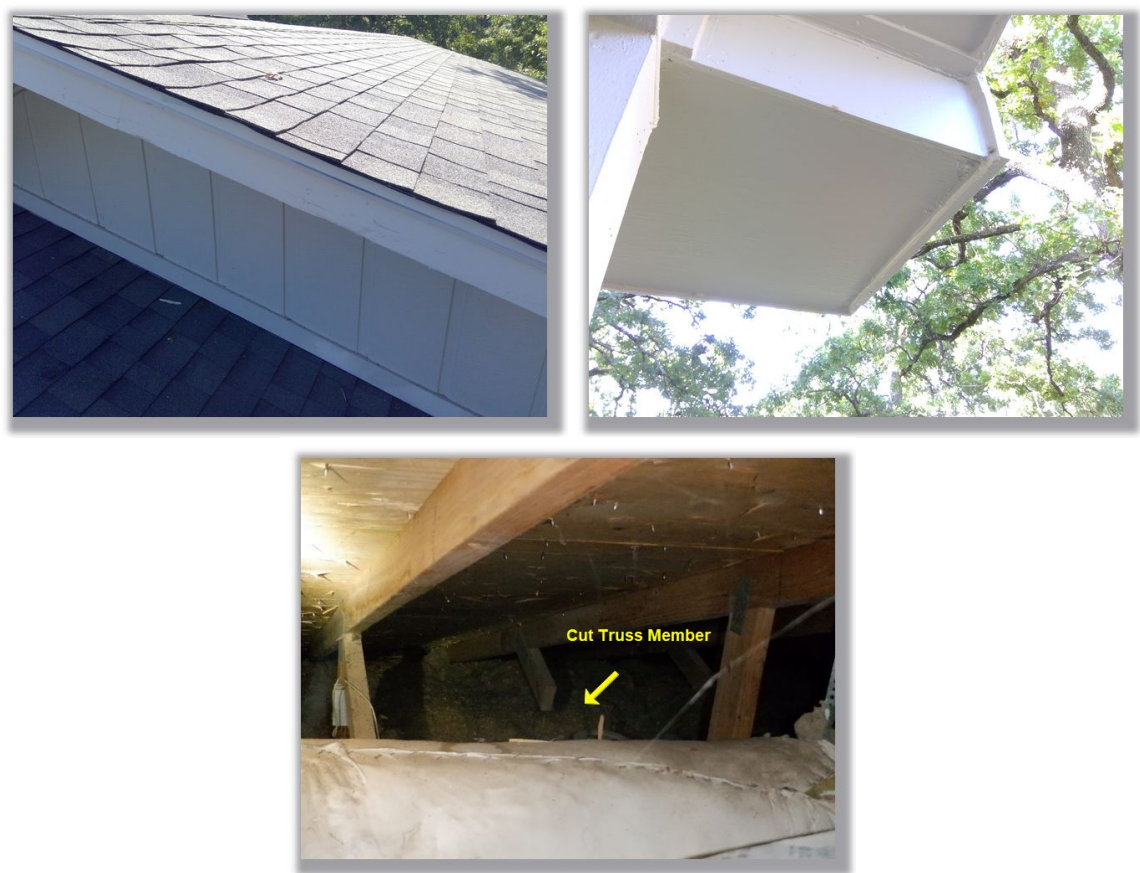
- The fascia board material has some deterioration and/or damage on the west side of the roof structure.
- The soffit material has some deterioration and/or damage on the south side of the roof structure.
- One of the trusses has been cut in two at the added whole house fan.

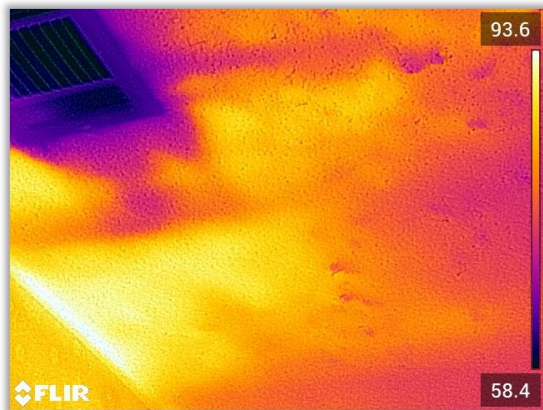
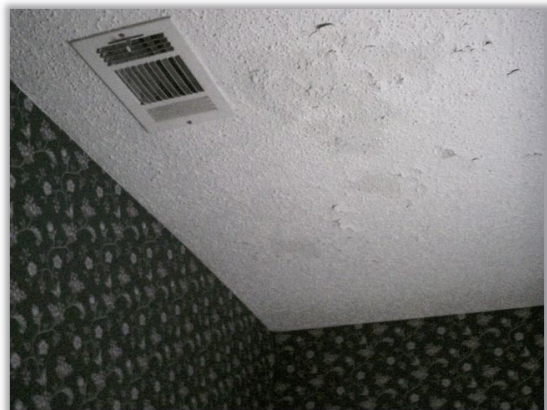
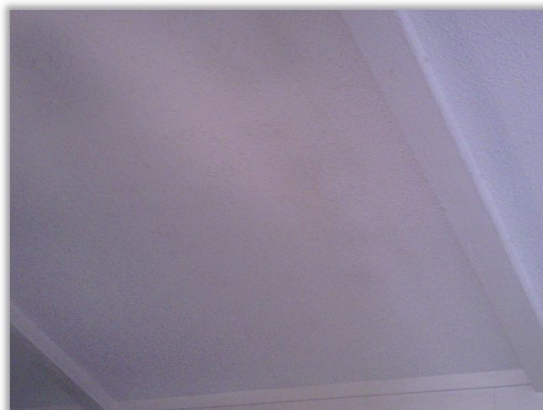
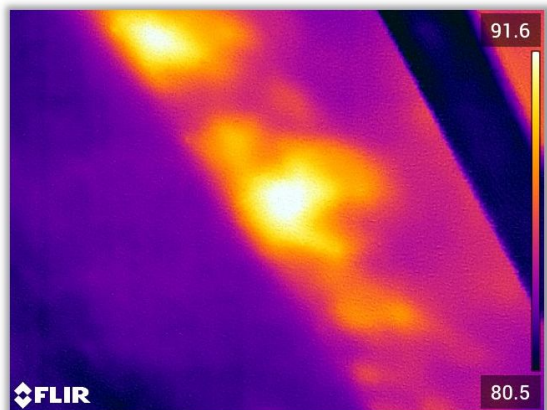
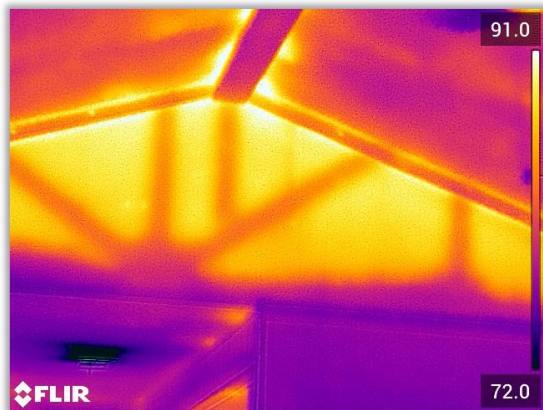
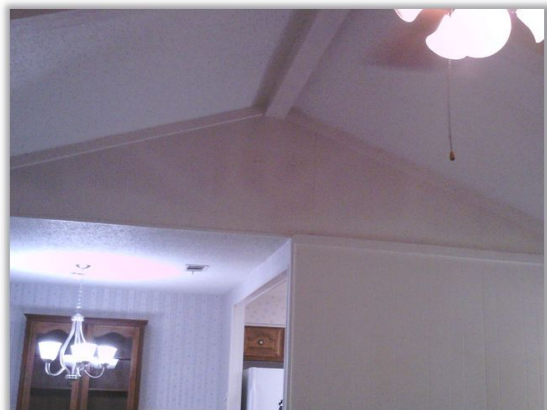
- The attic insulation is lower than typical and it is recommended to add additional insulation to achieve at least a R-30 rating.
- The sidewall insulation was observed to be missing in the attic area adjacent to the living room. This condition should be further evaluated and corrected as necessary.
- The attic floor insulation needs to be redistributed in one or more locations.
- The attic floor insulation was observed to be missing over the northeast corner bedroom and hall bathroom area(s).

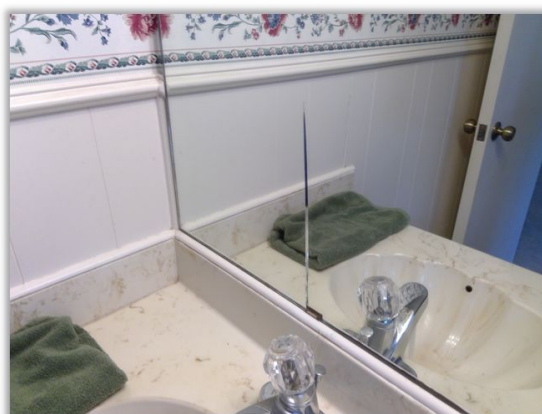
- Interior wall joint cracks were observed in various locations throughout the house.
- The wall mirror is cracked in the 2nd master bathroom.

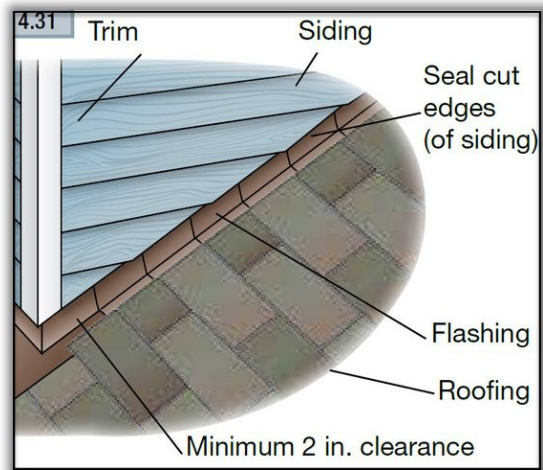
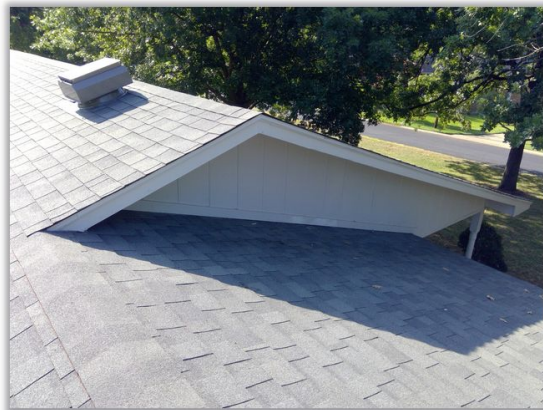
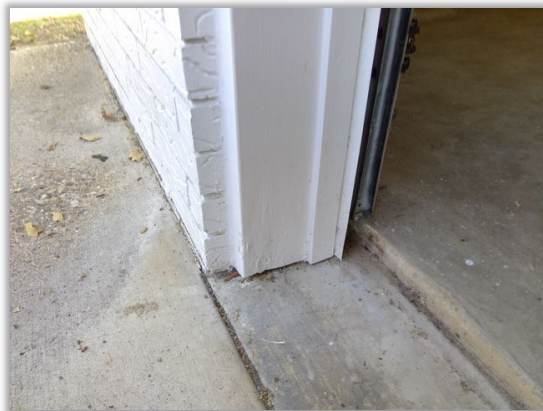
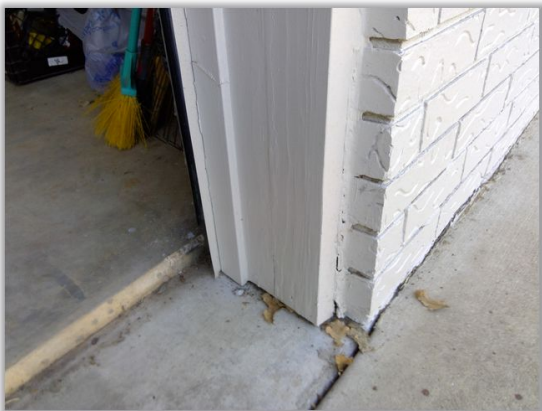
- The sidewall veneer / cladding is in contact with the roofing material. Under current building standards, there should be at least 2-inch of clearance between the roofing material and the sidewall veneer / cladding.
- The garage door trim has some deterioration and/or damage at the bottom.
- Caulking improvements are recommended for the area between the exterior veneer and the window frames. It is recommended to use an industry approved low-modulus elastomeric sealant.
- The wood veneer trim has some deterioration or damage on the south side of the structure.
- Caulking improvements are recommended for the area between the exterior veneer and the exterior door frames. It is recommended to use an industry approved low-modulus elastomeric sealant.

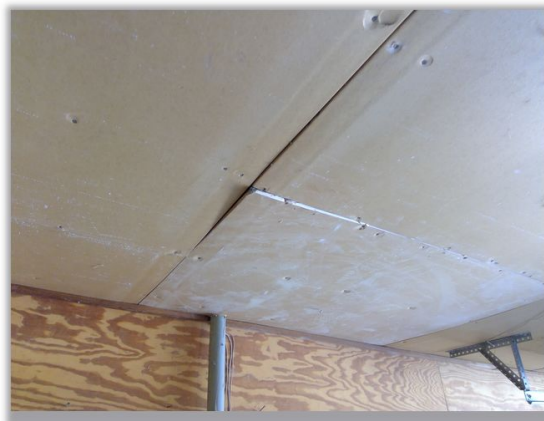
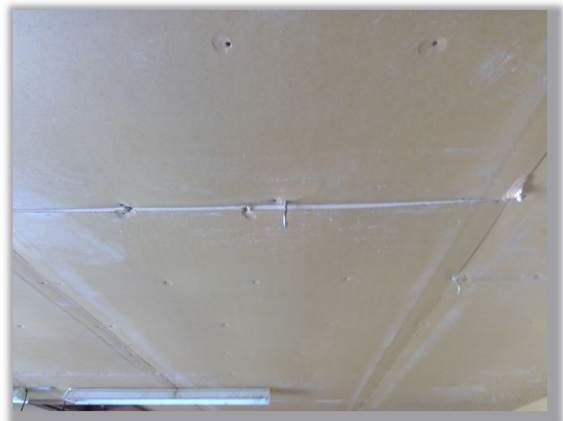
- Some of the ceiling finishing material was observed to be sagging in the garage.
- Water stains were observed on the ceiling finish in the garage and water heater area. The cause and remedy should be further evaluated and corrected as necessary.
- The cover to the attic hatch is damaged and/or missing and needs to be repaired and/or replaced for fire-blocking / attic separation reasons.
- Water stains and water damage was observed on the ceiling finishes in the hall bathroom. The cause and remedy should be further evaluated and corrected as necessary.
- The ceiling texture has some deterioration and/or damage in the hall bathroom.

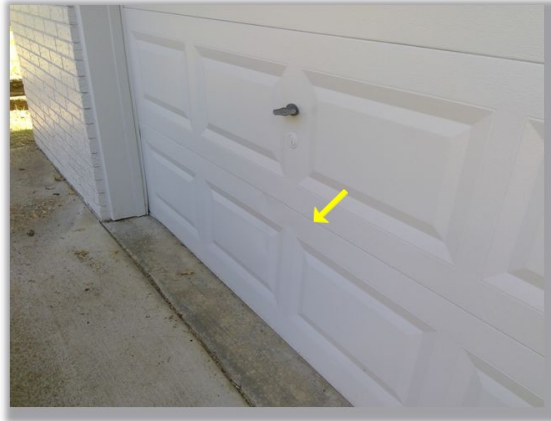
- The overhead garage door is not balanced properly and should be tuned-up and/or adjusted as necessary.
- Some minor damage to the overhead garage door was observed.

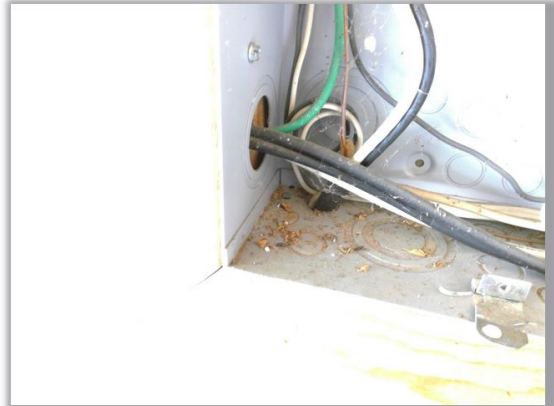
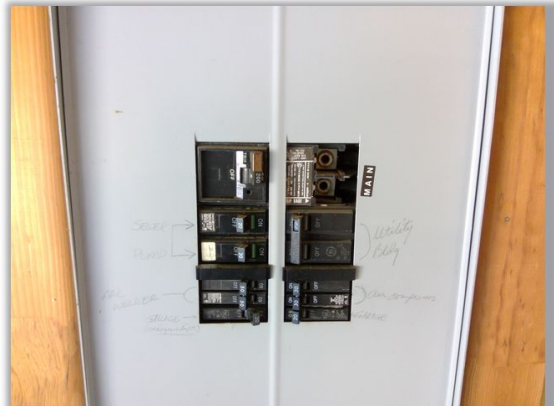
- The breakers (overcurrent devices) in the electrical panel are not properly labeled.
- There was no main disconnect observed in the panel box.
- The electrical cabinet cover plate (dead front) should be installed with blunt tip screws and not sharp wood type screws for reasons of safety.
- All openings (missing knockouts) in the electrical cabinet cover plate (dead front) and /or cabinet need to have fillers.
- The wires entering the electrical cabinet are not properly secured or protected from the sharp edges of the cabinet.
- One or more of the breaker trip-ties appear to be missing. The split overcurrent devices (breakers) servicing 240V appliances should be connected together by trip-ties.

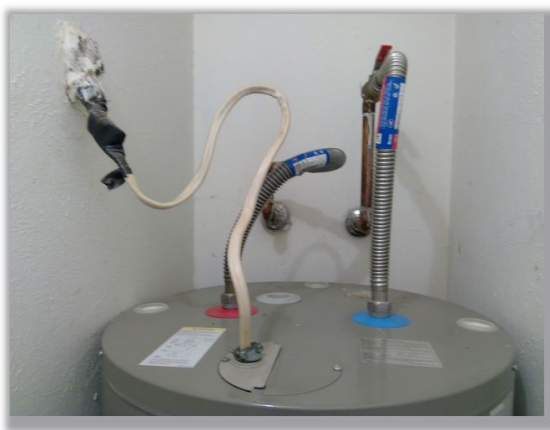
- Spliced electrical wires were observed in the attic area. Spliced wires in the attic should be properly enclosed in junction box(es) and secured to the ceiling joist. Spliced wires were located over the garage.
- Spliced wires were observed in the water heater closet. The spliced wires need to be properly enclosed in an electrical junction box for reasons of safety.
- All exposed distribution wiring should be properly enclosed in conduit. Exposed wiring was observed in the kitchen cabinet below the cooktop, kitchen cabinet above the cooktop and water heater closet.

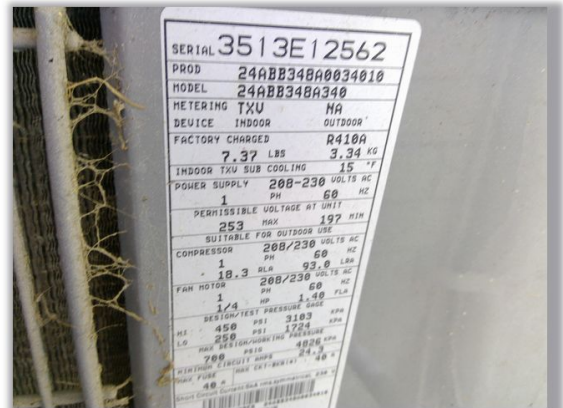
- **The temperature drop measured across the evaporative coils of the air conditioning system is lower than considered typical. The unit is not cooling properly and servicing is needed.**
- The evaporator coils were observed to be dirty and require cleaning.
- The electrical service disconnect is installed behind the outside condenser/coil. This does not meet the clearance requirements of the National Electrical Code or the International Residential Code and should be corrected as necessary.
- The manufacturers listing plate on the outside condenser/coil list that the maximum over current device (breaker) to be used should not exceed 40-amp. There is a 50-amp breaker in place at this time. This breaker in place does not meet the manufacturers listing plate requirements.

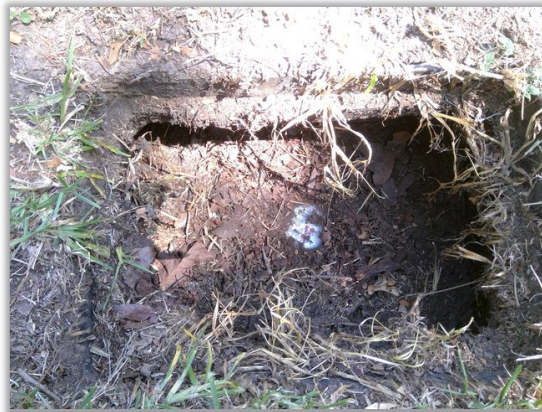
- The meter is covered with dirt. I was unable to observed the water meter at the time of this inspection.

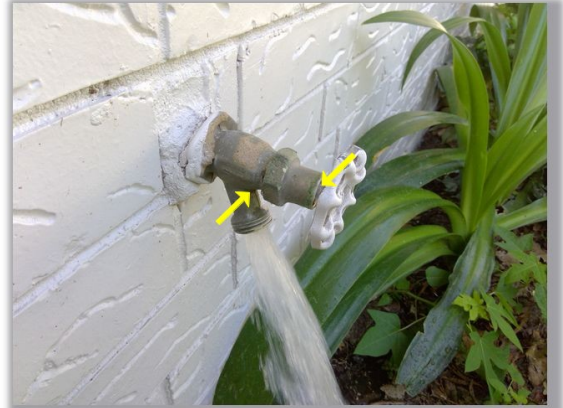
- The exterior water hose bibb (faucet) is leaking at the handle when operated on the north and south sides of the structure.

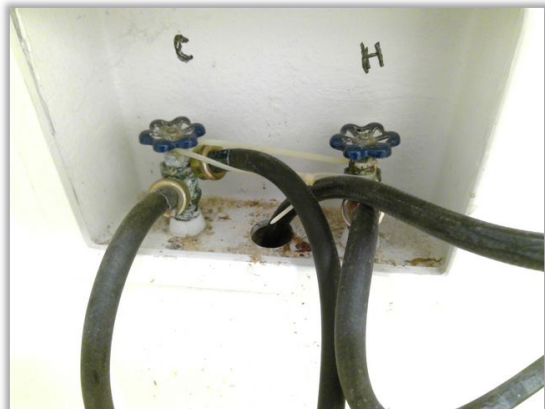
- Some rust and/or corrosion was observed at the laundry connection hose bibbs.

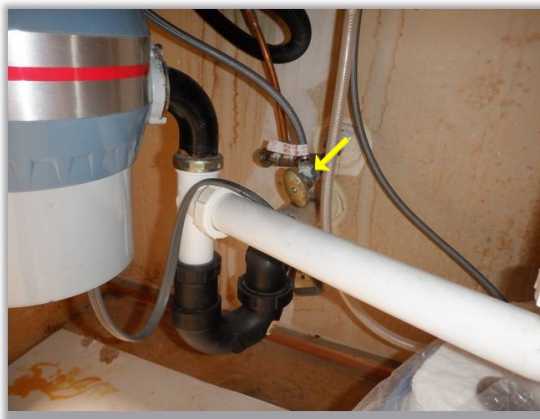
- **Note:** Some corrosion was observed at one and/or both of the water supply shutoff valves.
- **Note:** Previous water leaks were observed at and/or around the drain connections under the sink. This would indicate previous problems and should be closely monitored and corrected when necessary.

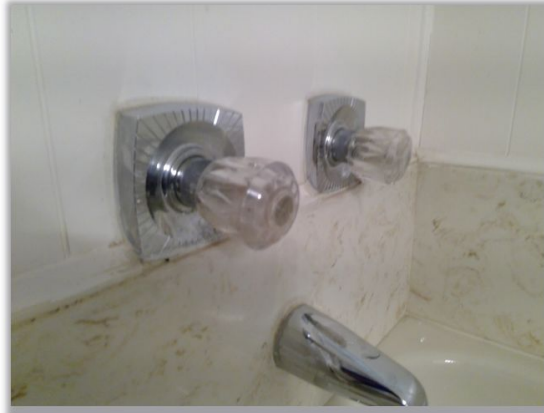
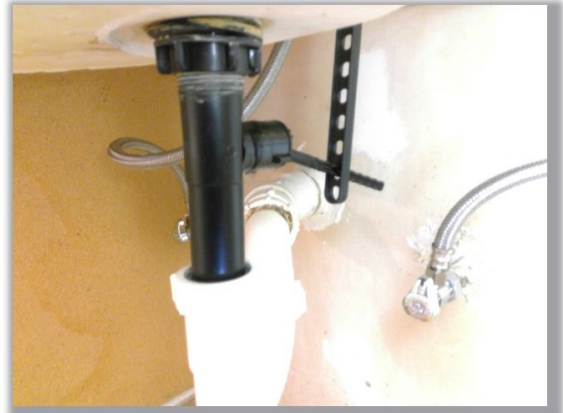
- The drain leaks water into the cabinet when drained under pressure with a large volume of water.

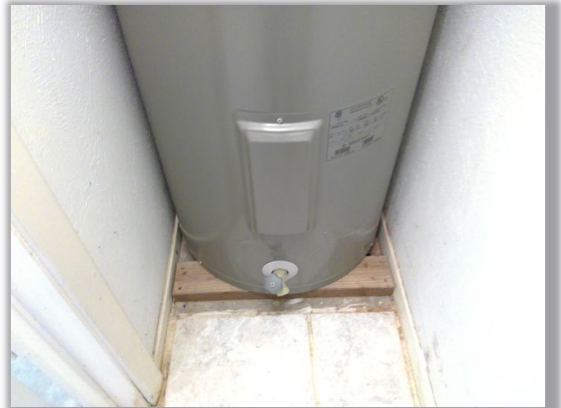
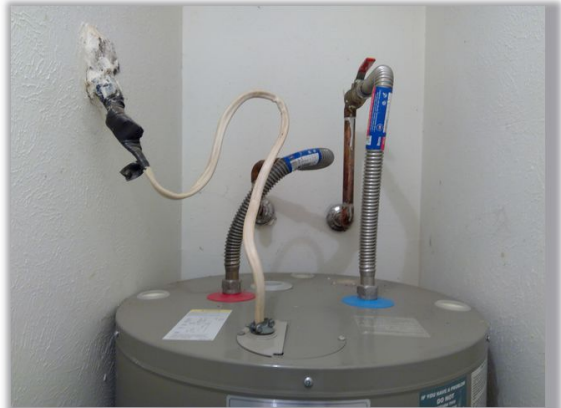
- The electrical wiring to the water heater is exposed and should be enclosed in conduit.
- There is no pan installed under the water heater.
- The exterior temperature and pressure relief (TPR) discharge pipe does not terminate at the proper height over the finished grade (ground). The TPR should terminate not more than 6 inches and not less than two times the discharge pipe diameter above the floor or waste receptor flood level rim.
- The exterior termination point of the temperature and pressure relief (TPR) valve discharge pipe is missing its 90-degree elbow. The TPR discharge pipe should turn 90-degrees downward and terminate within 6-inches of the ground.
- Some corrosion was observed on the water supply shutoff valve.

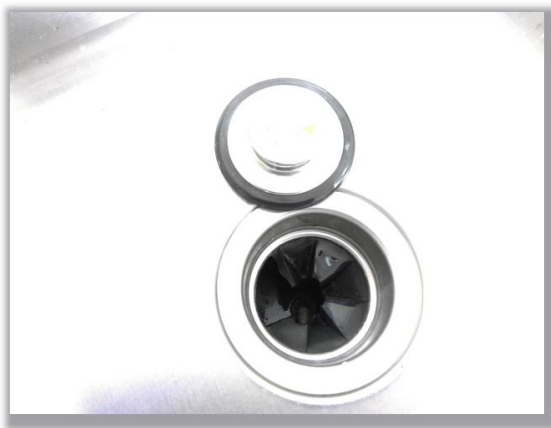
- The splashguard for the food waste disposer is damaged and/or missing.
- The electrical wiring to the food waste disposer is not properly secured to the disposer housing.

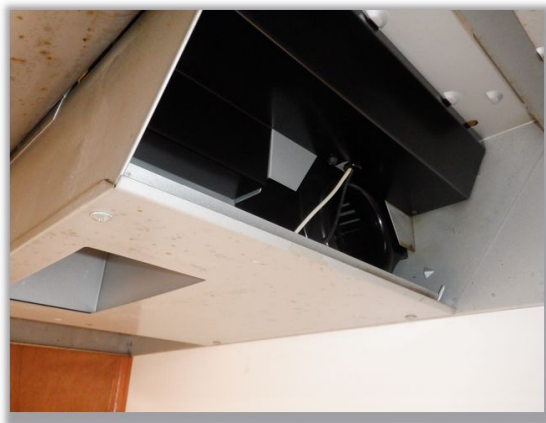
- The cooktop exhaust is terminated against the wall just above the exhaust. The exhaust does not perform or move air. This condition does not meet current mechanical installation standards.

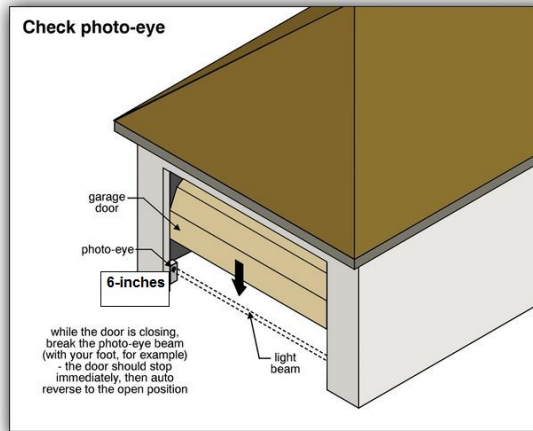
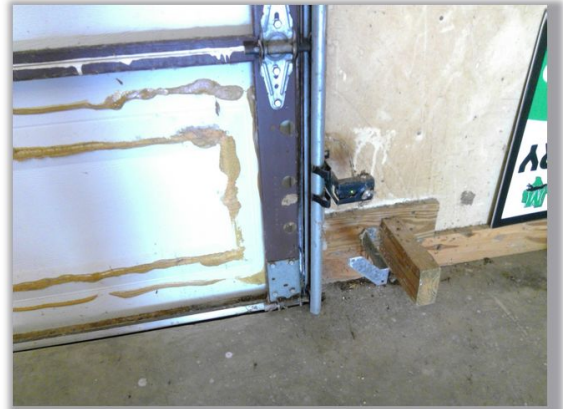
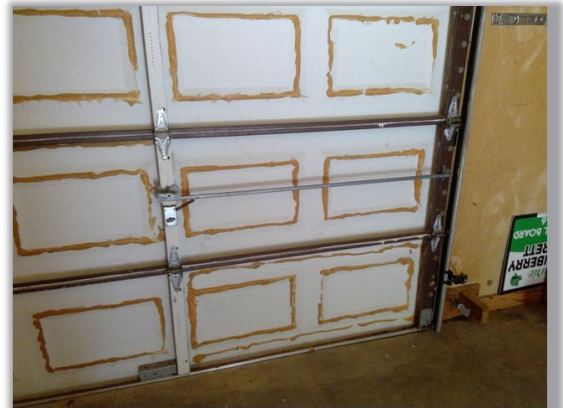
- The garage door opener button is poorly located. The garage door opener button should be installed on the opener side of the wall and within unobstructed view of the garage door.
- The garage door opener button should be installed at least 5-feet the floor of the garage, so to be out of the reach of children.
- When an automatic garage door opener is in use, the manual lock should be disabled or removed.
- The garage door reverse sensors are not properly installed. The garage door reverse sensors should be installed within 6-inches of the garage floor.

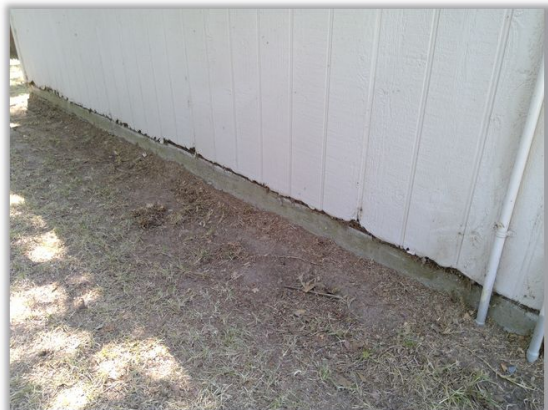
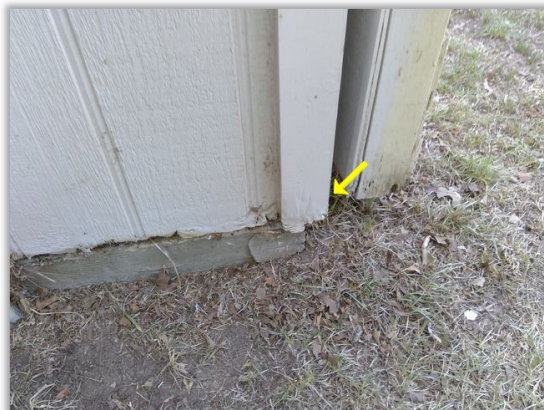
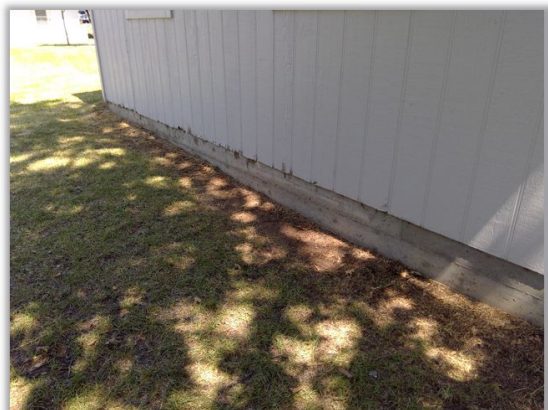
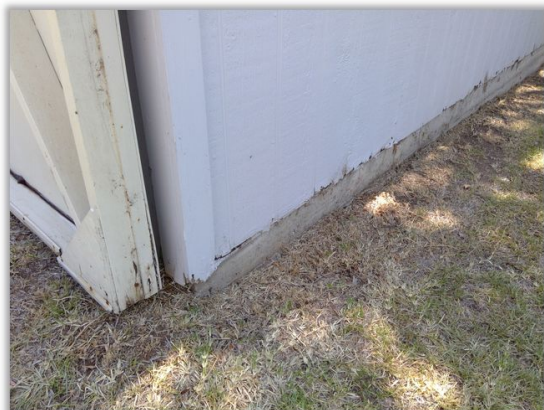
- The exterior veneer / cladding has some deterioration and/or damage on the north, east, west and south sides of the structure.
- The wood veneer trim has some deterioration or damage on the north, east, west and south sides of the structure.

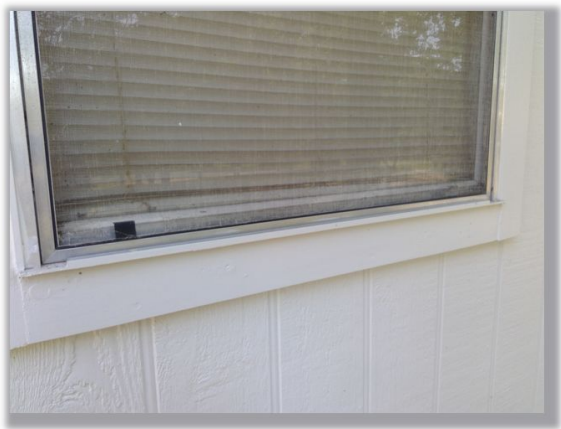
- One or more of the window screens were observed to be damaged.

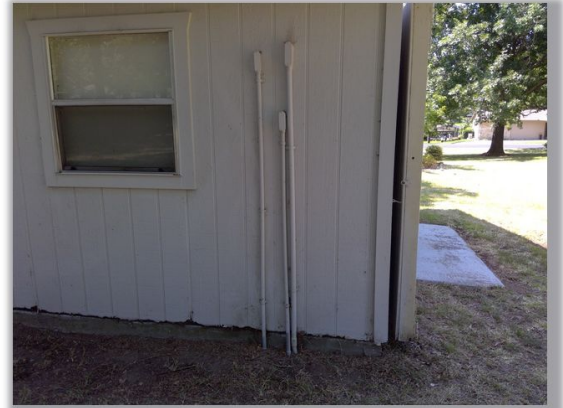
- I was unable to locate a grounding rod (Grounding Electrode) or supplement grounding source for the electrical system. This condition should be further investigated and corrected if necessary.

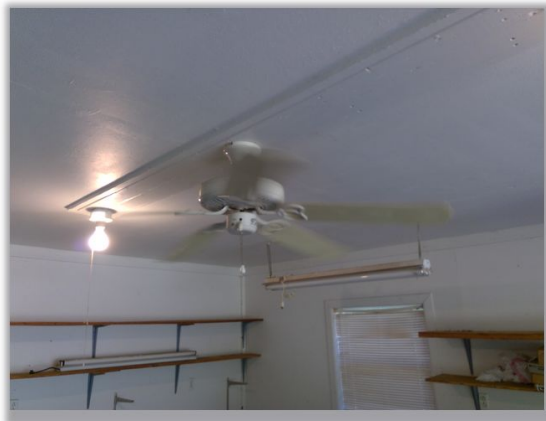
- The ceiling fan is not balanced properly and wobbles when operated.
