CLADDING MOISTURE REPORT

Cladding Inspection Report

Subject Property : Address, City, TX 00000

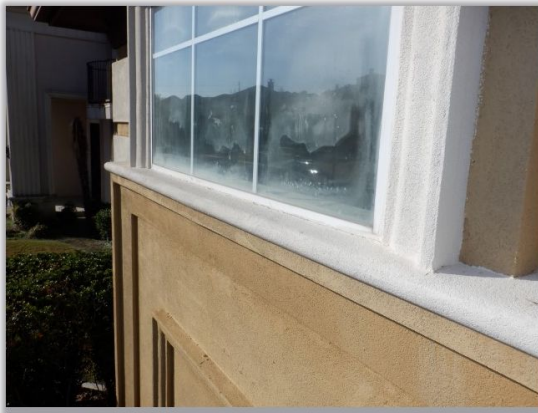
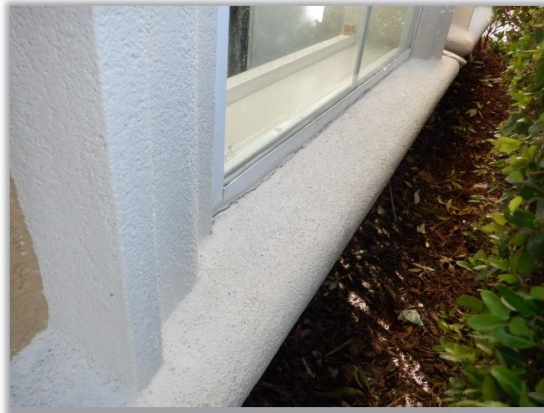
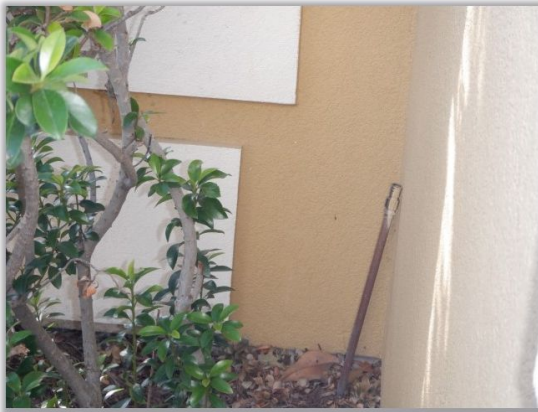
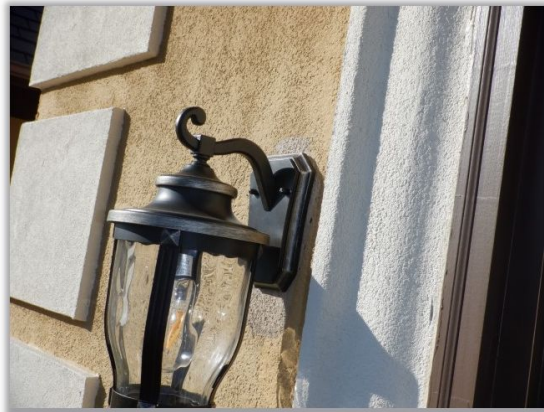
- There is foliage in contact with the exterior stucco finishes. It is recommended to trim the foliage at least 18-inches off the exterior walls.
- All sprinkler heads within 12-inches of the exterior walls should be relocated a minimum of 12-inches away from the walls and directed so that water does not spray directly onto the walls.

- There is failing and/or missing sealant at and around the window openings. It is recommended to remove and replace all old and failing sealant around the windows to help prevent water intrusion at these locations. It is recommended to use an industry approved low-modulus elastomeric sealant.

- The area between the exterior cladding / veneer and all of the wall penetrations / openings need to be properly sealed. Areas such as utility connections, downspouts, hose bibbs, lighting fixtures, receptacles etc. It is recommended to use an industry approved low-modulus elastomeric sealant.

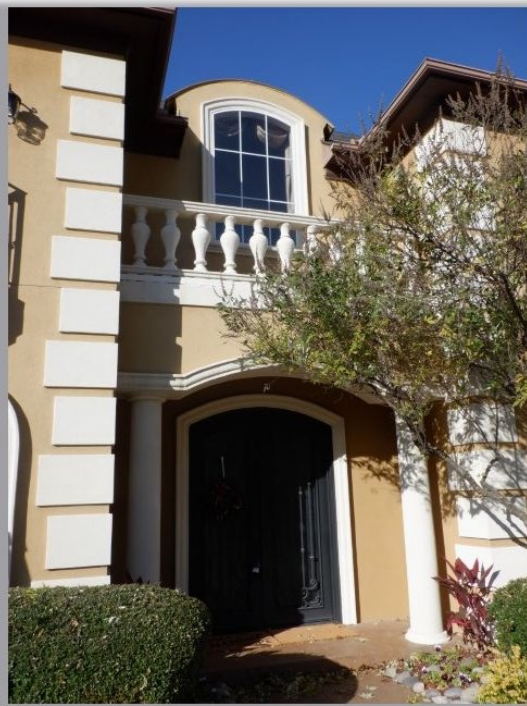
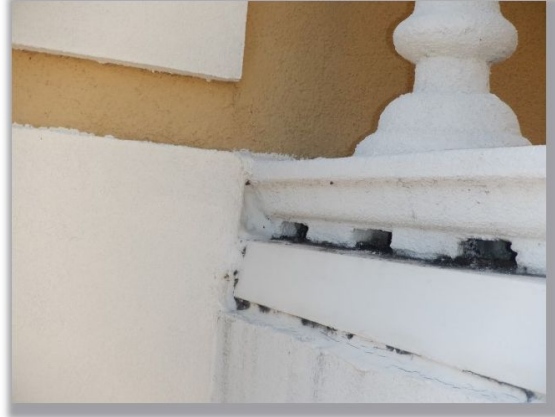
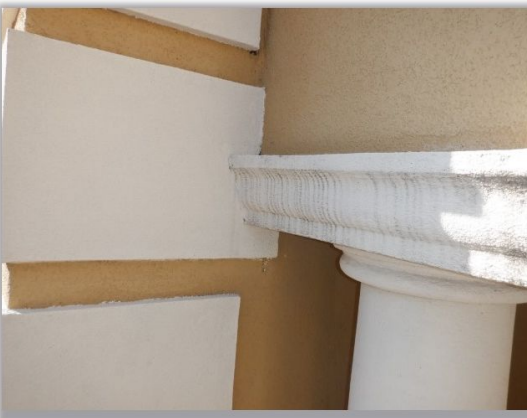
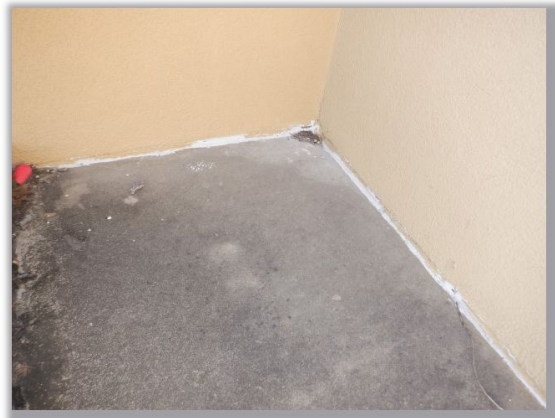
Balcony Over Front Door

- There is no visible end dam at the balcony interface with the stucco system. It is recommended to install end dams at this locations to help prevent water intrusion within the wall system.

- There is visible damage to the stucco finish and it has compromised the stucco. Removal is needed at this time.
- The balcony floor pan is not water tight or otherwise compromised. There is visible evidence of moisture leaking through the pan and behind the stucco system. This has caused larger than typical cracking of the stucco finishes. The leak source generator needs to be located and repairs made to prevent further moisture intrusion and damage to the stucco system. The stucco finishes need to be repaired after the leak source generator has been repaired.

- The stucco finish was observed to be releasing from the EPS panels in various locations. This condition needs to be further evaluated by a qualified stucco repair specialist. Remedial repairs will be needed.

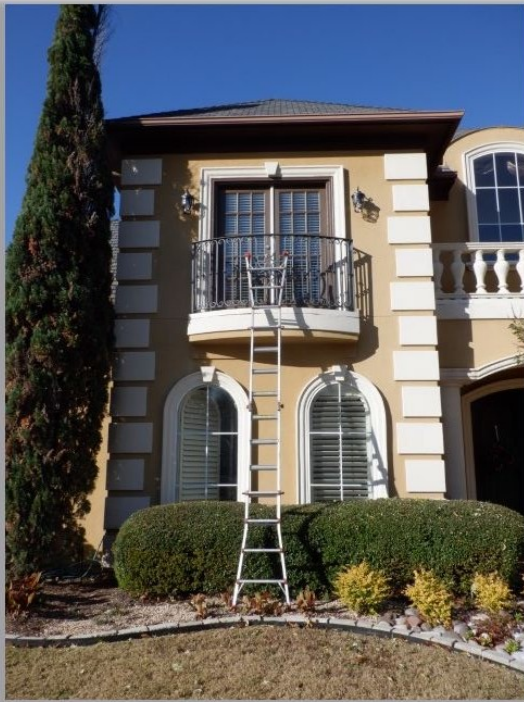
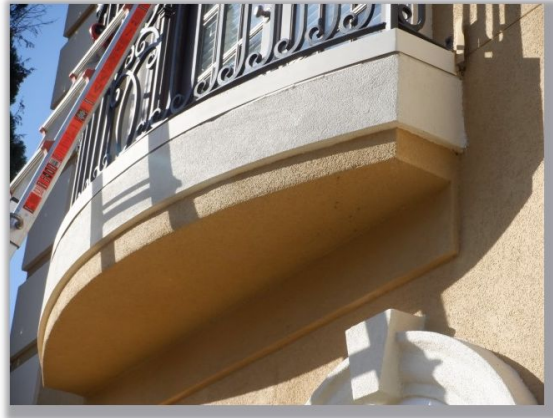
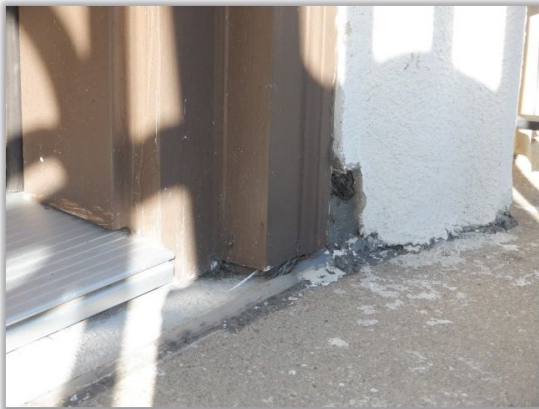
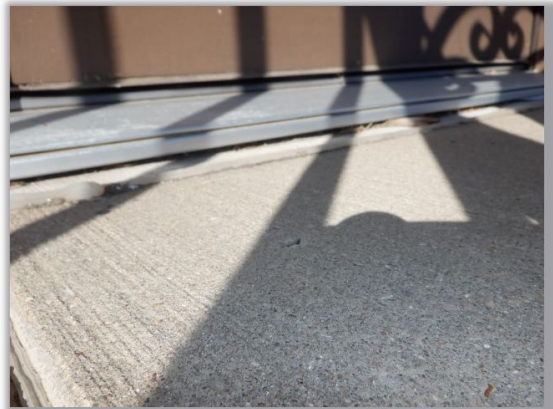
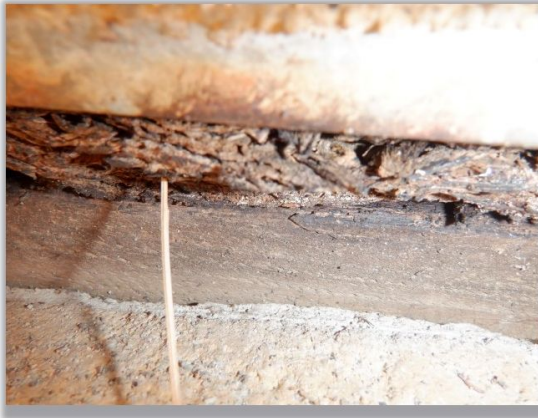
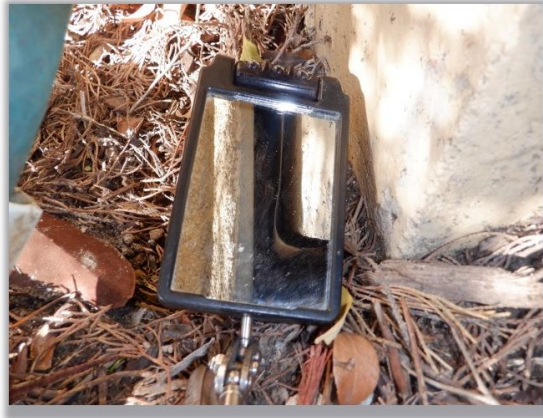
Balcony Over Master Bedroom Closet

- There is no visible end dam at the balcony interface with the stucco system. It is recommended to install end dams at this locations to help prevent water intrusion within the wall system.

- The EPS band(s) were observed to be damaged and repairs are recommended on both sides of the balcony doors.
- There is no visible through wall flashing (head flashing) above the door openings. Under current stucco installation standards, there should be through wall flashing continuously above all doors to help prevent water intrusion at these locations.

- There is not visible weep screed at the lower edge of the upper wall termination that projects over the lower wall. Under current manufacturer installation standards, there should be weep screed at the bottom termination of a stucco wall system to allow moisture to escape from the wall system. Repairs are recommended to help prevent damaged in these areas.

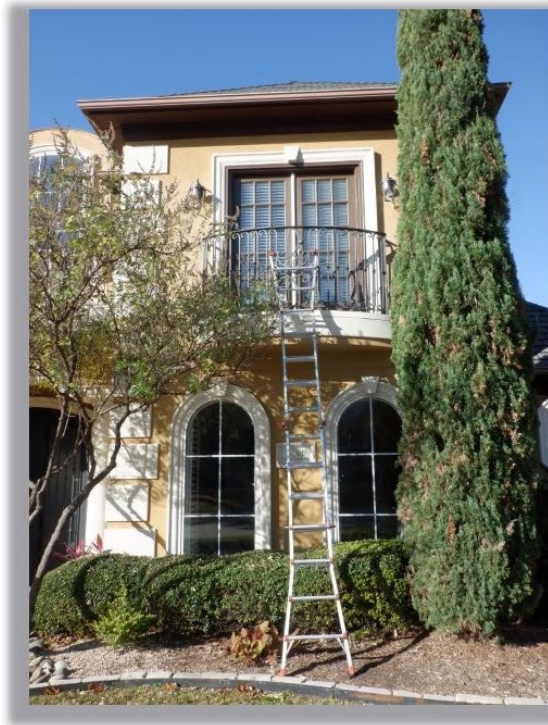
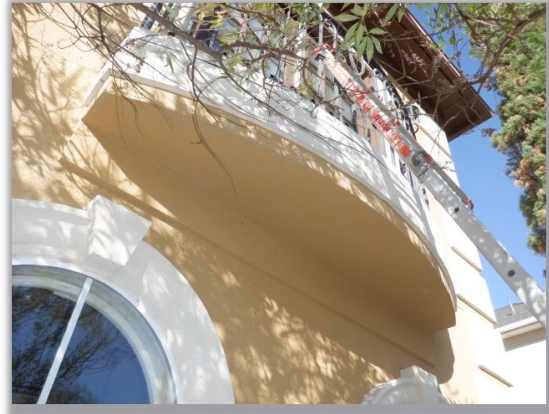
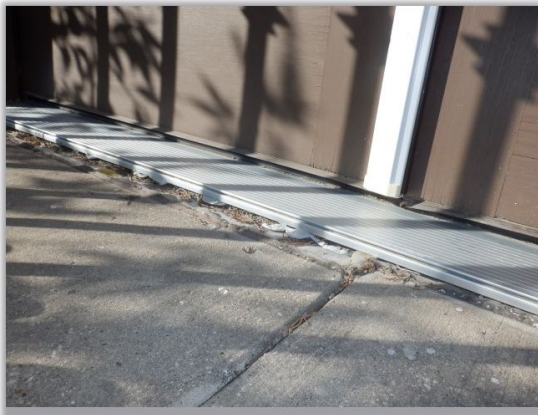
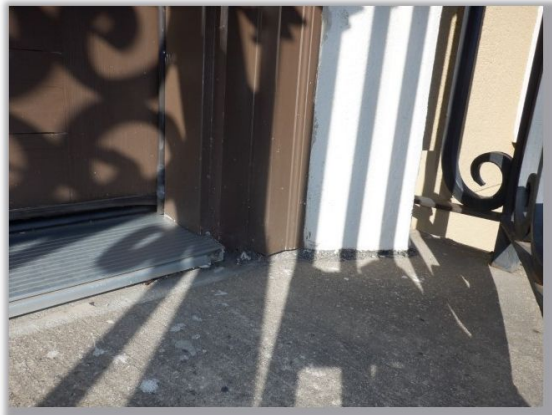
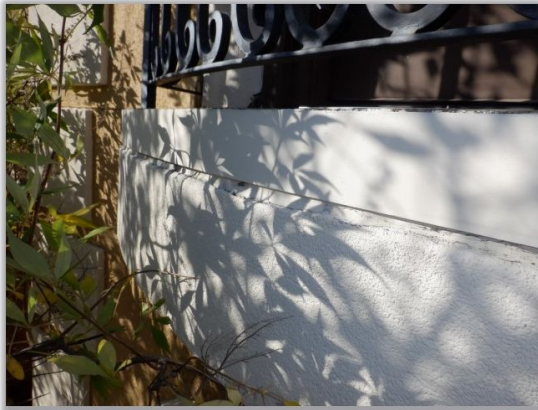
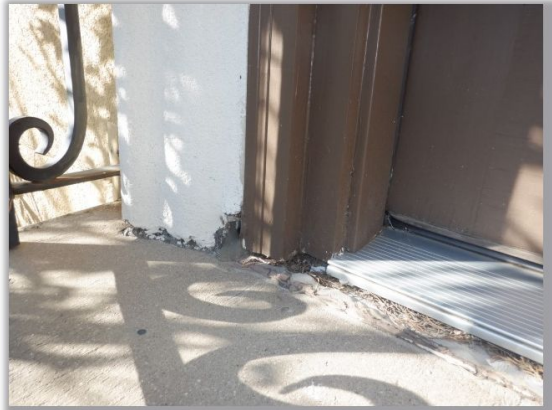
Balcony Over Dining Area

- There is no visible end dam at the balcony interface with the stucco system. It is recommended to install end dams at this locations to help prevent water intrusion within the wall system.

- The EPS band(s) were observed to be damaged and repairs are recommended on both sides of the balcony doors.
- There is no visible through wall flashing (head flashing) above the door openings. Under current stucco installation standards, there should be through wall flashing continuously above all doors to help prevent water intrusion at these locations.

- There is not visible weep screed at the lower edge of the upper wall termination that projects over the lower wall. Under current manufacturer installation standards, there should be weep screed at the bottom termination of a stucco wall system to allow moisture to escape from the wall system. Repairs are recommended to help prevent damaged in these areas.

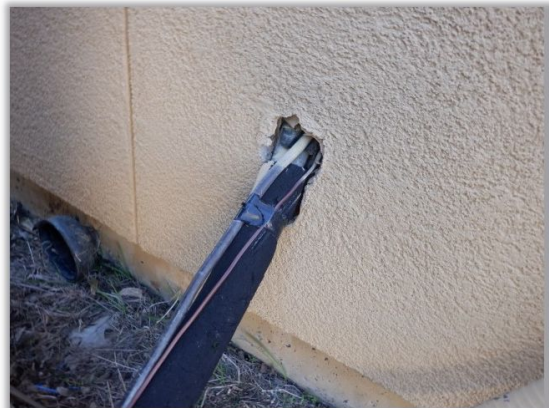
- The EPS decorative bands do not have a proper 6/12 slope away from the structures walls. Under current installation standards the EPS bands should have a 6/12 slope so water does not stand on top of the bands. There are no visible defects related to this application at this time and no remedial repairs are recommended.
- All sprinkler heads within 12-inched of the exterior walls should be relocated a minimum of 12-inches away from the walls and directed so that water does not spray directly onto the walls.
- The area between the exterior cladding / veneer and all of the wall penetrations / openings need to be properly sealed. Areas such as utility connections, downspouts, hose bibbs, lighting fixtures, receptacles etc. It is recommended to use an industry approved low-modulus elastomeric sealant.

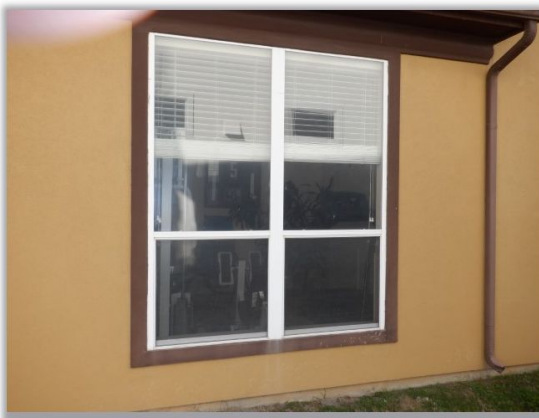
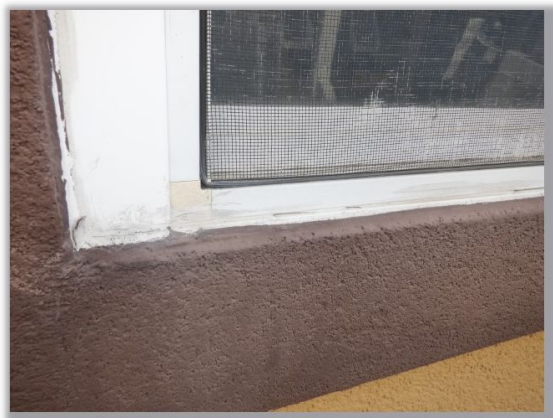
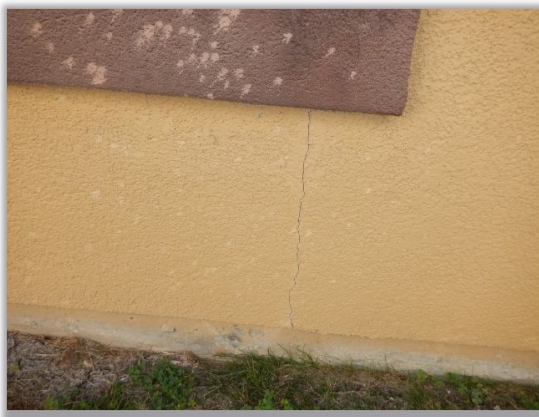
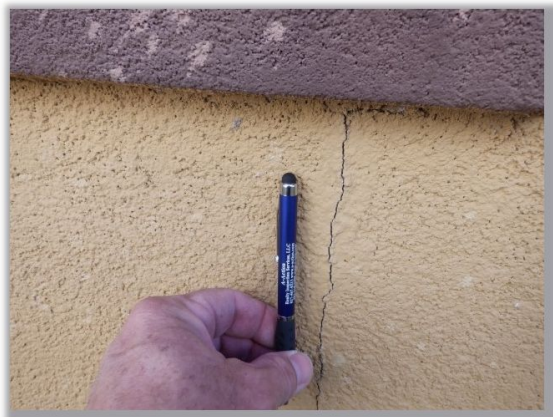
Workout Room Window

- There are larger than typical cracks observed in the stucco finish under the workout room window. The cause of the cracking needs to be further evaluated and repairs by a qualified stucco specialist.
- The stucco finish coat or sealant was observed to be installed over the window weepholes / tracks. It is recommended to clear all of the window weepholes / tracks to help prevent further water intrusion within the wall cavity.

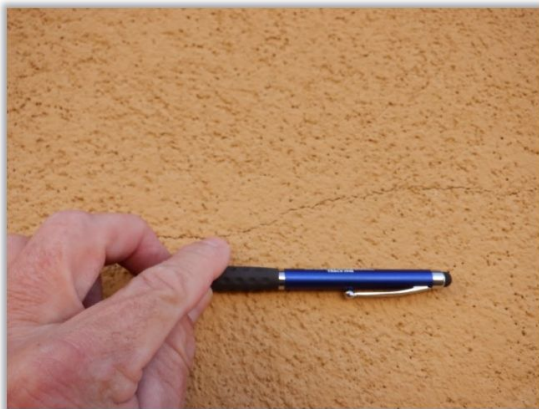
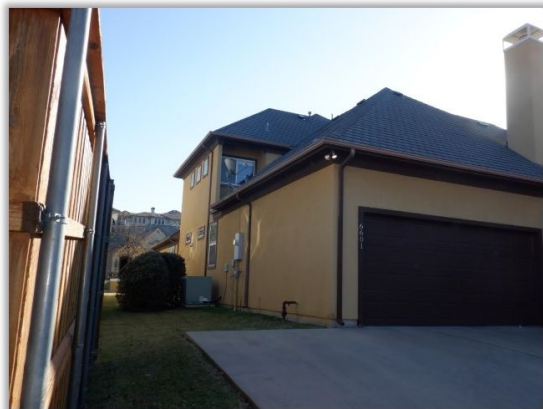
- Some minor cracking of the stucco finish was observed in one or more locations at the time of this inspection. The cracks observed were less than 1/16-inch and are consistent to be within accepted industry standards and no remedial repairs are recommended.

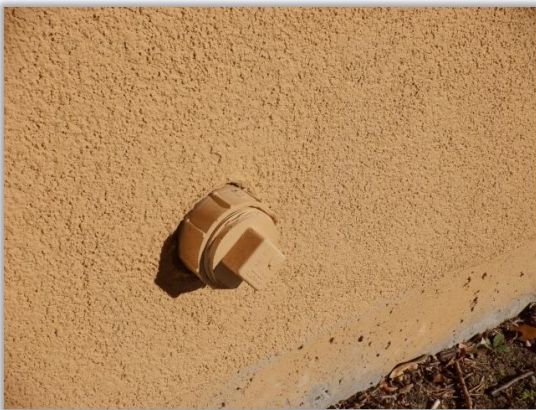
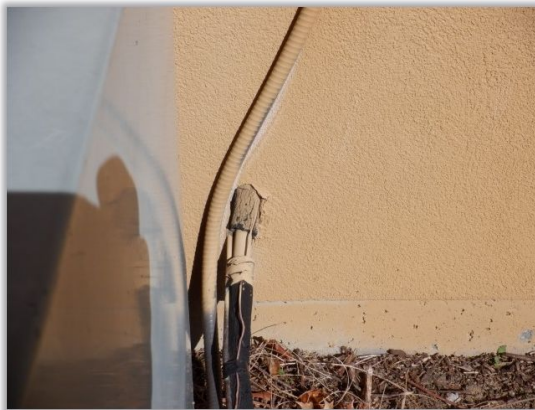
- The area between the exterior cladding / veneer and all of the wall penetrations / openings need to be properly sealed. Areas such as utility connections, downspouts, hose bibbs, lighting fixtures, receptacles etc. It is recommended to use an industry approved low-modulus elastomeric sealant.

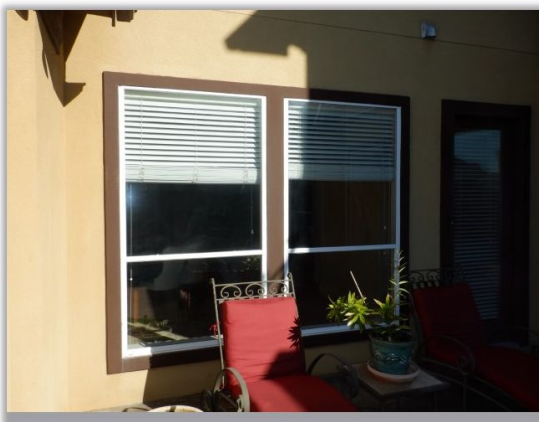
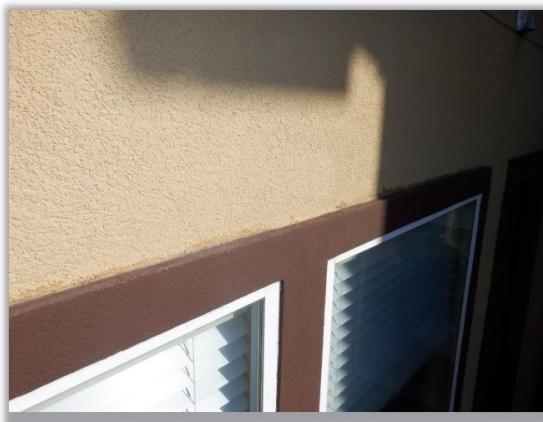
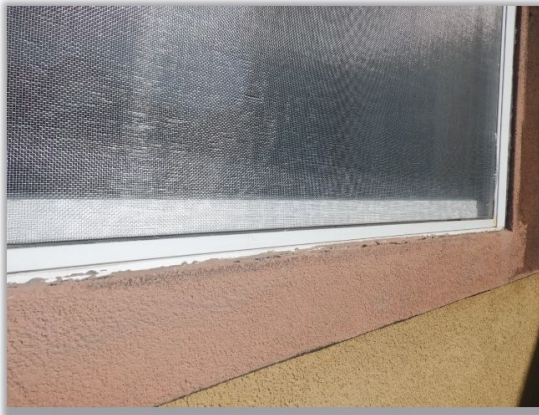
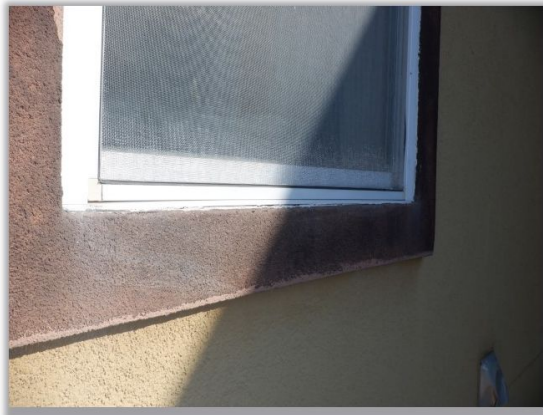
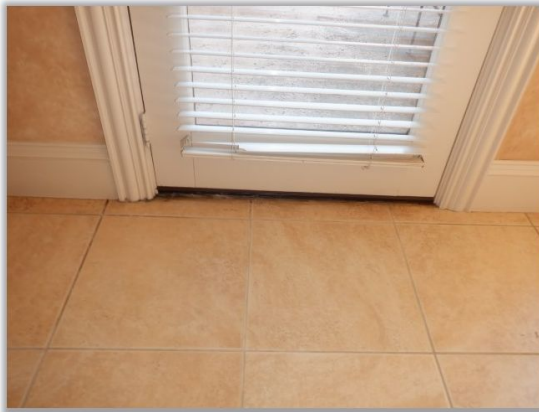
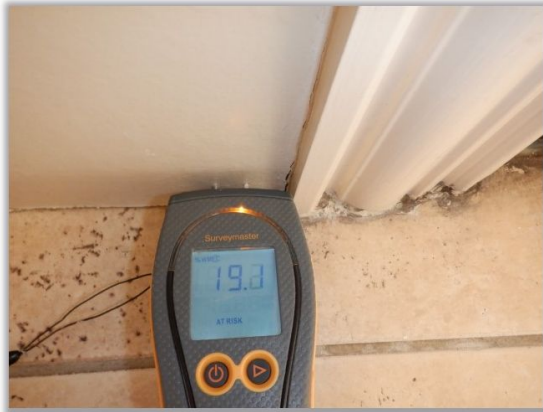
Breakfast Area Windows / Back Door

- There is no visible through wall flashing (head flashing) above the door openings. Under current stucco installation standards, there should be through wall flashing continuously above all doors to help prevent water intrusion at these locations. The lack of this flashing detail has allowed water into the wall cavity and leak to the interior of the structure.

- The stucco finish coat or sealant was observed to be installed over the window weepholes / tracks. It is recommended to clear all of the window weepholes / tracks to help prevent further water intrusion within the wall cavity.

- The substrate (sheathing) behind the stucco finishes appear to be compromised. The stucco is bulging and very spongy to the touch. This condition needs to be further evaluated and repaired as necessary. It is my professional opinion that the stucco in the affected areas will need to be removed, the substrate replaced and the stucco finishes replaced.

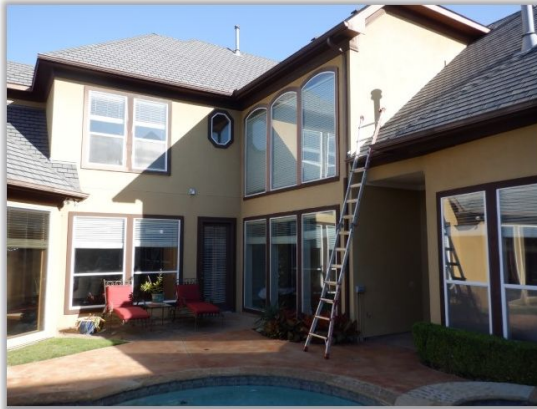
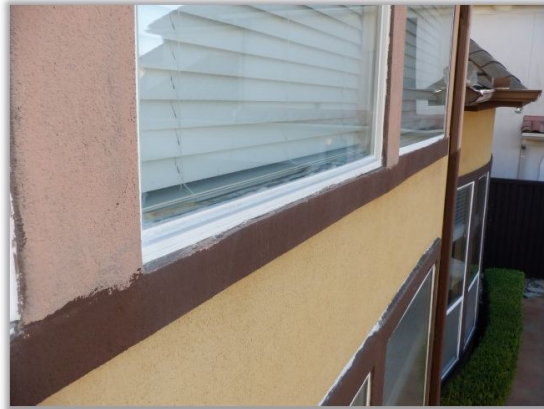
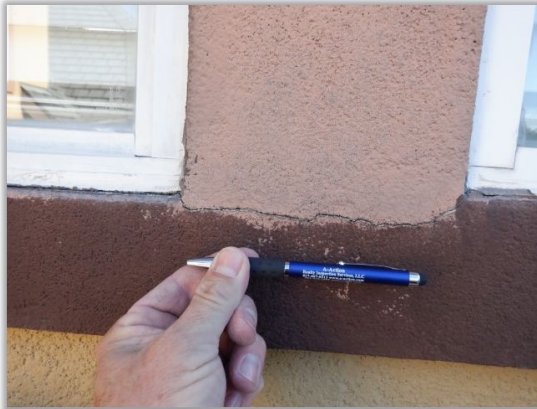
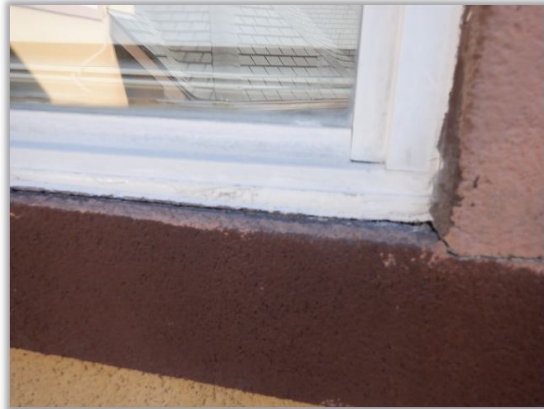
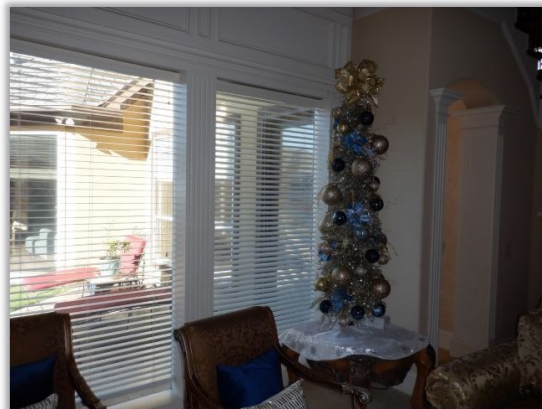
Living Area Windows

- Visible evidence of water intrusion was observed at and/or around the window(s) in the living room.
- There is no visible through wall flashing (head flashing) above the windows. Under current stucco installation standards, there should be through wall flashing continuously above all windows to help prevent water intrusion at these locations.
- There is visible evidence of water intrusion through the stucco cladding system on the back side of the structure at and around the living area windows. This condition has caused some visible damage to the stucco cladding. This condition should be further evaluated and corrected as necessary.
- There are larger than typical cracks observed in the stucco finishes. The cause of the cracking needs to be further evaluated and repairs by a qualified stucco specialist. Further moisture testing recommended.

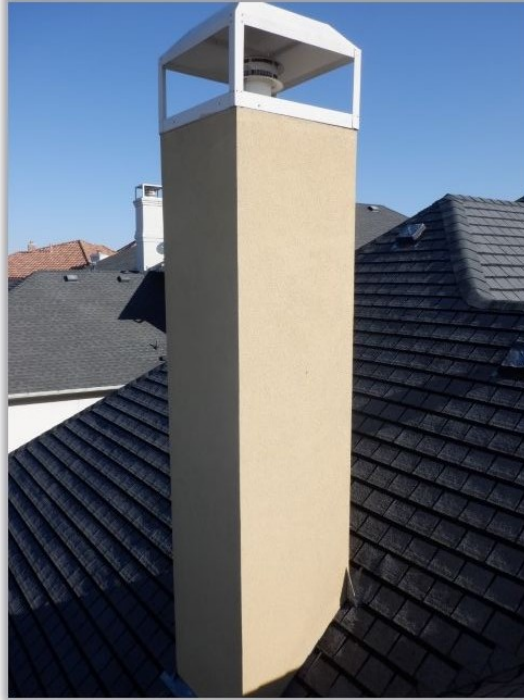
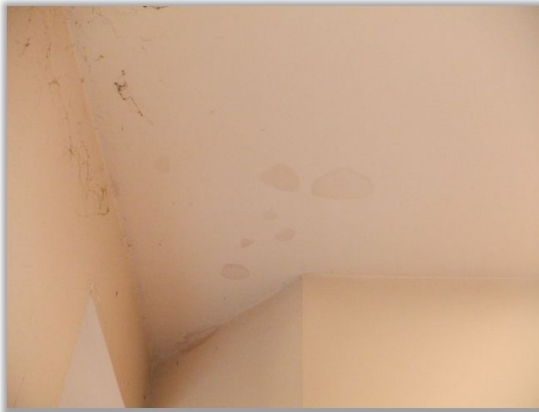
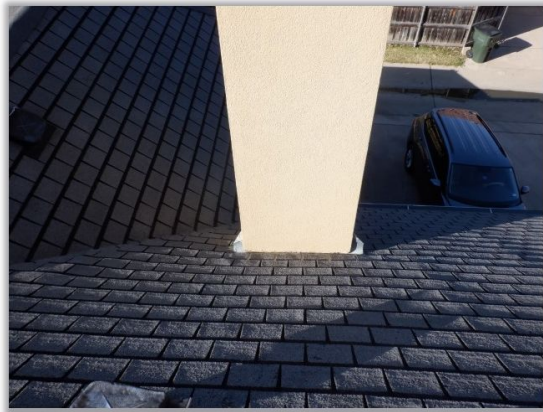
Roof Level Chimney

- The ceiling was observed to have water damage in the garage. The roof level chimney flashing details need to be further evaluated.
