PHASE 1 PRE-POUR INSPECTION REPORT

PRE-POUR INSPECTION REPORT

Prepared For:	Client Name Here	(Name of Client)	
Concerning:	Address, City, TX 00000	(Address of Inspected Property)	
By:	Brian Murphy, Lic #3948 (Name of Inspector)		Date Here (Date)

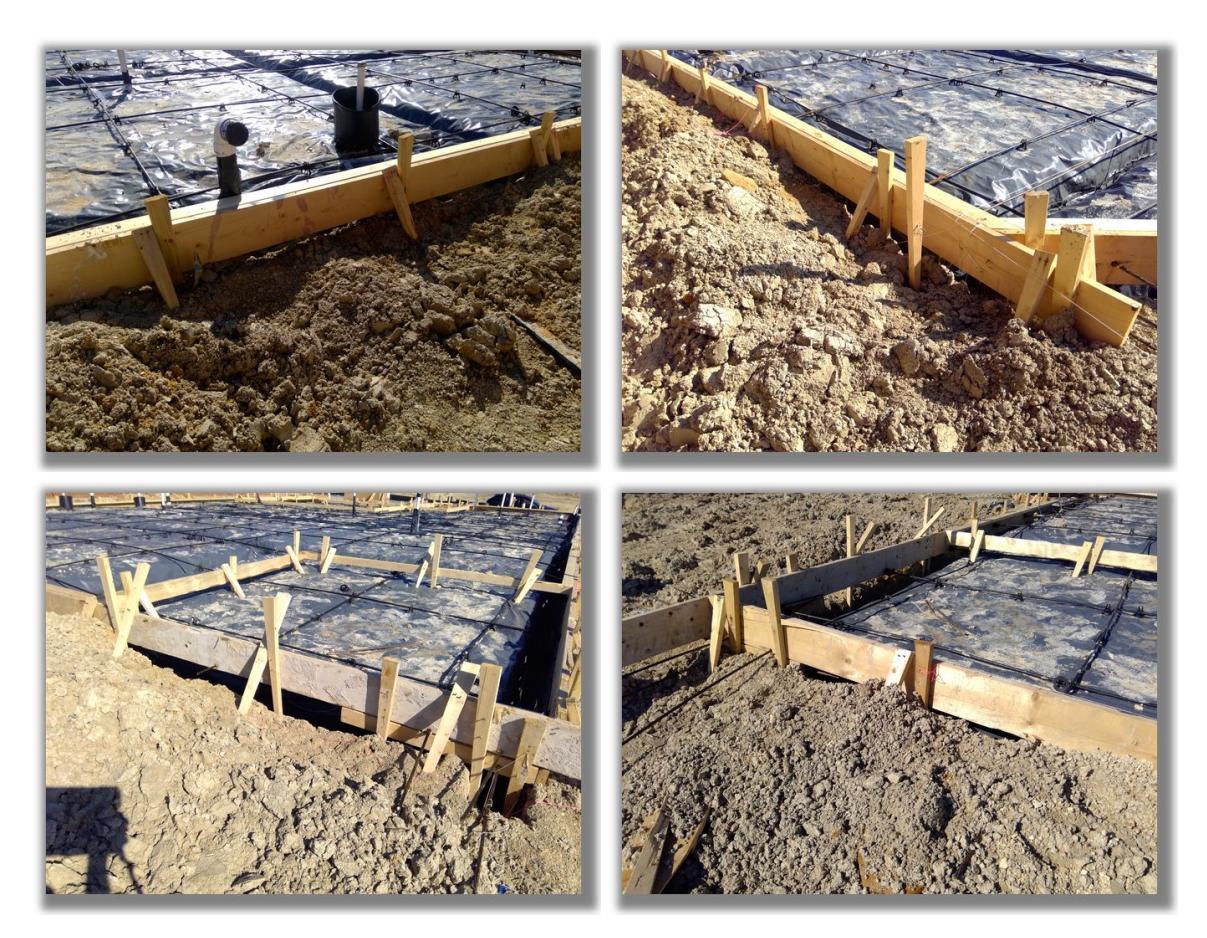
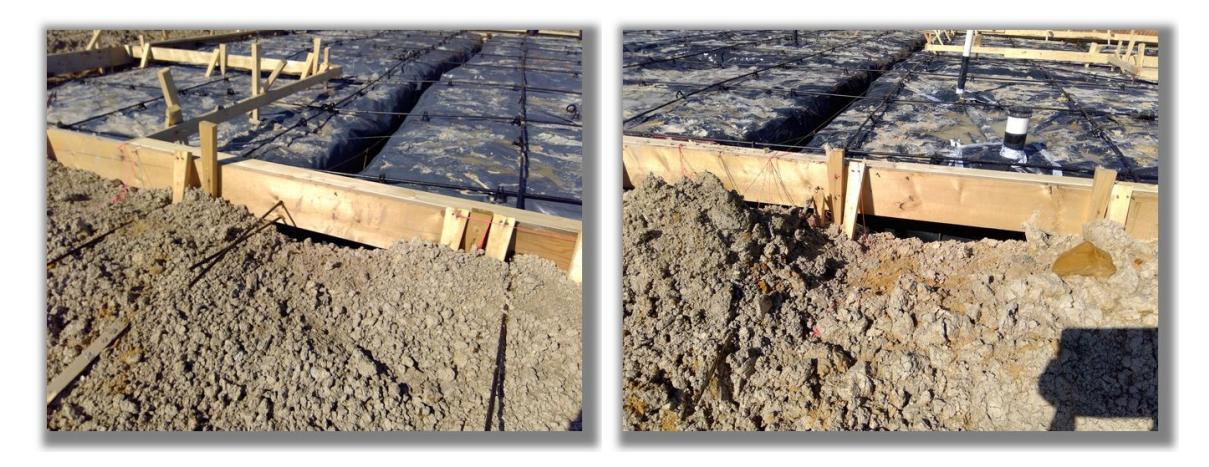
• The form boards are not properly backfilled to help prevent blowouts on the north, south and west sides of the foundation.

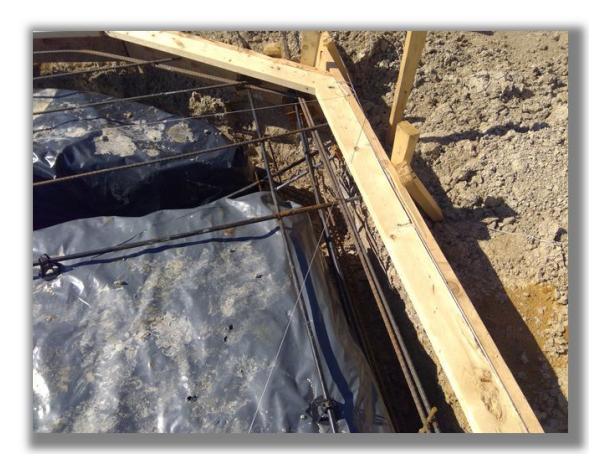
• The engineered drawings call out for a minimum beam depth of 30-inches. The beam in the area of master bedroom is too shallow per the plans and should be corrected.

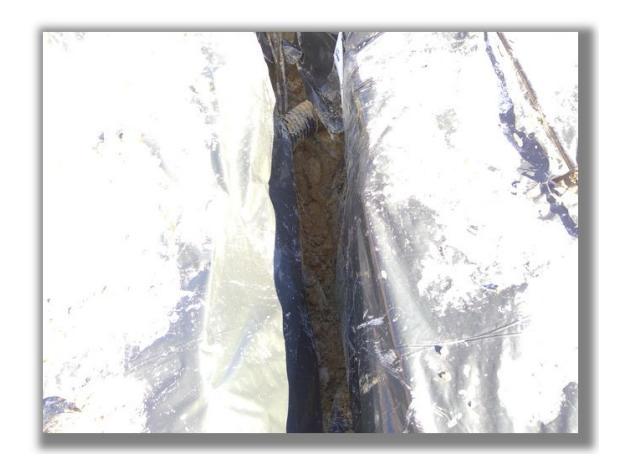
• The engineered drawings call out for a minimum beam depth of 30-inches. The beam in the area of laundry room is too shallow per the plans and should be corrected.

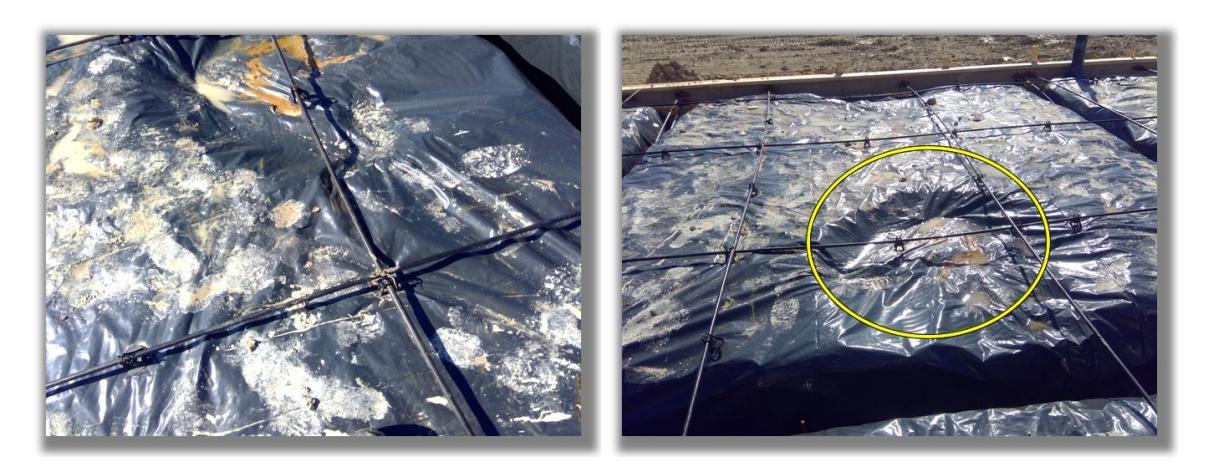
• The slab does not have proper thickness in the area of HD1. Detail HD1 is not properly located and should be moved 2-feet to the south of its current location.

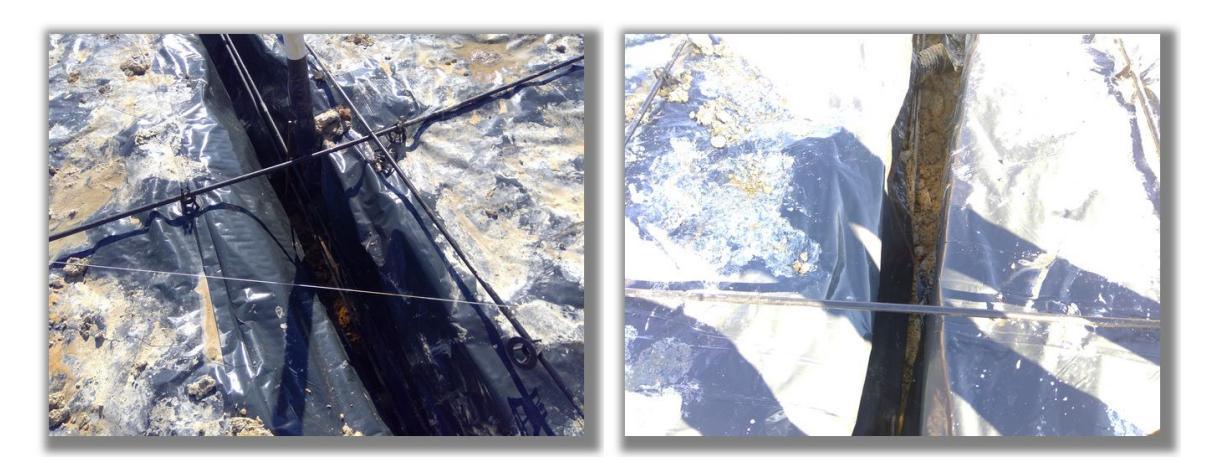
• There is a cave-in in the beam in the area of the laundry room and hall bathroom. The cave-in needs to be cleaned out to maintain the proper beam depth and width.

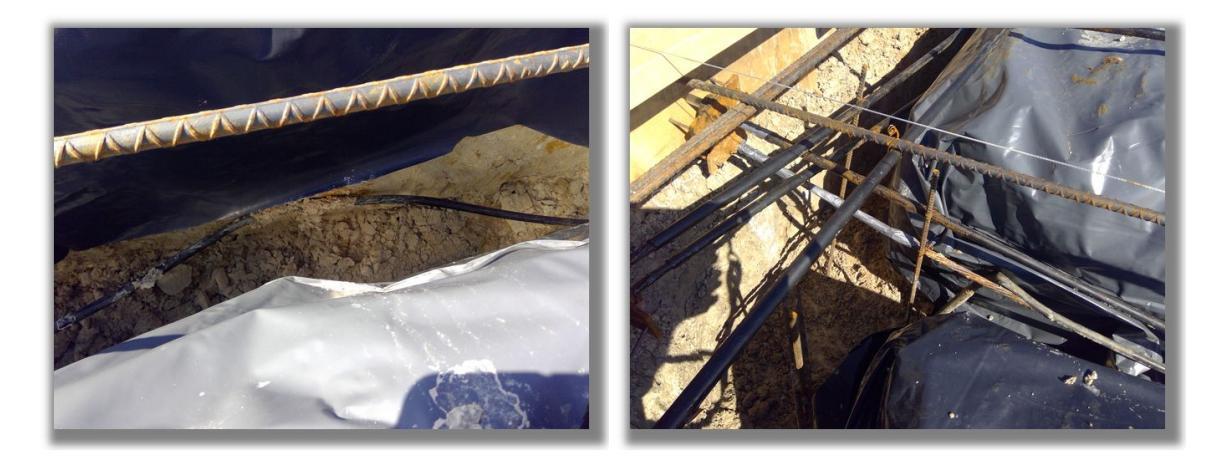
- Excessive sagging of the tendons was observed in various locations. The tendons should be tightened and straightened prior to pouring the concrete.
- There is damaged sheathing on the post tension cables in the area of the master bedroom. This should be corrected to help prevent concrete from adhering to the metal post tension cable.

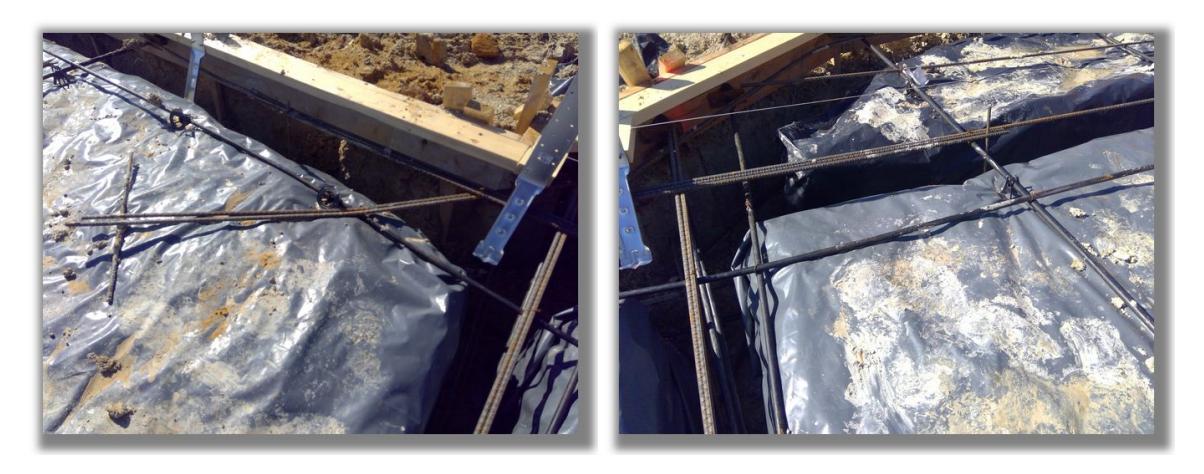
• The reinforcement intersections are not properly supported with chairs or blocks and secured (tied) in place. All reinforcement intersection need to be further evaluated and properly chaired and secured together prior to pouring concrete.

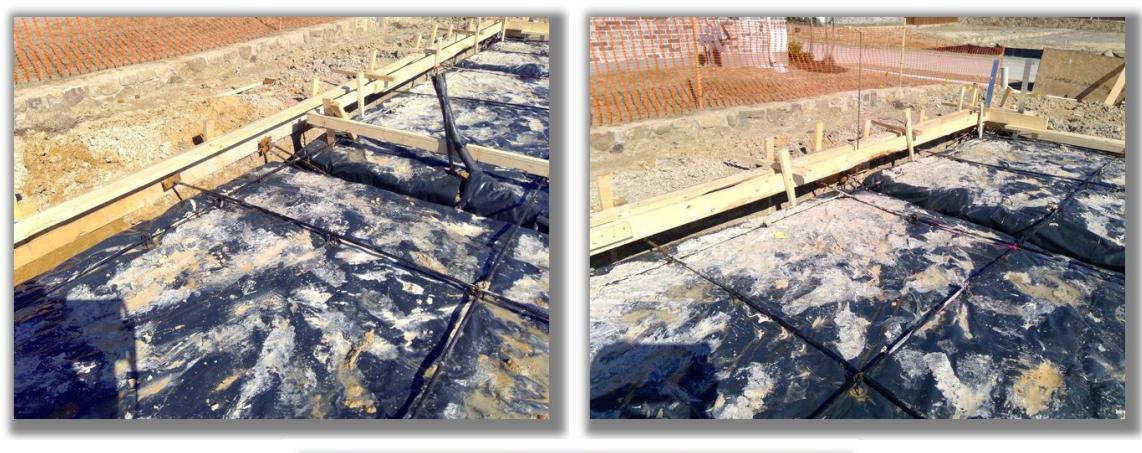
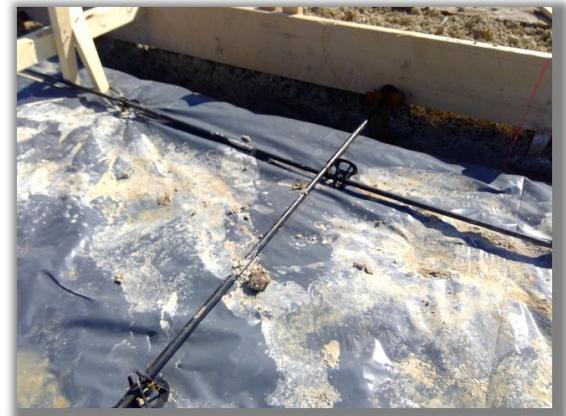
• The reinforcement intersections are not properly supported with chairs or blocks and secured (tied) in place. All reinforcement intersection need to be further evaluated and properly chaired and secured together prior to pouring concrete.

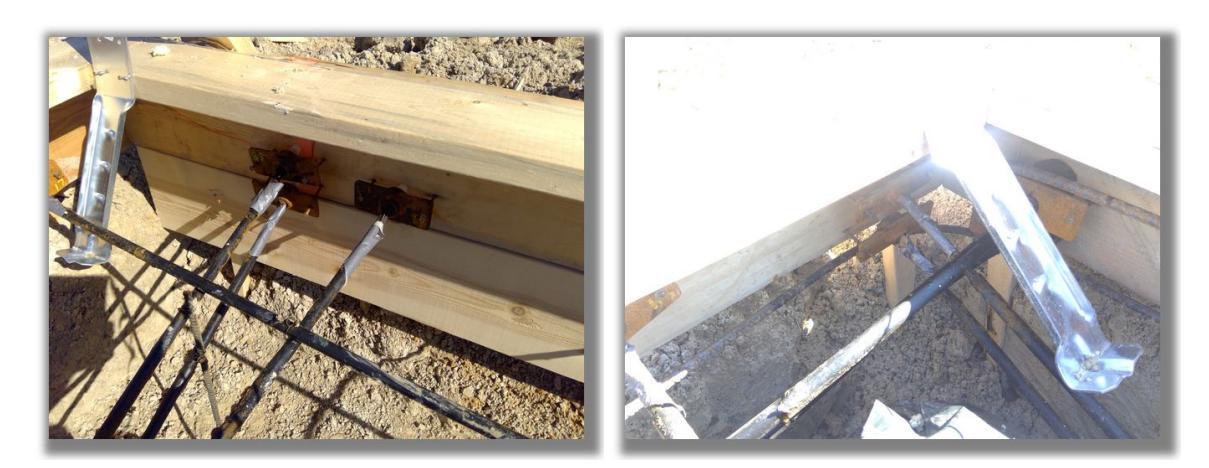
• There is damaged sheathing on the post tension cables in various locations throughout the house. This should be corrected to help prevent concrete from adhering to the metal post tension cable.

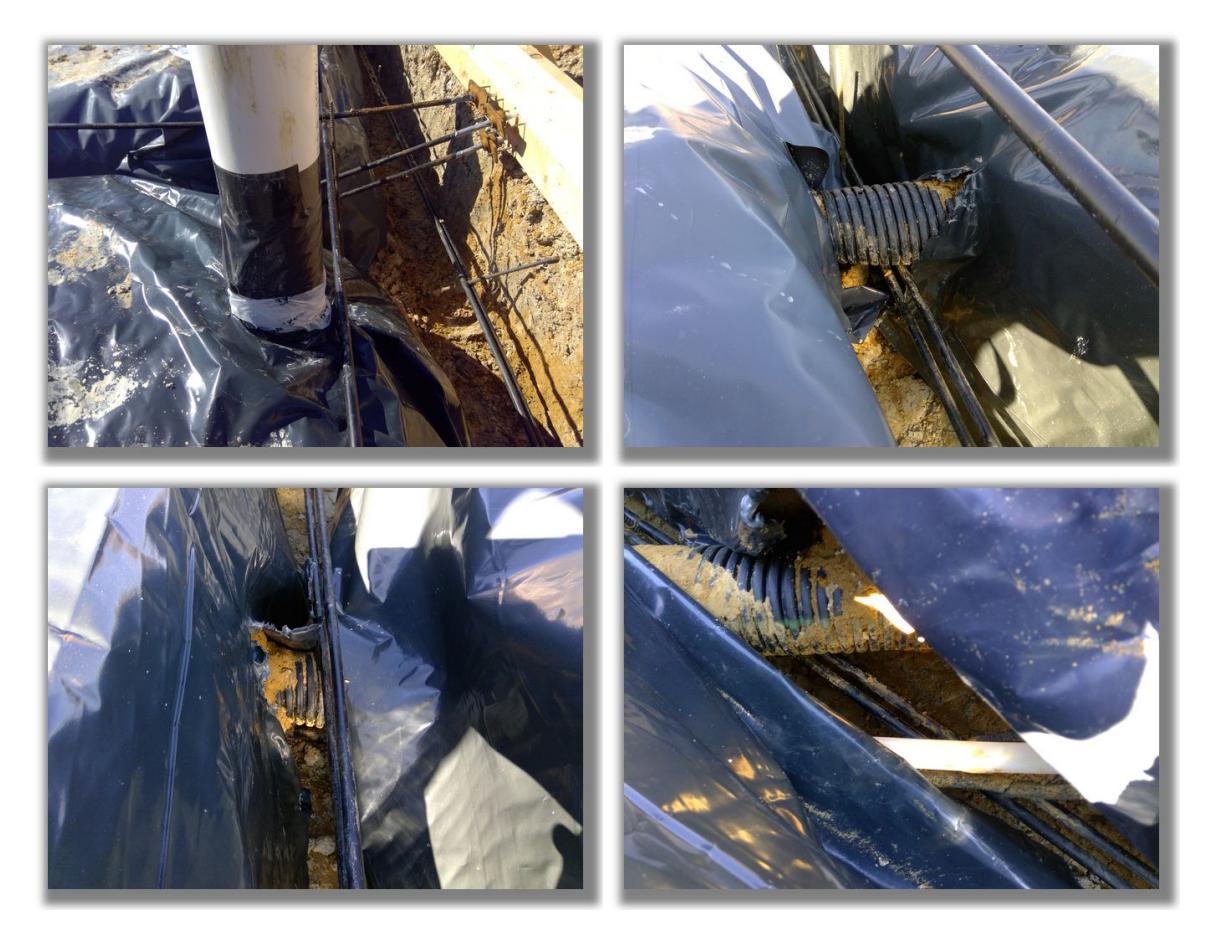
• The post tension tendon should have a minimum of 3-inches of clearance from waste pipes through the beams footings. The tendon has poor clearance in the area master bathroom. A support chair can be placed between the pipe and the tendon tied in place to correct this condition.

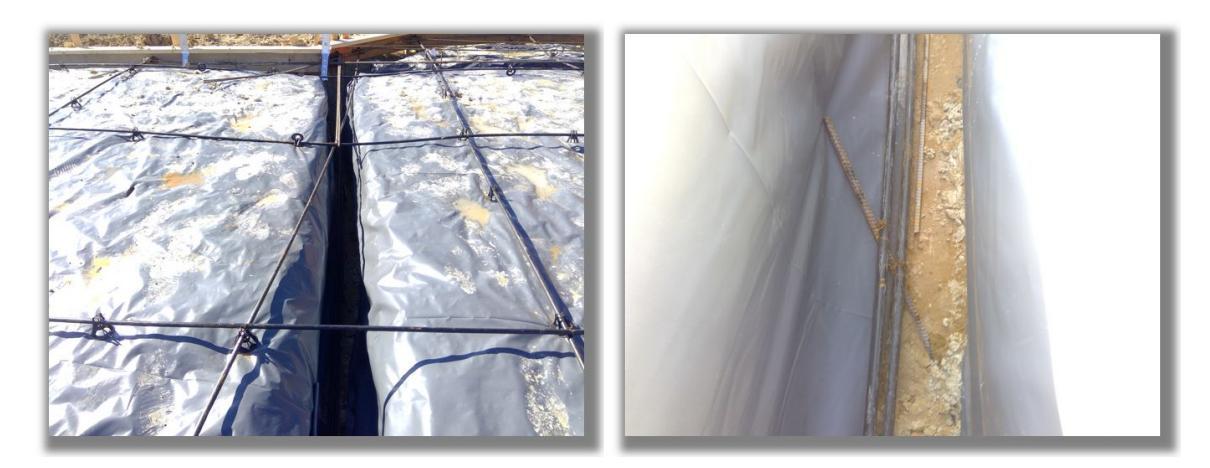
• Excessive sagging of the tendons was observed in various locations. The tendons should be tightened and straightened prior to pouring the concrete.

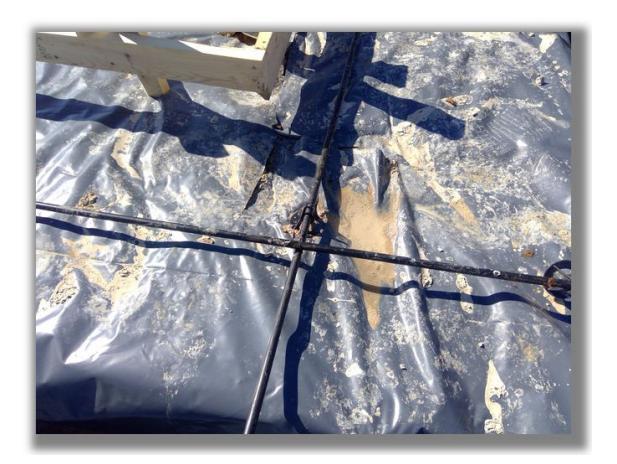
• Damage to the moisture/vapor barrier was observed in one or more locations. The moisture/vapor barrier should be repaired by applying and overlapping additional moisture/vapor barrier material a minimum of 6-inches passed the damaged area, then taped in place to provide a continuous sheet under the entire foundation.

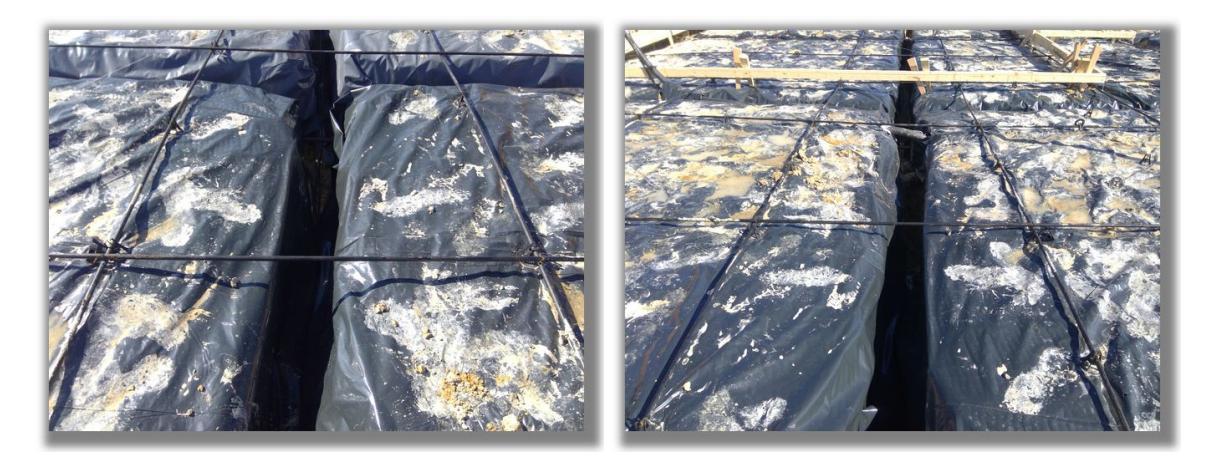
• The moisture/vapor barrier is installed over the top of some of the tendons. This condition should be corrected to help prevent air pockets / voids from occurring.

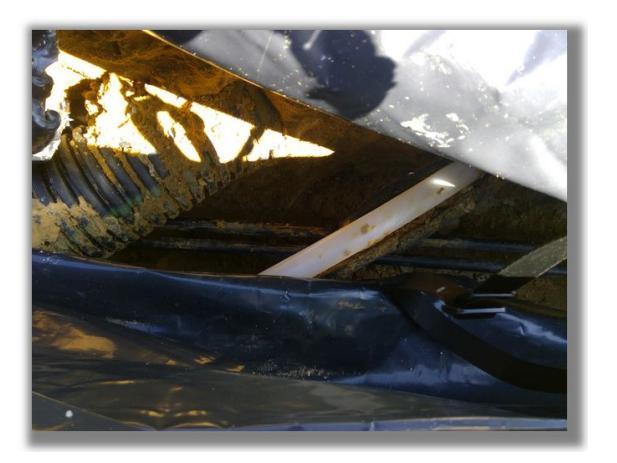
• The water supply lines need to be properly protected in the beam / footing areas. The water line is not properly insulated across the beam / footing. This condition should be corrected prior to the concrete being poured to help prevent future slab leaks from occurring.

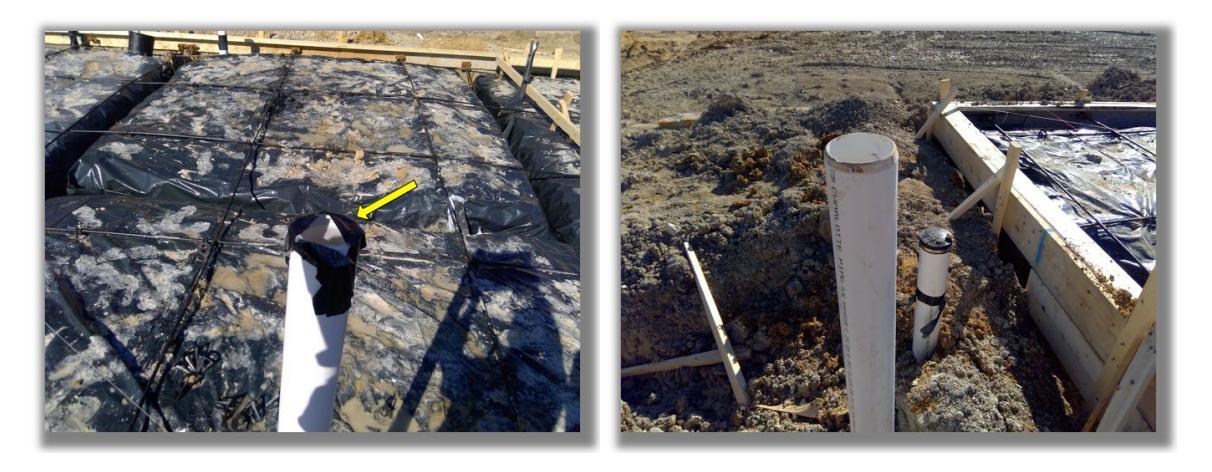
• All plumbing risers / stand pipes should be properly capped. Tape should not be used to seal the top of the plumbing risers / stand pipes.
