PROPERTY INSPECTION REPORT

Prepared For: Client Name Here
(Name of Client)

Concerning: Address, City, TX 00000
(Address or Other Identification of Inspected Property)

By: Brian Murphy, Lic #3948 Date Here
(Name and License Number of Inspector) (Date)

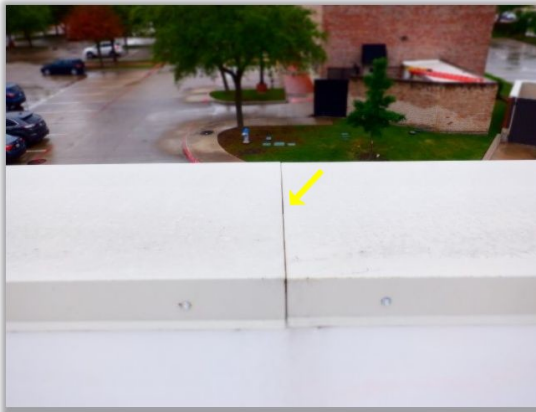
- The parapet cap seams need to be properly sealed to help prevent water intrusion.

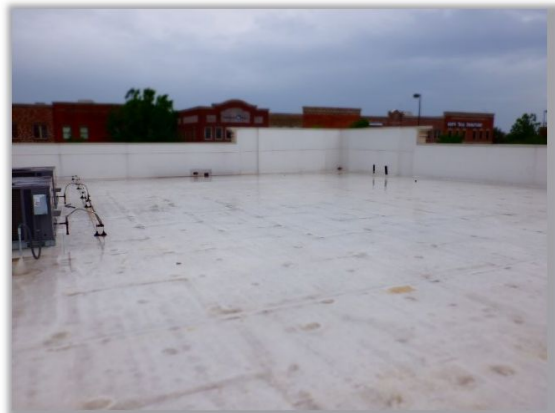
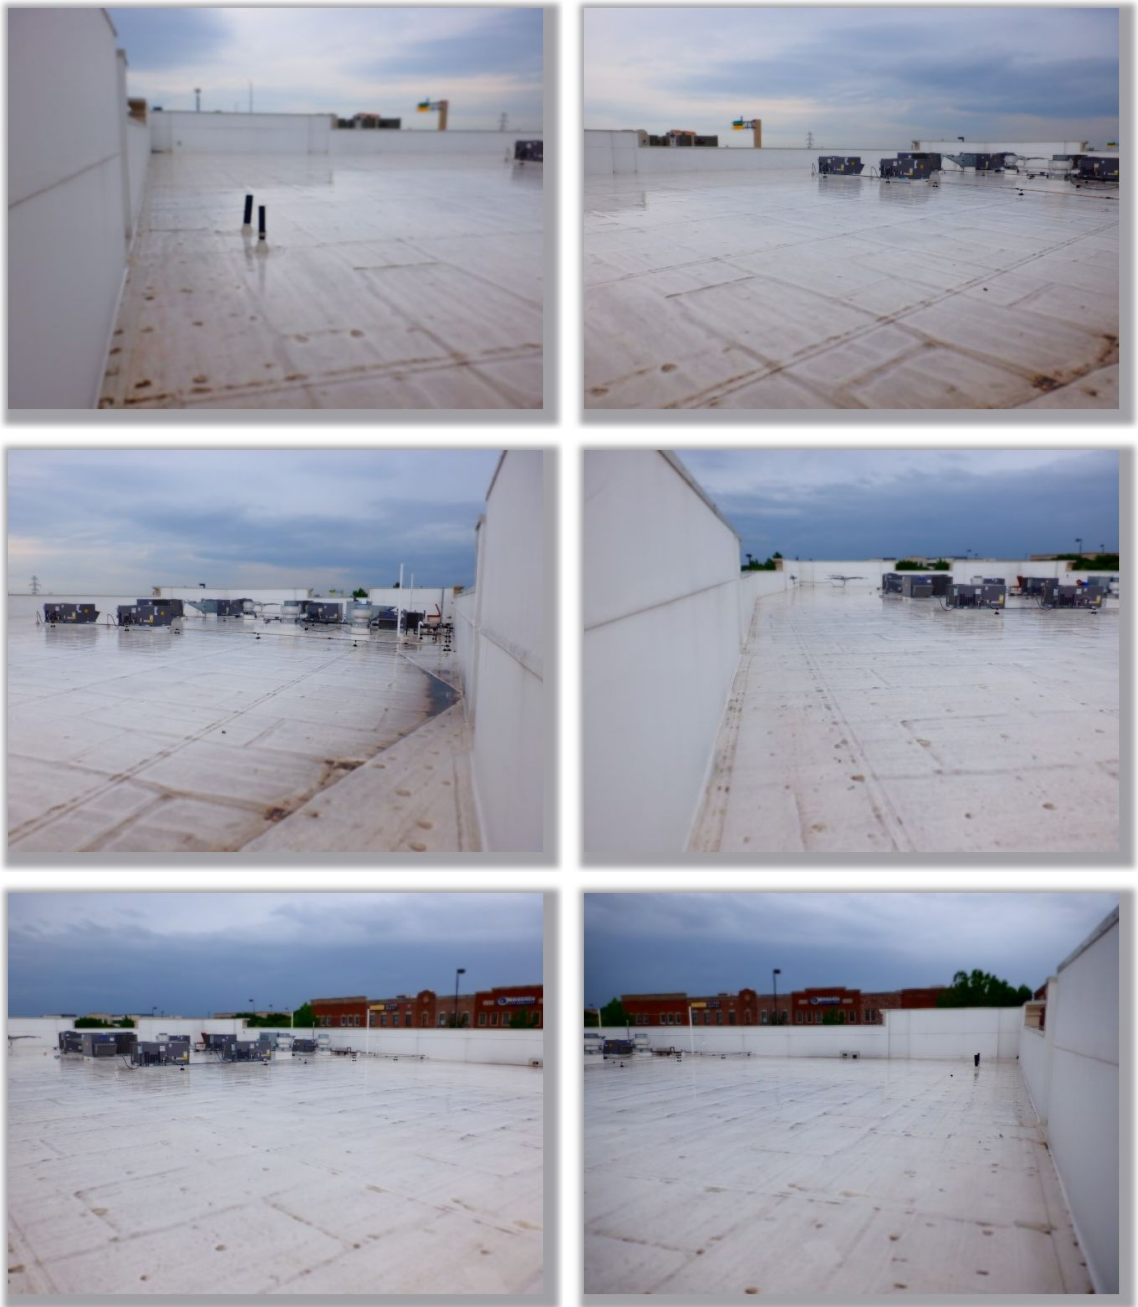
All components appear to be performing adequately on the day of this inspection. The roofing material components appear to be shedding water and achieving the operation, function or configuration relative to accepted industry standard practices with consideration of age and normal wear and tear from ordinary use.

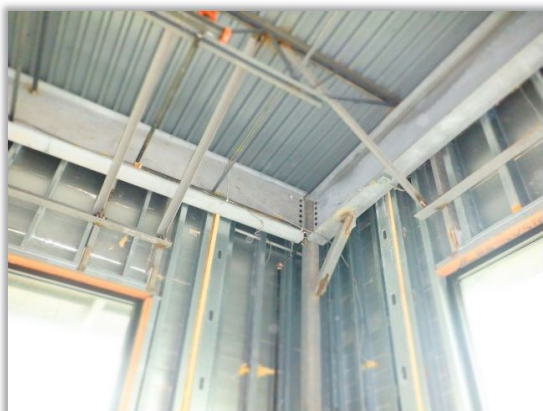
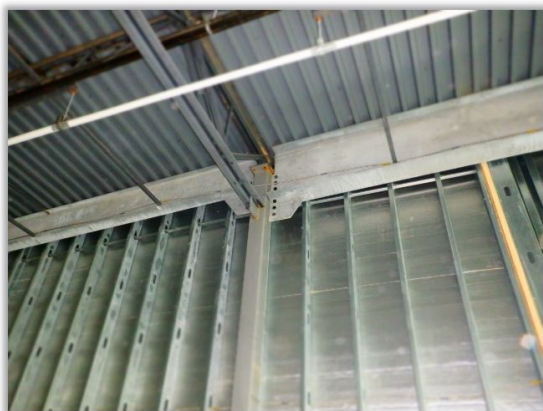
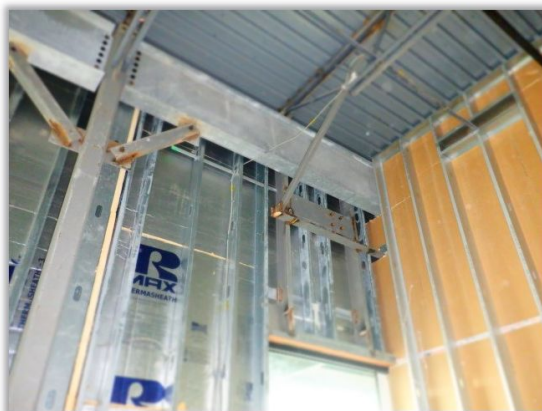
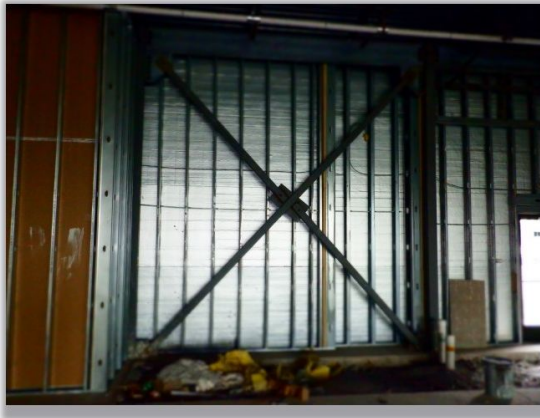
All components appear to be performing adequately at the time of this inspection.

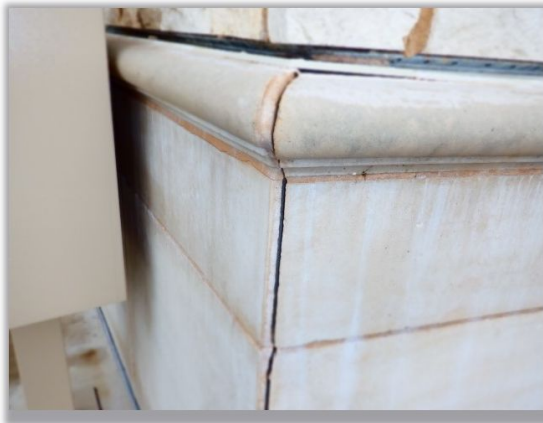
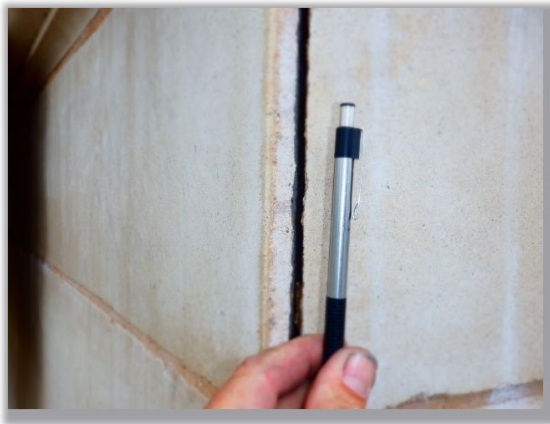
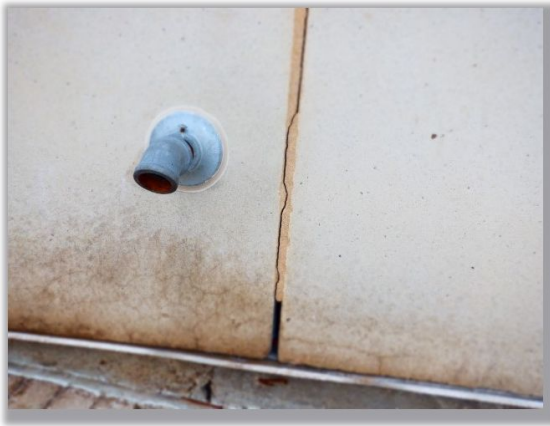
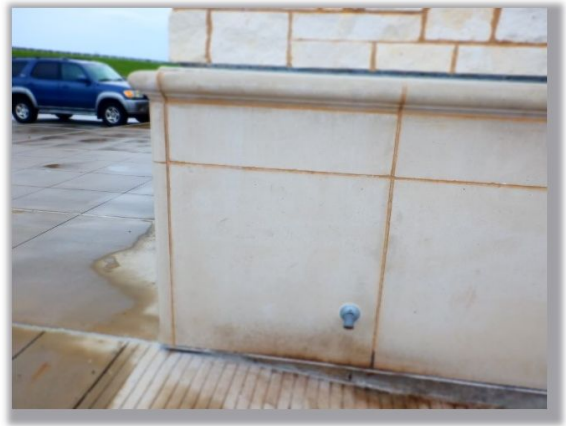
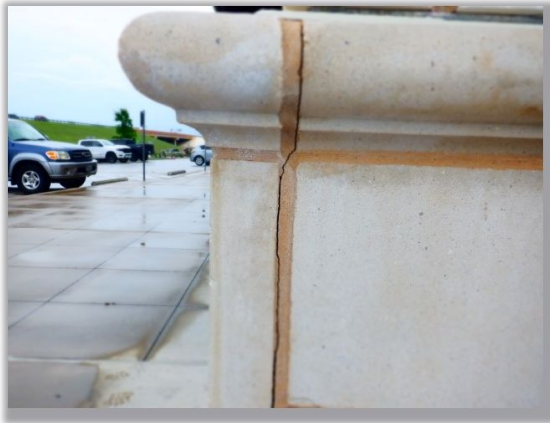
Exterior Walls & Surfaces

- Mortar improvements are recommended for the exterior masonry veneer on the east and south sides of the structure. The cast stone mortar needs to be improved in several locations.
- The large corner cast stone has settled downward and has caused a large gap in the seam on the southeast corner of the structure.

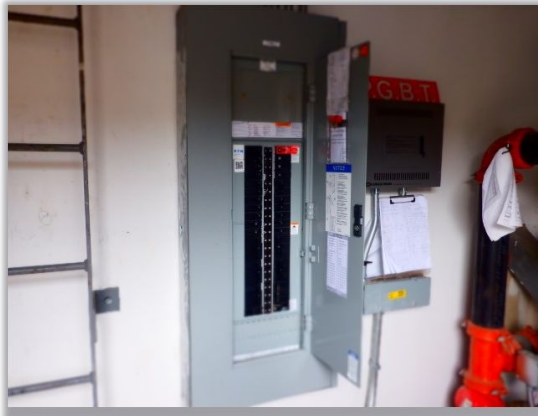
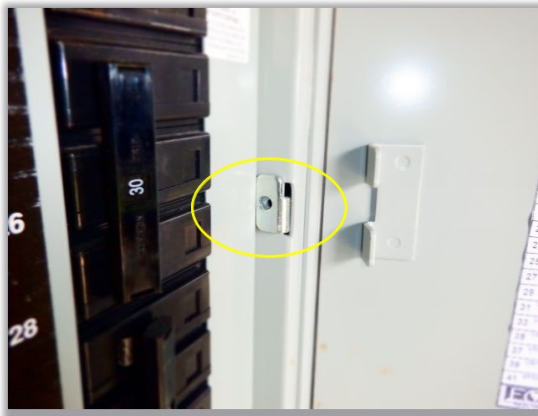
- The breakers (overcurrent devices) in the electrical panel are not properly labeled.
- All openings (missing knockouts) in the electrical cabinet cover plate (dead front) and /or cabinet need to have fillers.
- The front cover set lock is missing the screw that secures it in place.

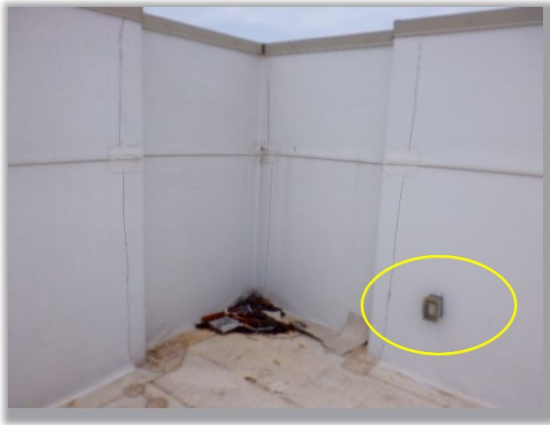
- One of the ground fault circuit interrupter (GFCI) devices does not appear to be functioning properly at the time of this inspection. The device in question is located on the roof level perimeter walls.

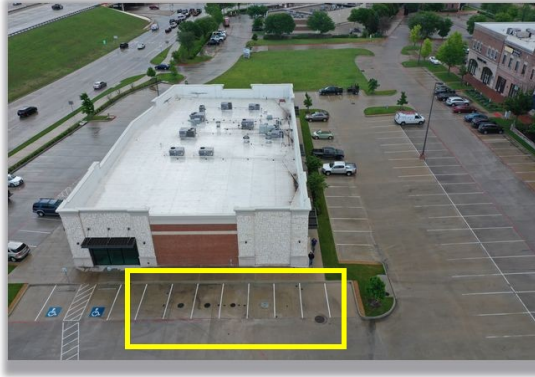
Main Double Clean-out Location: Within 5-feet of north Parking Area

All components were found to be performing and in satisfactory condition on the day of the inspection.

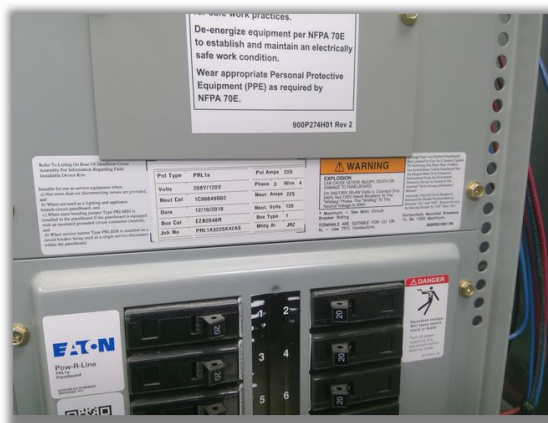
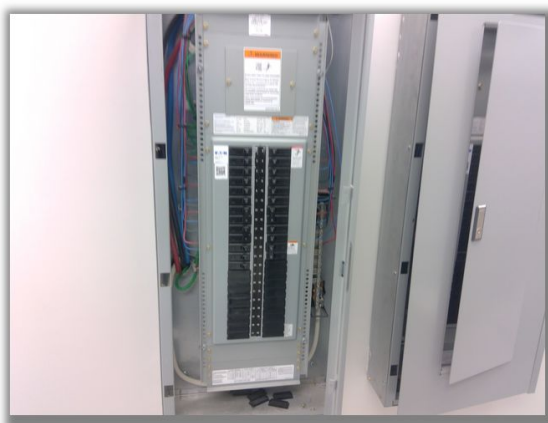
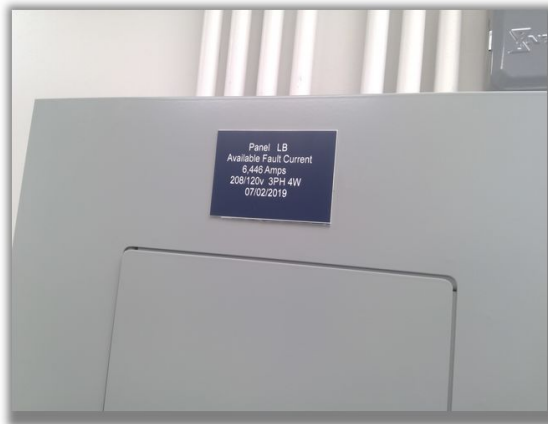
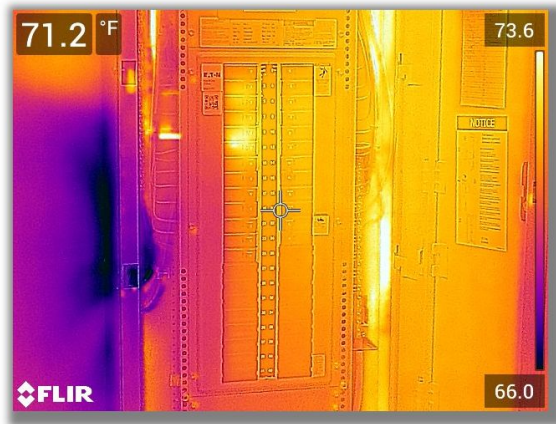
Sub Panel #LB

- The breakers (overcurrent devices) in the electrical panel are not properly labeled.

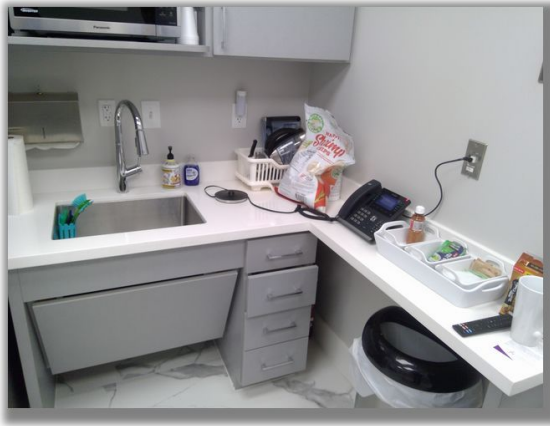
Receptacle Outlets

- The receptacles within 6-feet of the break room sink do not appear to be connected to a ground fault circuit interrupter (GFCI) device. Under current electrical standards, all receptacles within 6-feet of a sink should have GFCI protection.

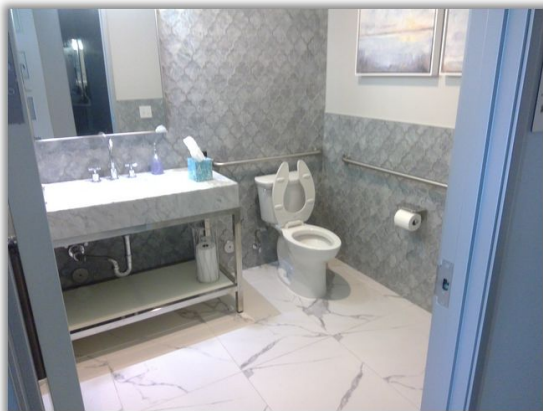
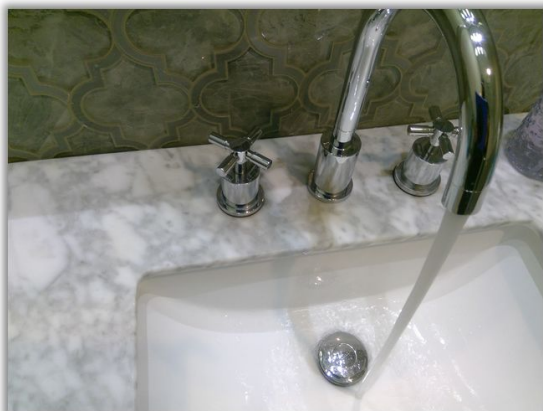
Lavatory / Sink

- The hot side faucet is not functioning properly at this time.

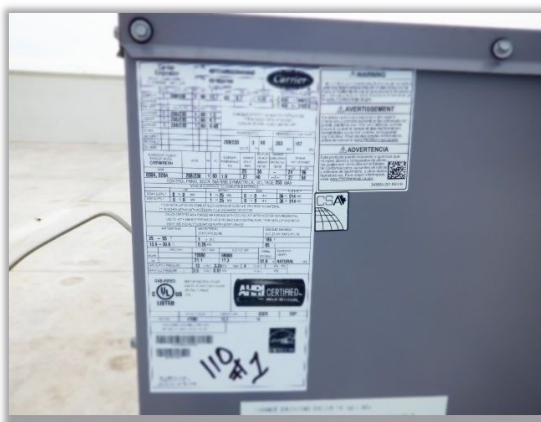
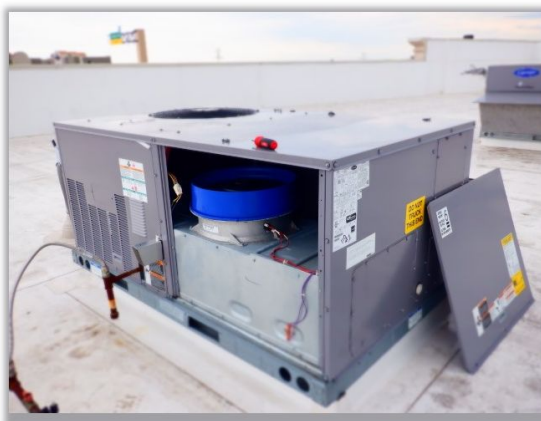
Additional Observations and/or Comments:

- The fins of the outdoor portion of the air conditioning system were observed to be damaged. This condition can reduce the efficiency of the system.
- There is no primary condensate drain line installed for this unit. This condition does not meet current mechanical installation standards. It is recommended to install a primary condensate drain line that terminates to an approved waste receptor.

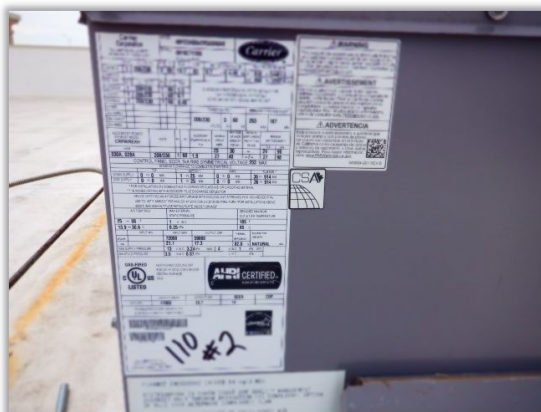
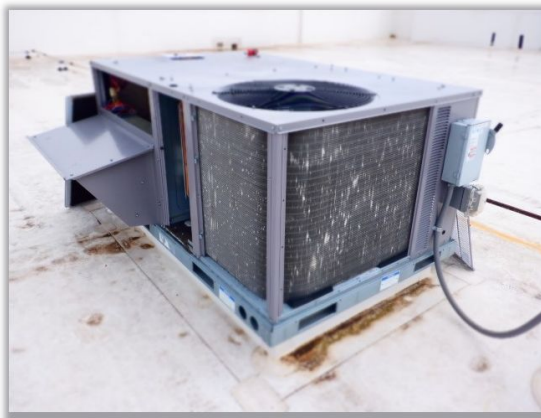
- The fins of the outdoor portion of the air conditioning system were observed to be damaged. This condition can reduce the efficiency of the system.
- There is no primary condensate drain line installed for this unit. This condition does not meet current mechanical installation standards. It is recommended to install a primary condensate drain line that terminates to an approved waste receptor.

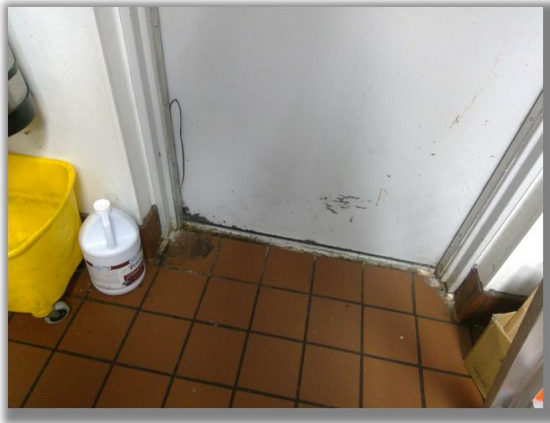
Exterior Doors

- Visible evidence of previous water intrusion was observed at and/or around the exterior backyard entry door(s). The cause and remedy should be investigated and corrected as necessary.

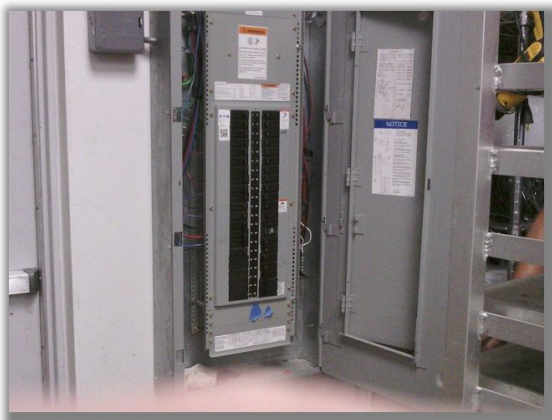
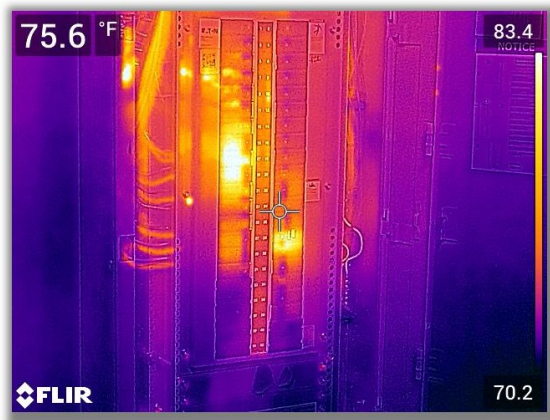
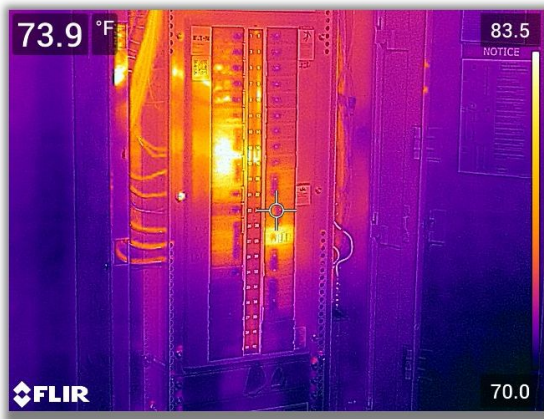
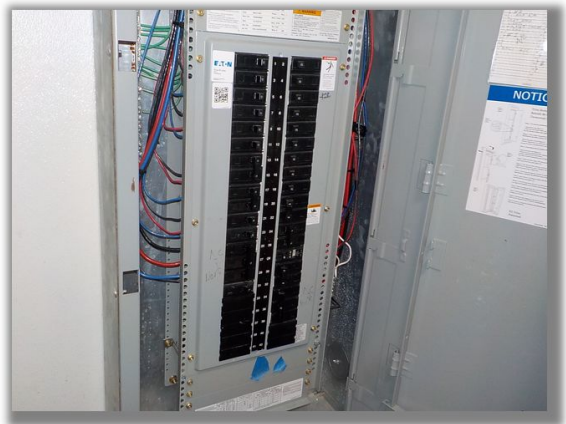
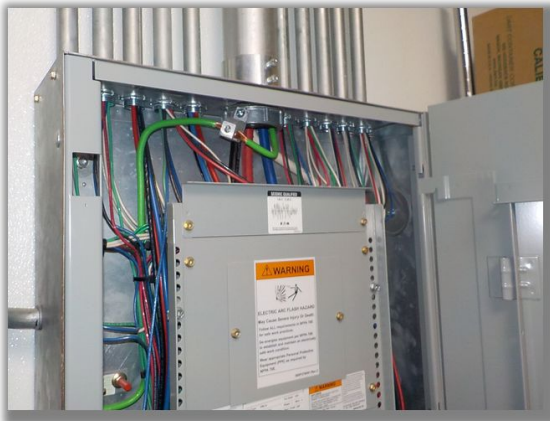
- The breakers (overcurrent devices) in the electrical panel are not properly labeled.

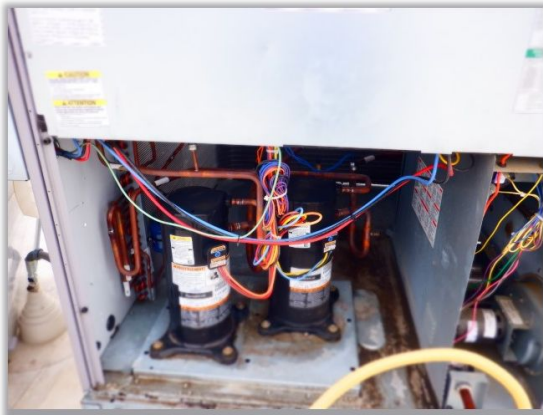
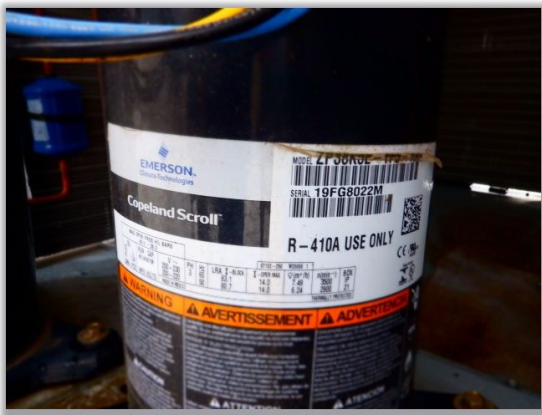
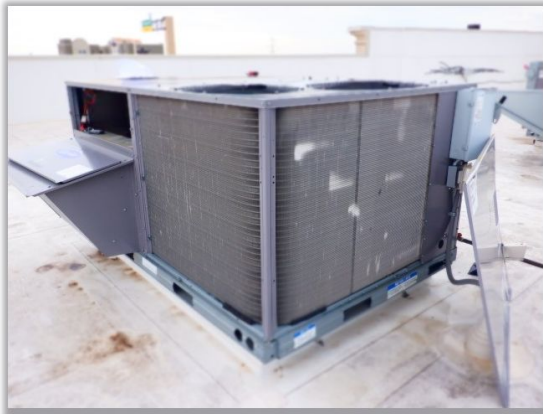
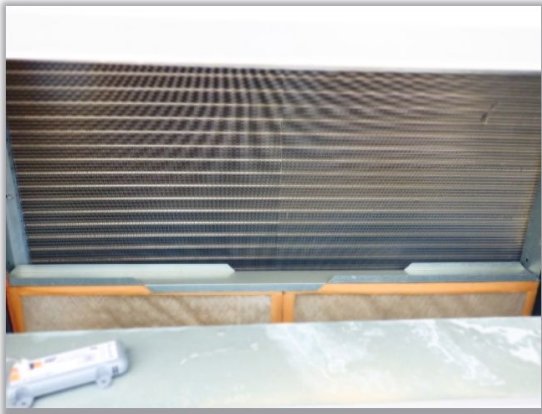
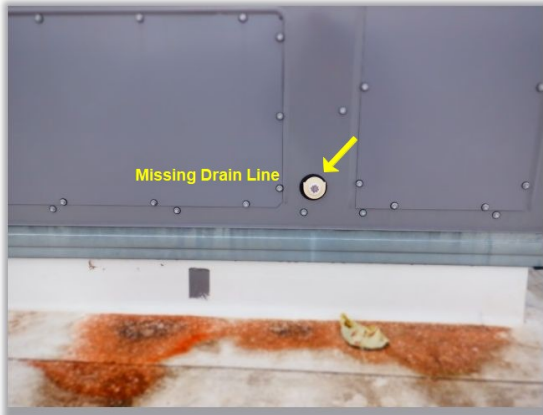
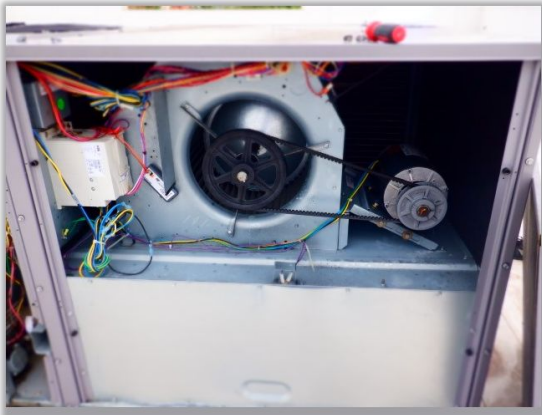
- **The temperature drop measured across the evaporative coils of the air conditioning system is lower than considered typical. The unit is not cooling properly and servicing is needed.**

- The air filter is missing and needs to be replaced.
- There is no primary condensate drain line installed for this unit. This condition does not meet current mechanical installation standards. It is recommended to install a primary condensate drain line that terminates to an approved waste receptor.

- The fins of the outdoor portion of the air conditioning system were observed to be damaged. This condition can reduce the efficiency of the system.
- **The heater exhaust terminate to close to the building air intake. This will pull carbon monoxide from the HVAC system and into the occupied space of suite 120. This needs to be corrected for reasons of safety.**

- The outdoor unit of the air conditioning system requires cleaning.

The HVAC system and equipment needs to be checked and serviced by a Qualified / Licensed HVAC Technician. The observations made to support the rendering of this opinion are listed but may not be limited to the following:

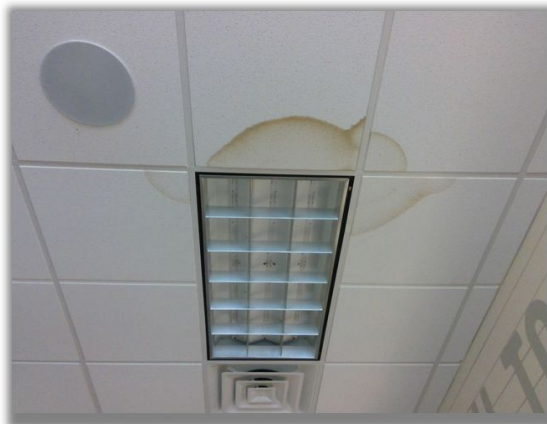
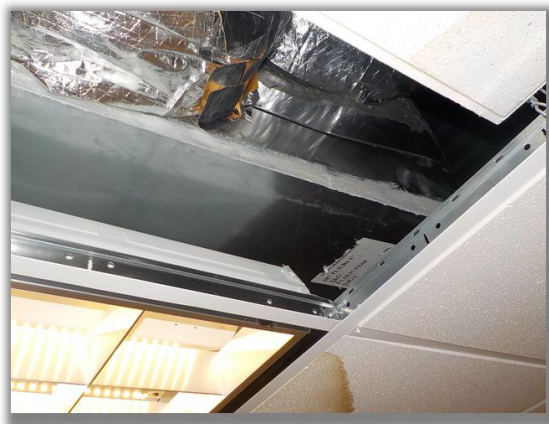
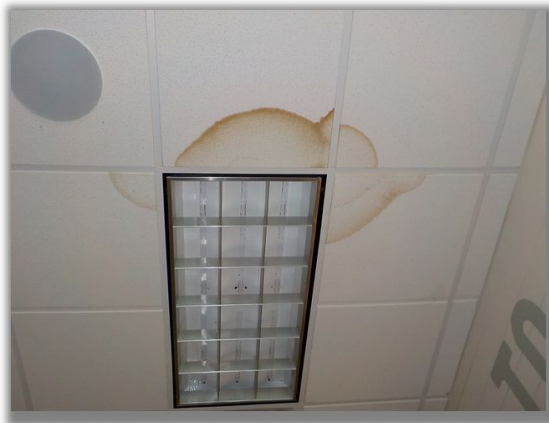
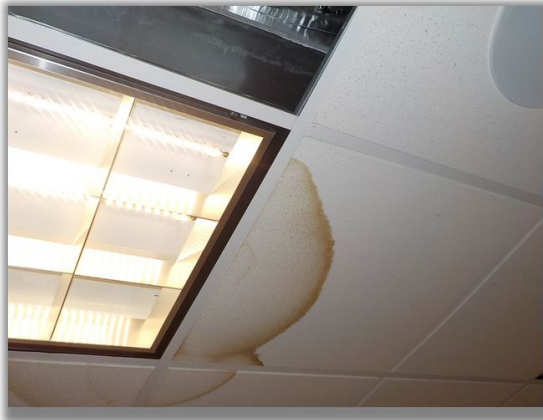
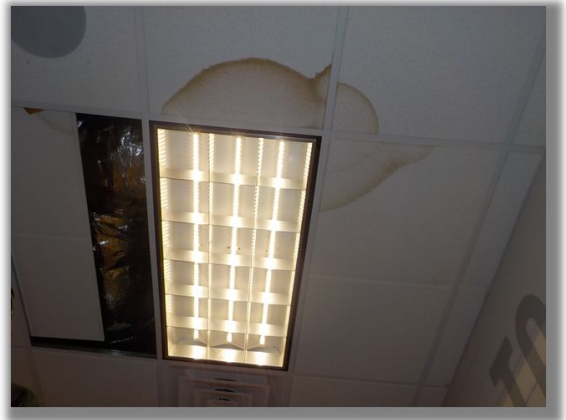
Ceilings

- The drop ceiling tiles were observed to be water stained and damaged in various locations. It is recommended to replace all damaged and stained tiles.
- There is a roof leak at and around the roof level HVAC curb above the lobby area.
- Elevated moisture levels were detected in the ceiling finished surfaces over the lobby area. The cause and remedy should be further evaluated and corrected as necessary.

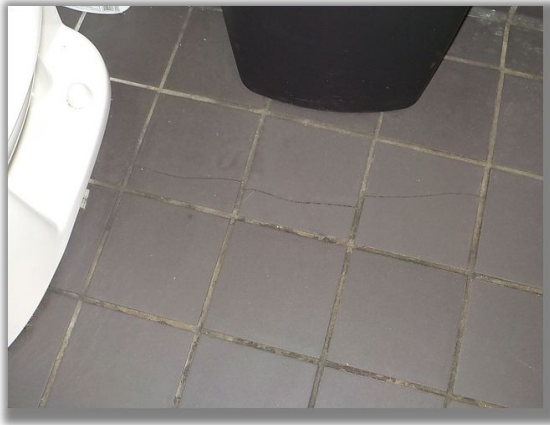
Floors

- The floor tile(s) were observed to be cracked and/or damaged in women's bathroom.

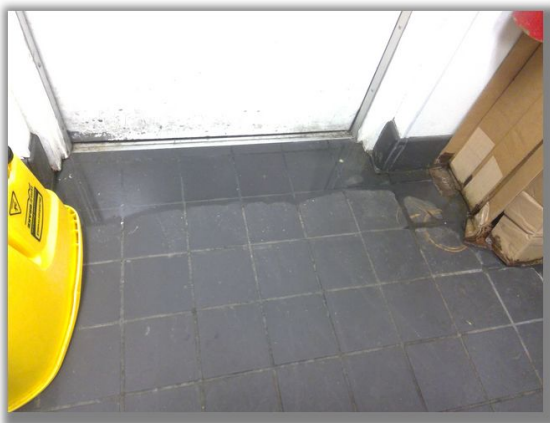
Exterior Doors

- Visible evidence of previous water intrusion was observed at and/or around the exterior back entry door(s). The cause and remedy should be investigated and corrected as necessary.

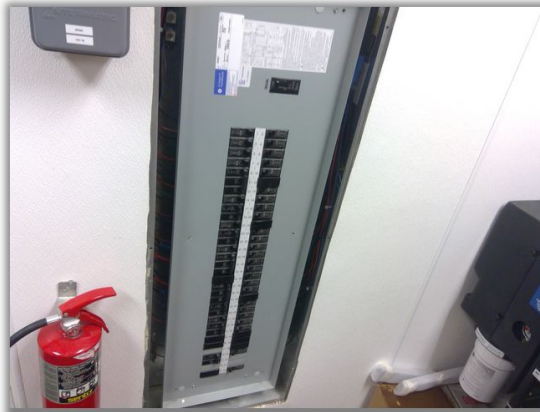
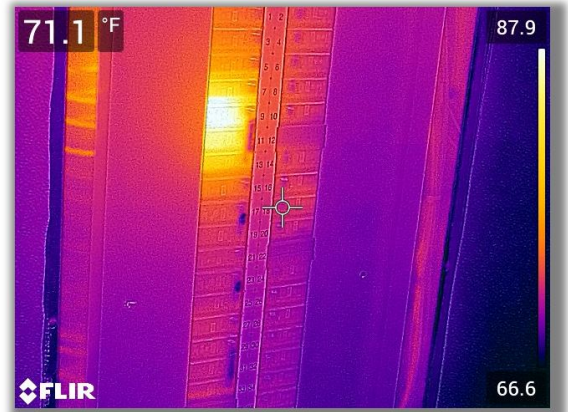
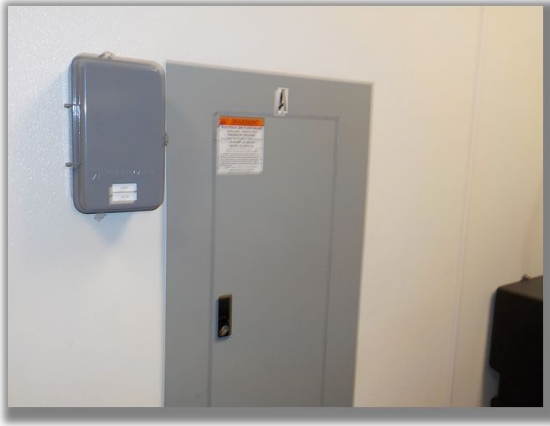
Sub Panel

- The breakers (overcurrent devices) in the electrical panel are not properly labeled.

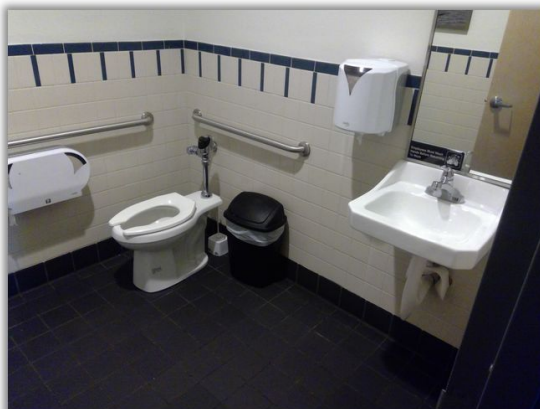
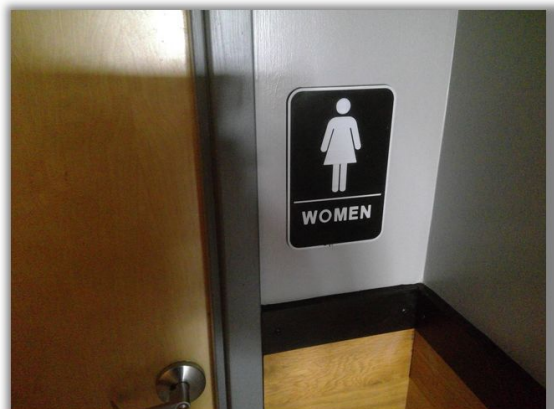
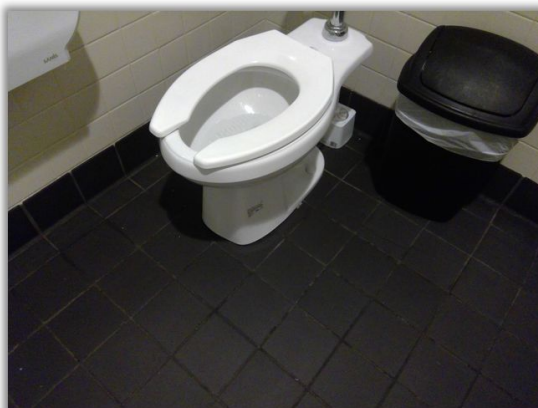
Commode / Toilet

- The commode is loose at the floor mount.

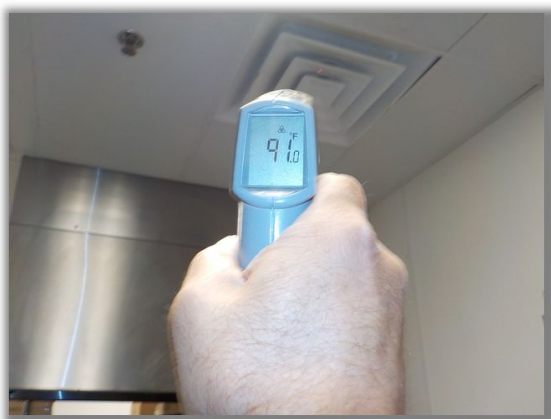
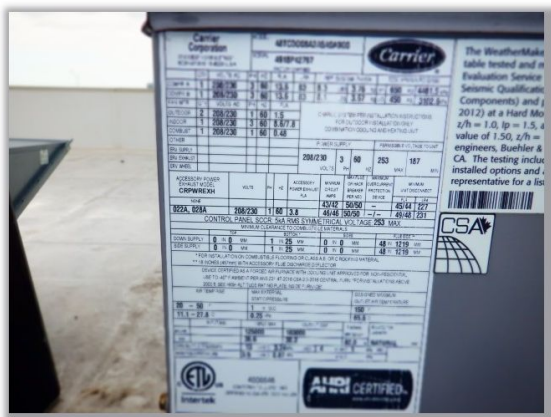
- **The temperature drop measured across the evaporative coils of the air conditioning system is lower than considered typical. The unit is not cooling properly and servicing is needed.**
- The dirty air filter should be replaced.
- The main blower belt was observed to be loose. The belt needs to be tightened to improve performance and air movement.
- The fins of the outdoor portion of the air conditioning system were observed to be damaged. This condition can reduce the efficiency of the system.

The HVAC system needs to be checked and serviced by a Qualified / Licensed HVAC Technician. The observations made to support the rendering of this opinion are listed but may not be limited to the following:

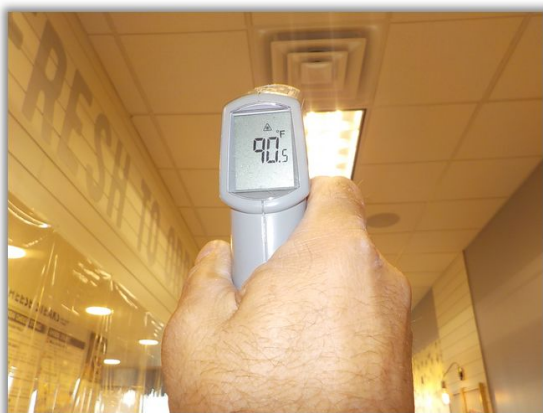
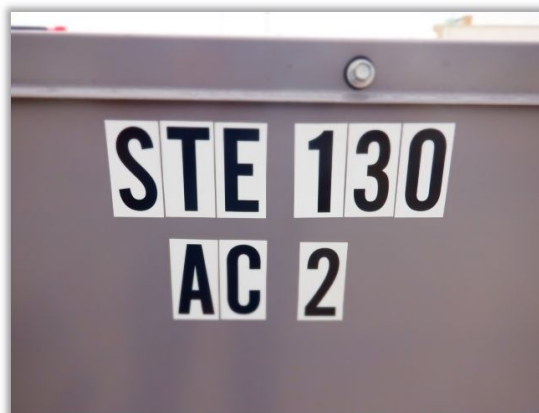
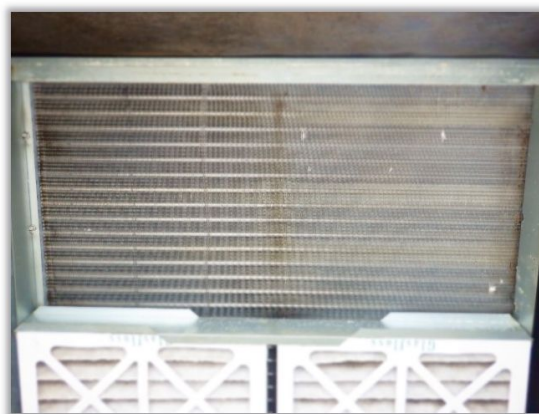
- The main blower belt was observed to be damaged and loose. The belt needs to be replaced at this time.
- The dirty air filter should be replaced.
- The fins of the outdoor portion of the air conditioning system were observed to be damaged. This condition can reduce the efficiency of the system.

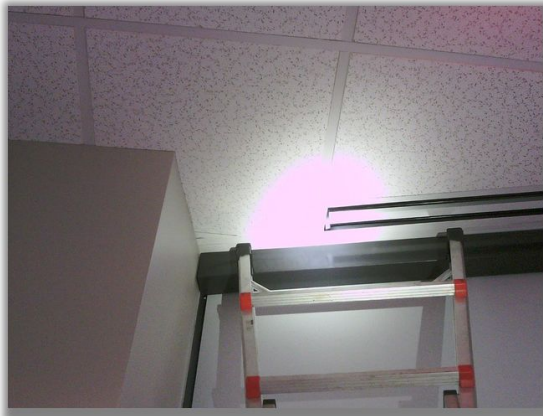
Ceilings

- The drop ceiling tiles were observed to be water stained and damaged in lobby area over the front door. It is recommended to replace all damaged and stained tiles. There was no elevated moisture at the time of this inspection. It did rain during the inspection.

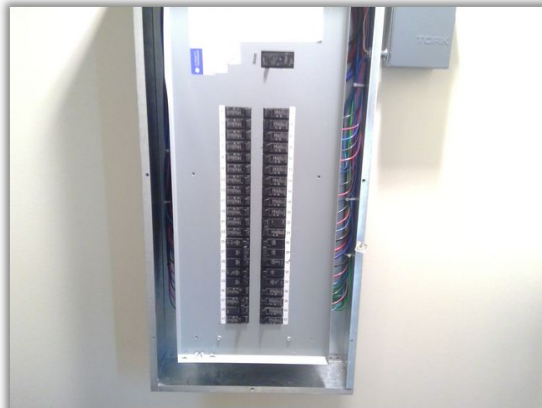
Sub Panel LA

- The breakers (overcurrent devices) in the electrical panel are not properly labeled.

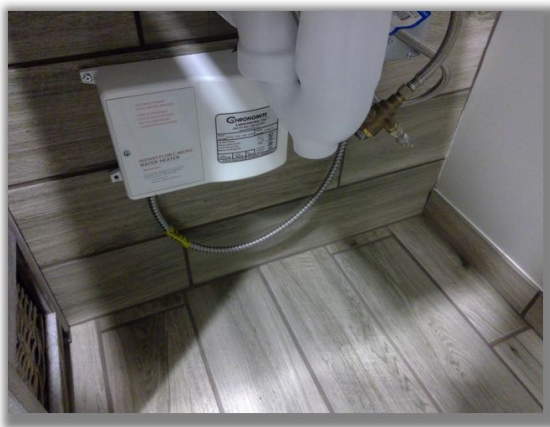
- The water heater was inoperative at the time of the inspection.

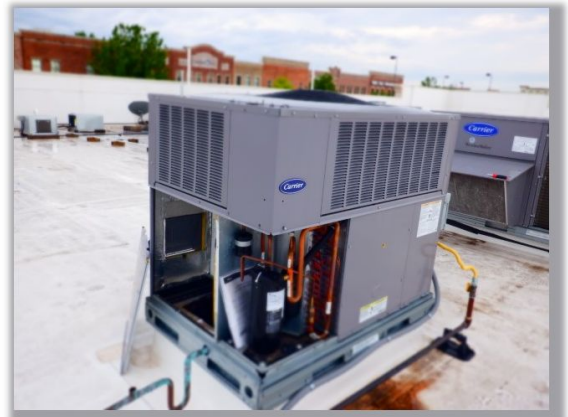
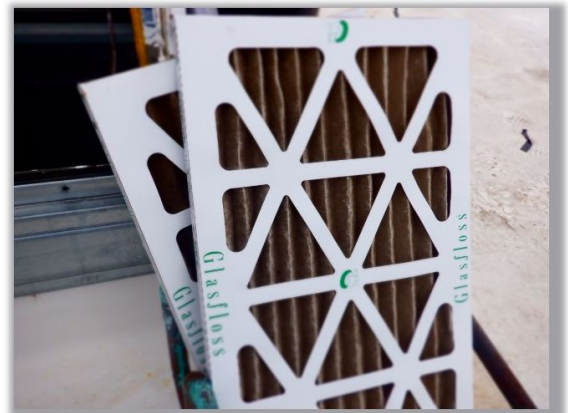
Additional Observations and/or Comments:

- The dirty air filter should be replaced.

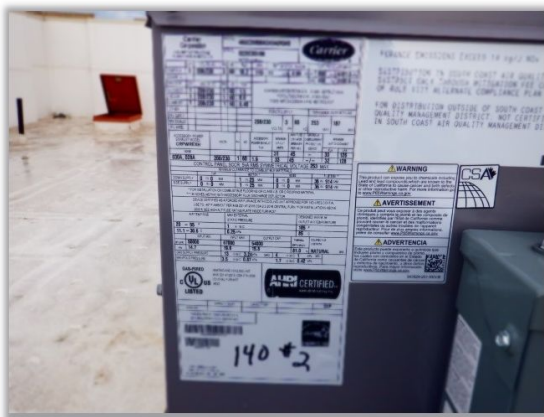
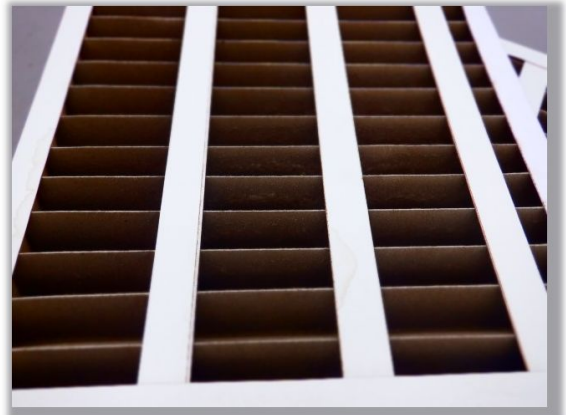
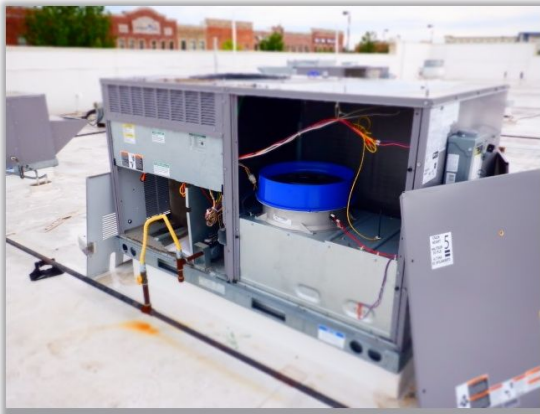
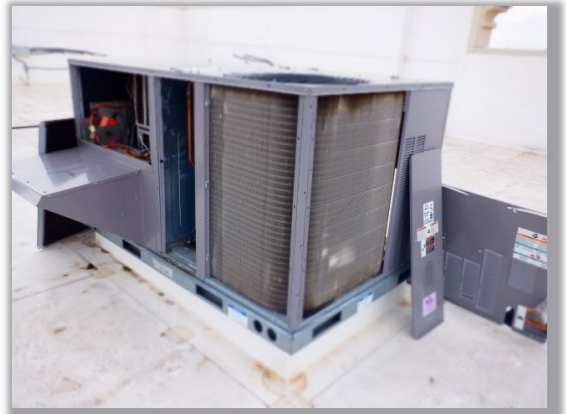
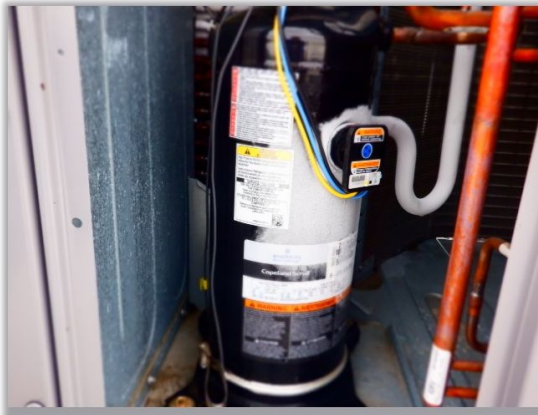
Unit #2 / Lobby

- The dirty air filter should be replaced.

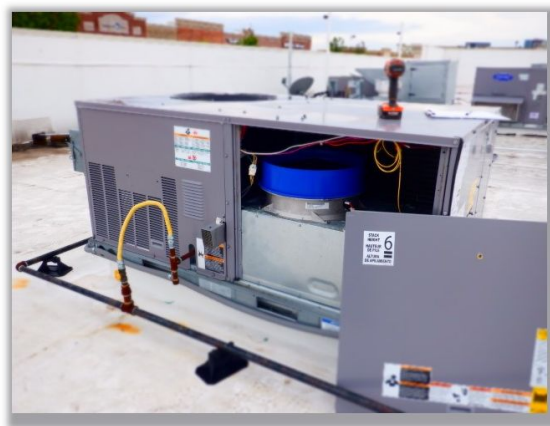
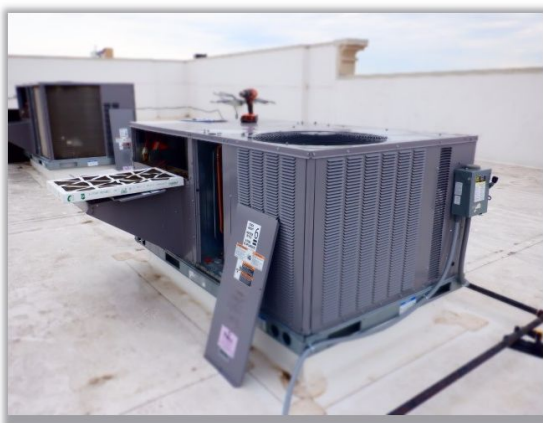
Notice: Temperature differential readings (Delta-T) are an accepted industry standard of practice for testing the proper operation of the cooling system. Our company policy normal acceptable range is considered approximately **between 15 to 20 degrees °F** total difference (Delta-T) measured between the return air and supply air within close proximity of the related coils of the system being evaluated. Conditions such as but not limited to; excessive humidity, high or low outdoor temperatures or restricted airflow may indicate abnormal operation even through the equipment is functioning basically as designed and occasionally may indicate normal operation in spite of an equipment malfunction. *The inspector will not be able to anticipate future events, conditions or changes in performance of any component or system due to changes in use or occupancy. The inspector makes no guarantee or warranty, express or implied, as to future performance of any item, system or component.*

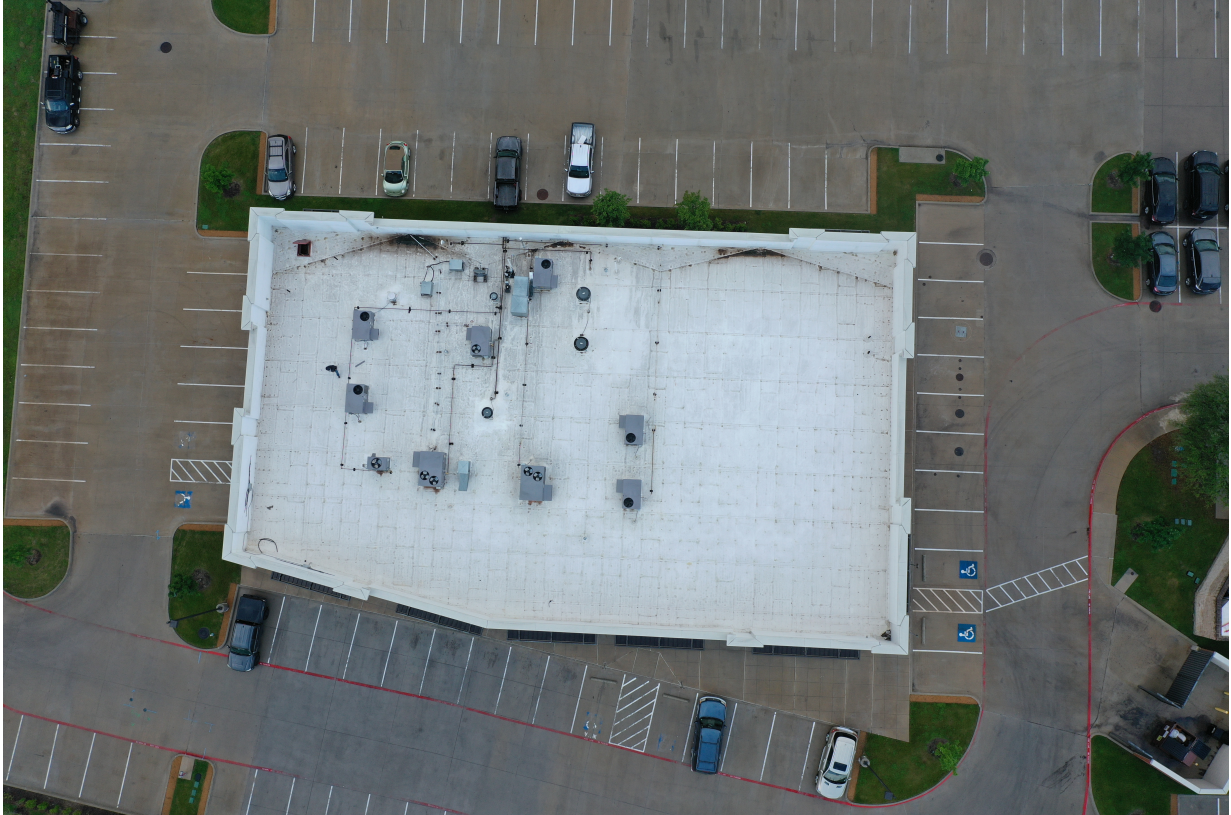
The inspector must draw a diagram including approximate perimeter measurements and indicate active or previous infestation and type of insect by using the following codes: E-Evidence of infestation; A-Active; P-Previous; D-Drywood Termites; S-Subterranean Termites; F-Formosan Termites; C-Conducive Conditions; B-Wood Boring Beetles; H-Carpenter Ants;

Additional Comments There is no visible evidence of active wood destroying insects found at the time of this inspection.
