**July 21, 2021**

## PROPERTY INSPECTION REPORT

**Concerning:** Address, City, TX 00000

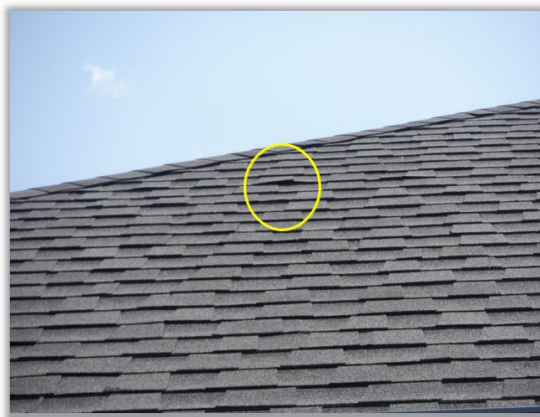
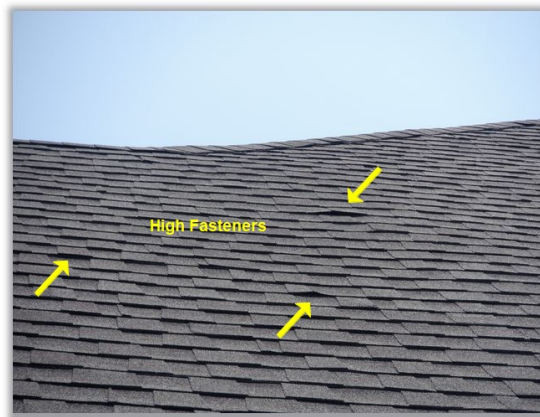
- **Note:** High shingle fasteners (staples and/or nails) were observed in various locations.

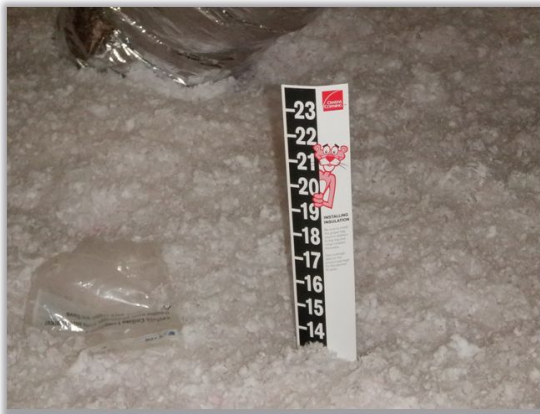
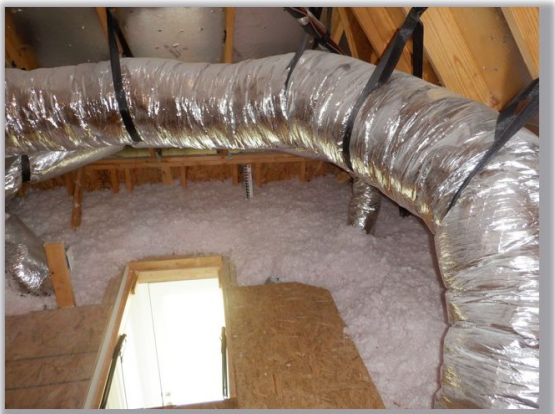
**Downstairs Attic Ladder**

All components appear to be performing adequately at the time of this inspection. They are achieving an operation, function or configuration relative to accepted industry standard practices with consideration of age and normal wear and tear from ordinary use.

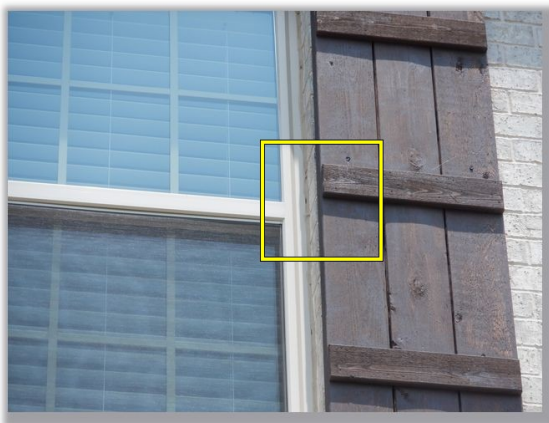
- Minor caulking improvements are recommended for the area between the exterior veneer and the upstairs front middle bedroom window frame. It is recommended to use an industry approved low-modulus elastomeric sealant.

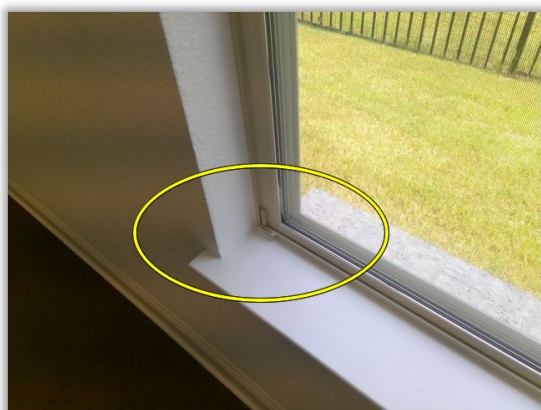
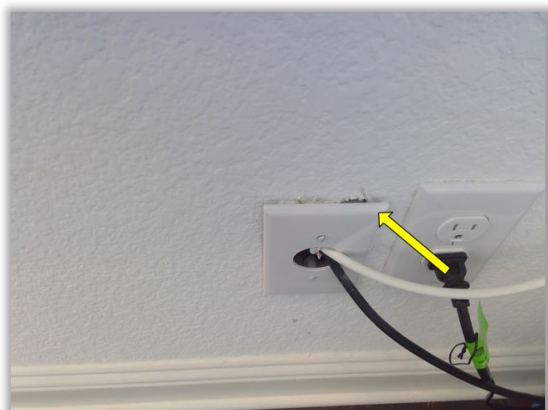
- The wall texture has some deterioration and/or damage in the music room.
- Wall surface damage was observed in the living room, stairway.

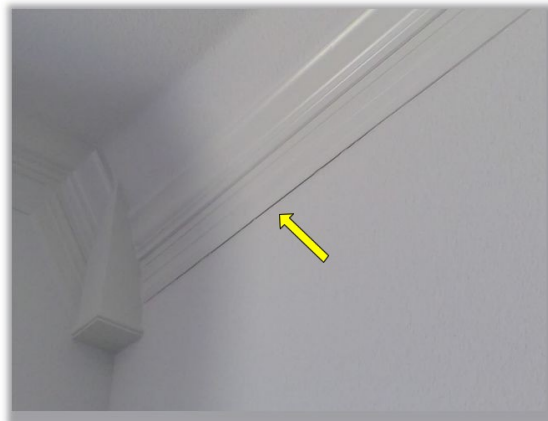
- Caulking improvements are needed at the master bedroom crown molding.

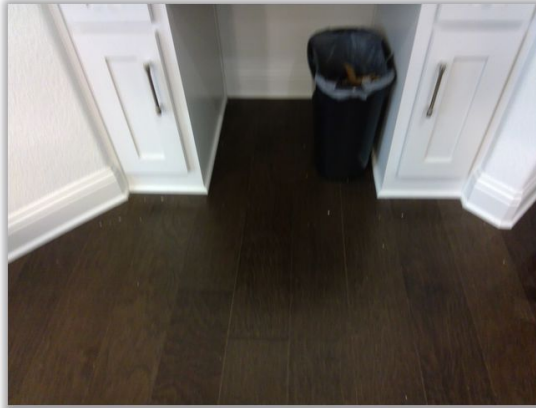
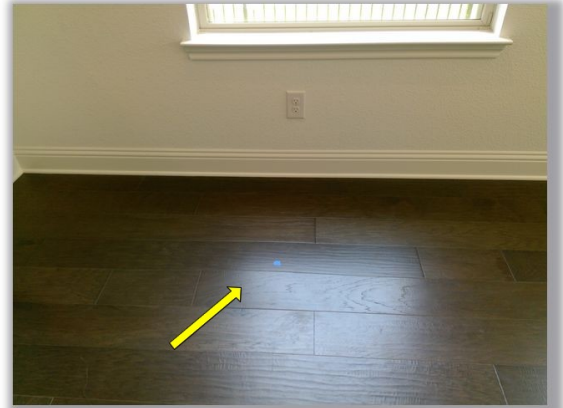
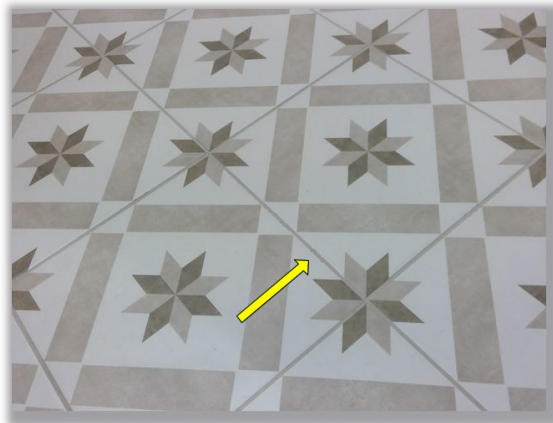
- The wood flooring material in the kitchen area and music room was observed to be loose and tenting. This condition needs to be corrected.
- The floor tile(s) were observed to be cracked and/or damaged in half bathroom.

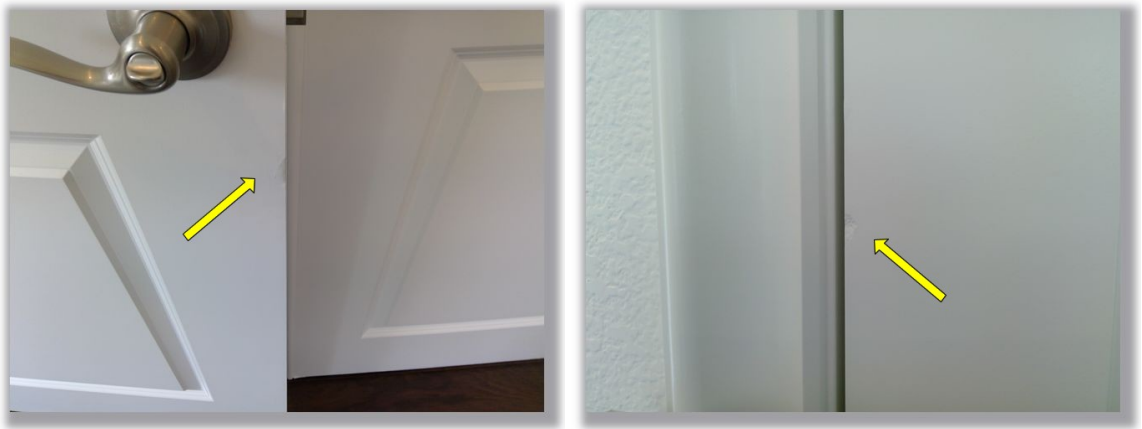
- The door has some surface damage to the music room.
- The door is sticking to the upstairs front corner bedroom.

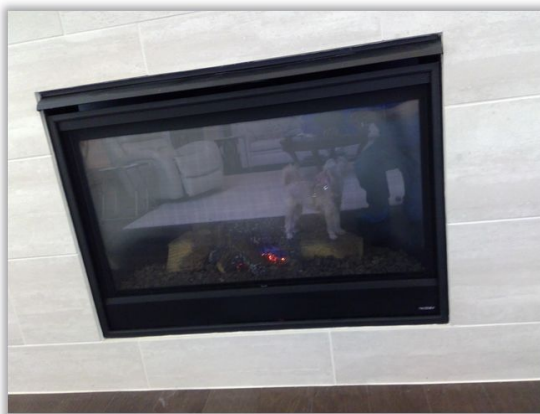
**Family Room Fireplace / Chimney**

All components were found to be performing and in satisfactory condition on the day of the inspection.

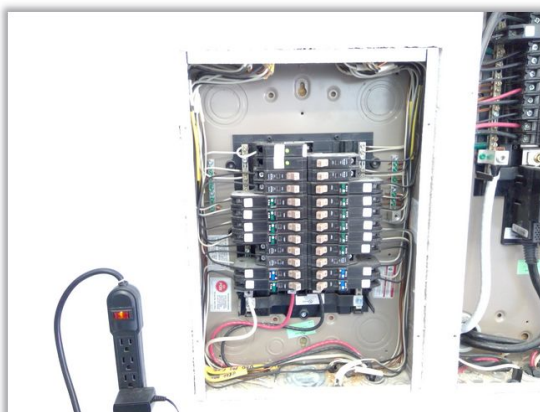
### Sub Panel

All components appear to be performing adequately at the time of this inspection.

They are achieving an operation, function or configuration relative to accepted industry standard practices with consideration of age and normal wear and tear from ordinary use.

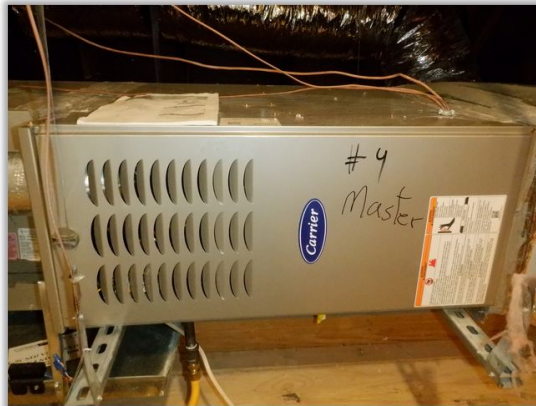
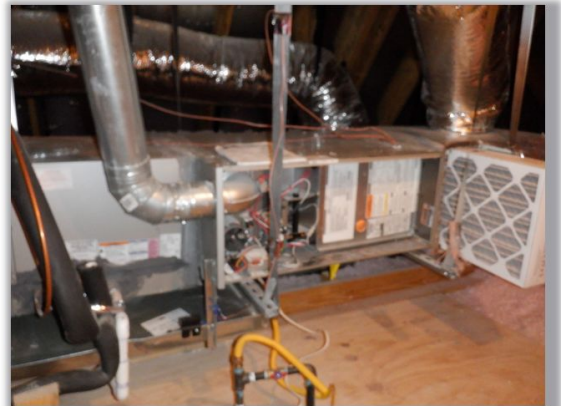
**Master Bedroom Central Heating System** – *Energy Source:* Gas

This component appears to be performing adequately at the time of this inspection.

It is achieving an operation, function or configuration relative to accepted industry standard practices with consideration of age and normal wear and tear from ordinary use.

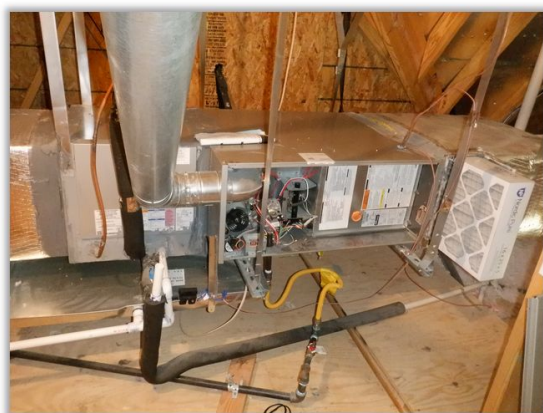
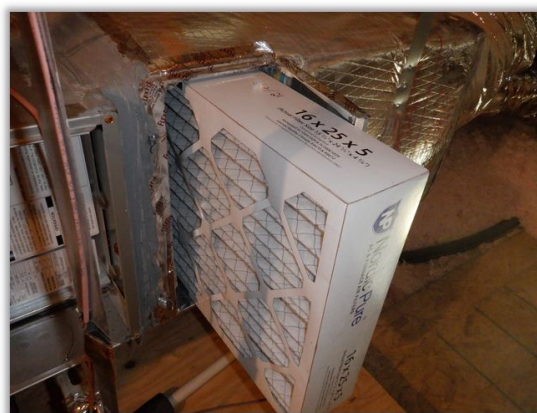
**Music Room Heating System – Energy Source: Gas**

This component appears to be performing adequately at the time of this inspection.

It is achieving an operation, function or configuration relative to accepted industry standard practices with consideration of age and normal wear and tear from ordinary use.

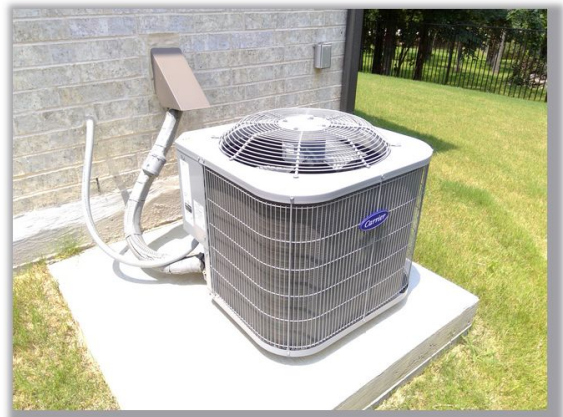
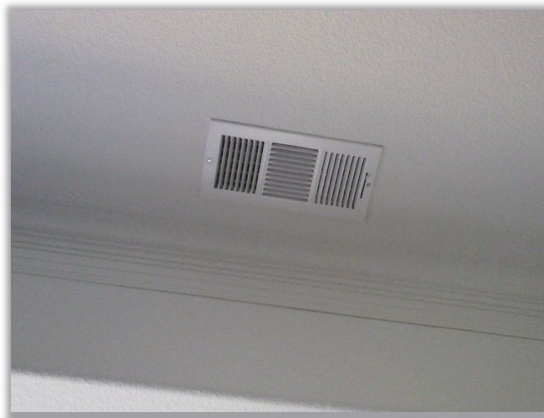
Today's Temperature Differential (Delta-T): **16**  
 Approximate System Age: **2020**  
 Approximate System SEER: **16**  
 Approximate System Size: **1.5 ton**  
 Listed Refrigeration Type: **410A**  
 Filter Size: **16 x 25**      Location: **At Attic Unit**  
 Brand Name: Carrier

This component appears to be performing adequately at the time of this inspection. This unit achieved an adequate temperature differential reading (Delta-T) as determined by accepted industry standard of practice for measuring cooling performance for air conditioning systems. This component is achieving an operation, function or configuration relative to accepted industry standard practices with consideration of age and normal wear and tear from ordinary use.

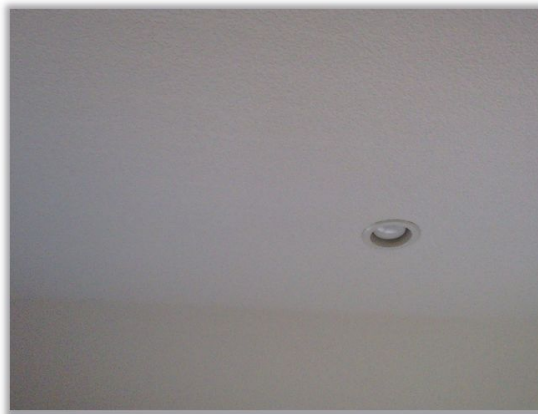
- One of the register boots was covered with drywall in the gameroom area.

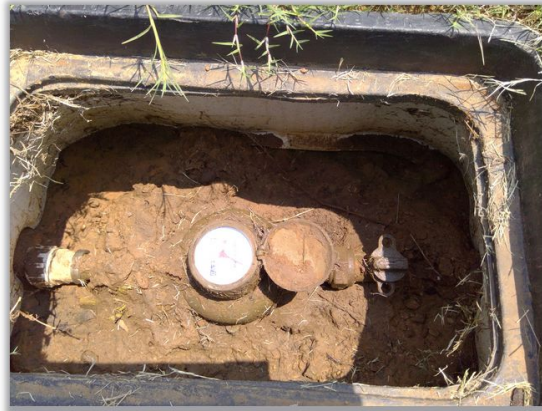
*Static water pressure reading:* 60 to 70 psi

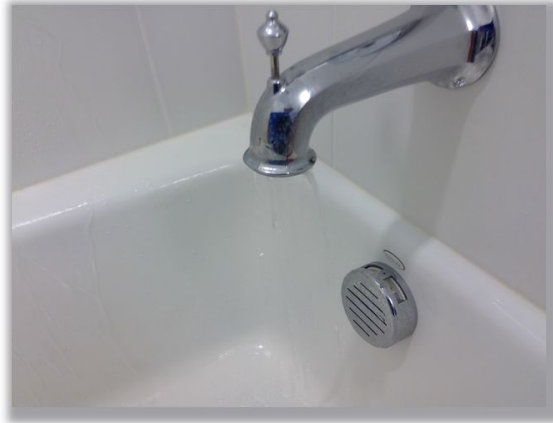
- The bathtub shower head diverter is not functioning properly.

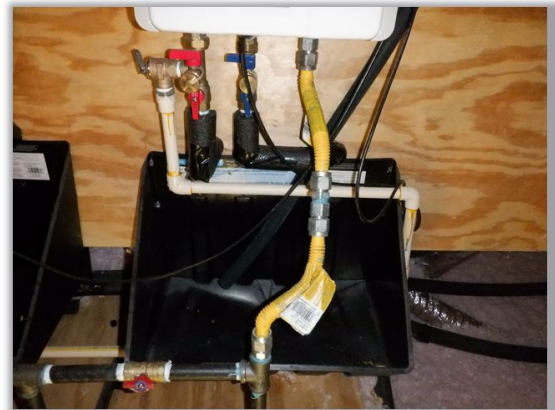
- Two flexible appliance connectors have been connected together to attached this gas appliance to the gas supply system. This type of installation does not meet current plumbing or mechanical installation standards.

**G2422.1.2.1 (411.1.3.1) Maximum length.** Connectors shall have an overall length not to exceed 6 feet (1829 mm). Measurement shall be made along the centerline of the connector. **Only one connector shall be used for each appliance.**

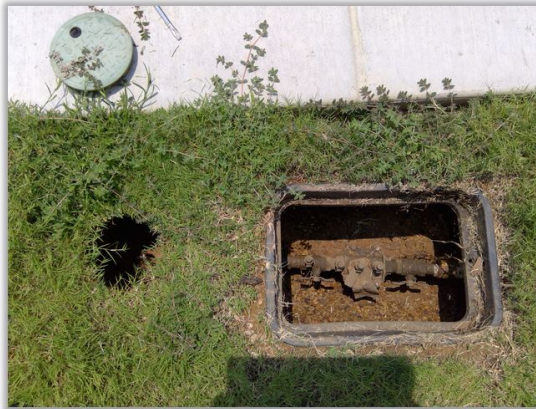
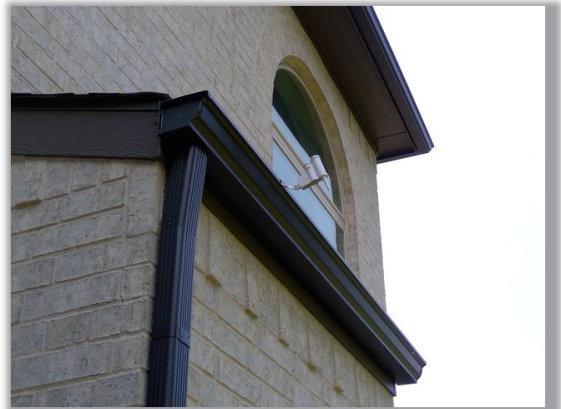
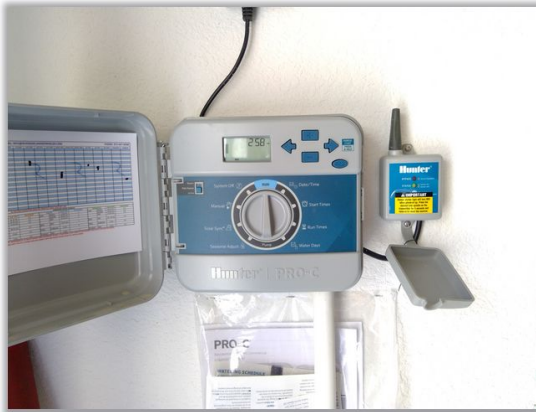
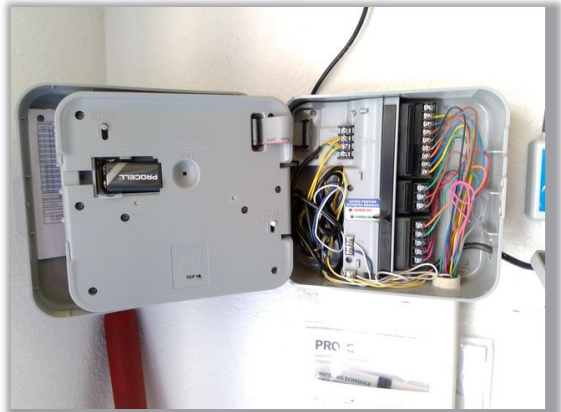
- The exterior moisture (rain/freeze) sensor device does not appear to be properly installed and should be corrected for proper sensor operation.
- One or more of the sprinkler heads need to be adjusted so not to disperse water onto concrete flatwork (such as; roadways, sidewalks, porches, patios or driveways) in station(s); **3, 4, 13.**
- One or more of the sprinkler heads do not pop-up high enough to disperse water properly in station(s); **3, 4, 9.**
- One or more of the sprinkler heads need to be adjusted so not to spray water onto the exterior walls, surfaces or windows in stations; **8, 9.**
