PROPERTY INSPECTION REPORT

Prepared For:	Clients Name Here	г. о
	(Name of C	lient)
Concerning:	Property Address Here	
	(Address or Other Identification	n of Inspected Property)
Ву:	Inspectors Name Here	Date of Inspection
-	(Name and License Number of Inspector)	(Date)
	(Name, License Number and Signature of Sponso	oring Inspector, if required)

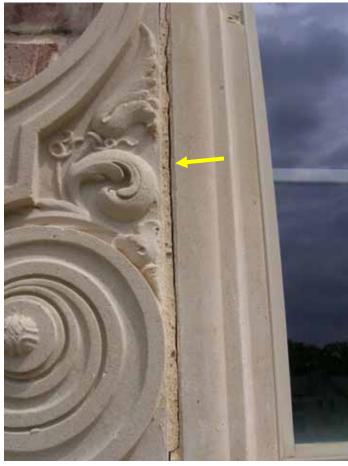
Mortar improvements are needed.

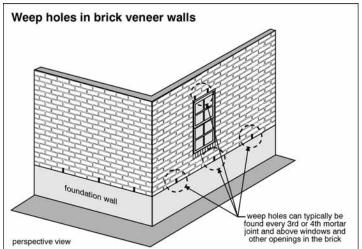
No weepholes over the garage door and window steel lintels.

International Residential Code for One & Two Family Dwellings R703.7.2.1 Support by steel angle.
