PROPERTY INSPECTION REPORT

Prepared For: Client Name Here
(Name of Client)

Concerning: Address, City, TX 00000
(Address or Other Identification of Inspected Property)

By: Scott Lewis, Lic #10539 Date Here
(Name and License Number of Inspector) (Date)

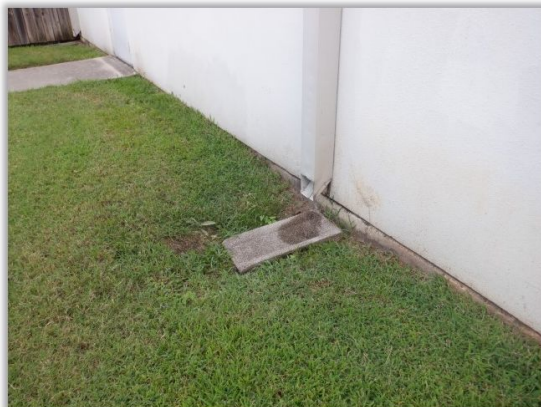
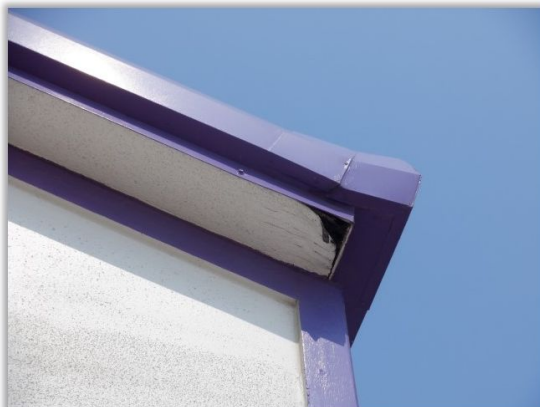
Gutter & Downspout System

- The gutter downspouts should discharge water at least sixty inches (60") away from the foundation perimeter beam. Storm water should be encouraged to flow away from the structure at the points of discharge. The current condition has caused some erosion at the downspout terminations.
- Minor leaks in the gutter joints and seams should be repaired. This condition has caused some wood rot at the front entrance cover.

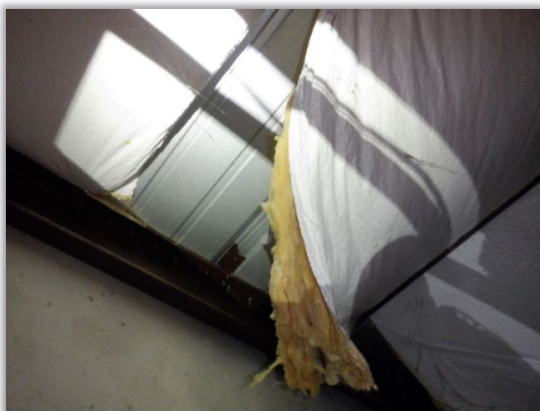
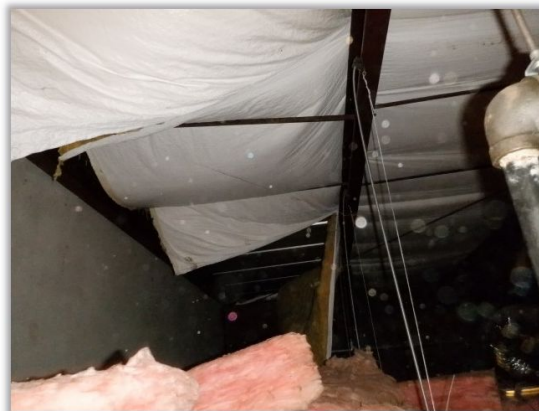
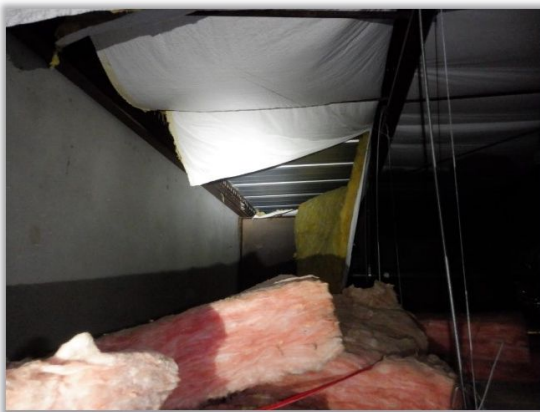
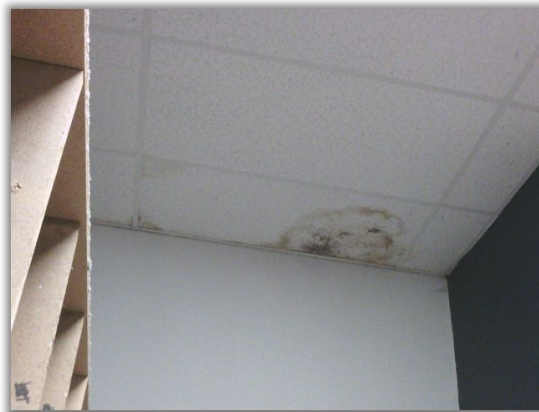
Attic Insulation

- The insulation under the metal roofing material was observed to be pulling loose and falling out of place along the east and west perimeter walls. This condition has caused condensation damage to the drop ceiling tiles. The drop ceiling tiles were observed to be water damaged under the loose insulation and suspended HVAC units above the drop ceiling tiles.

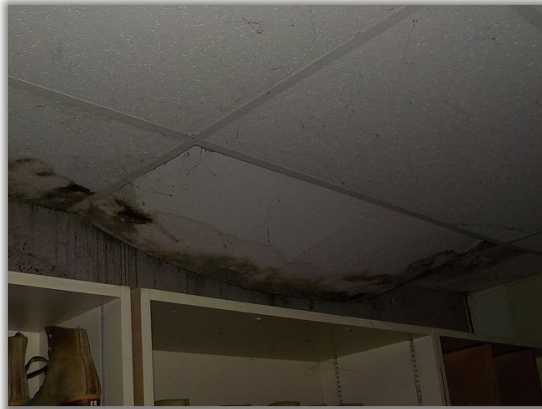
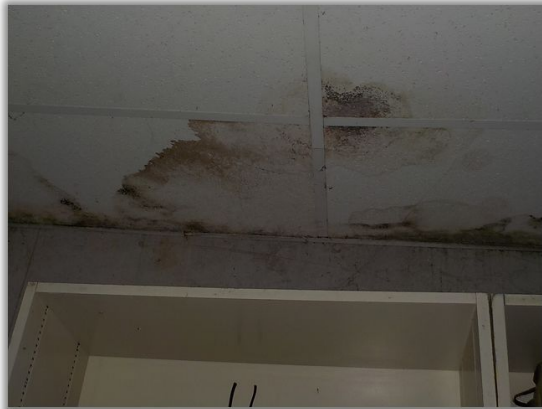
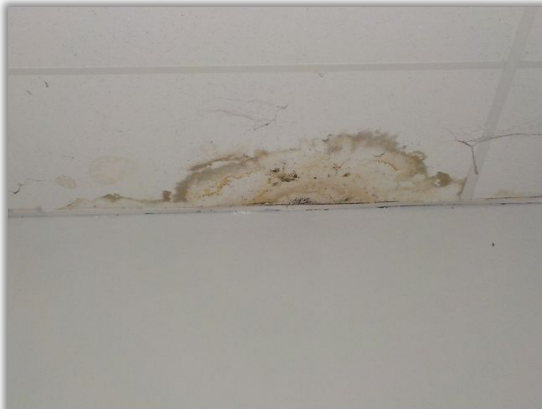
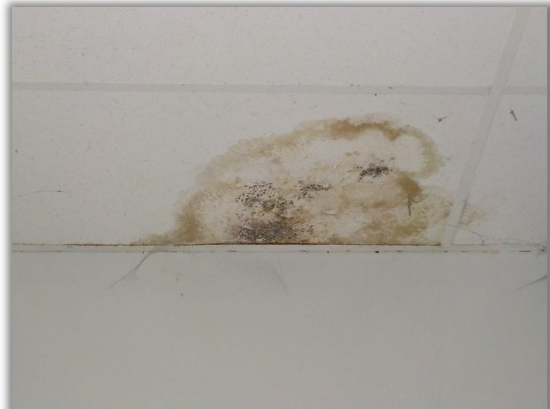
Ceilings

- The drop ceiling tiles were observed to be water stained and damaged in various locations. It is recommended to replace all damaged and stained tiles. It has rained in the last 24 hours and with the use of thermal imaging, there was no elevated moisture levels detected in the drop ceiling tiles at the time of this inspection.

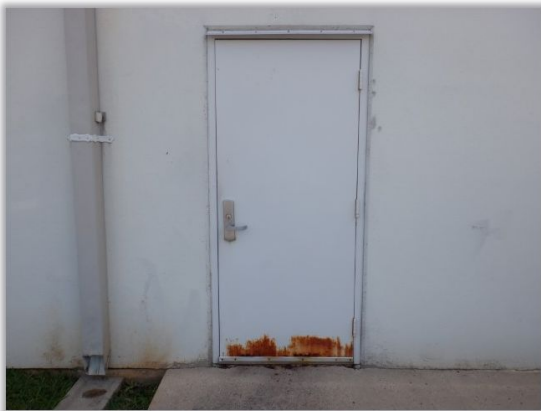
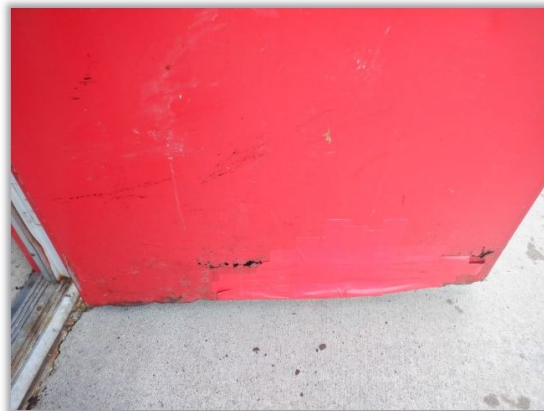
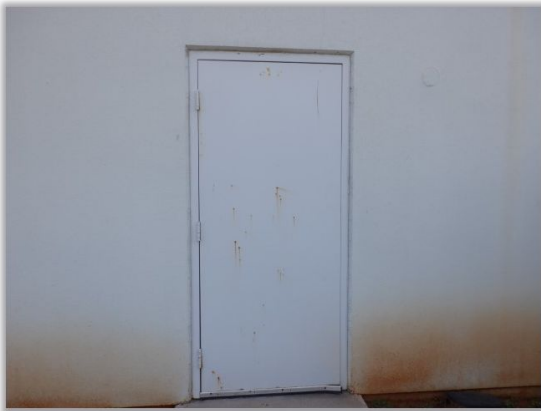
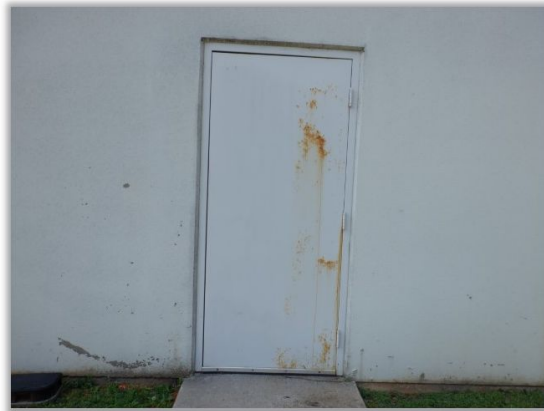
Exterior Doors

- The exterior doors on the north and west sides of the structure were observed to be rusted through and replacement is necessary at this time.

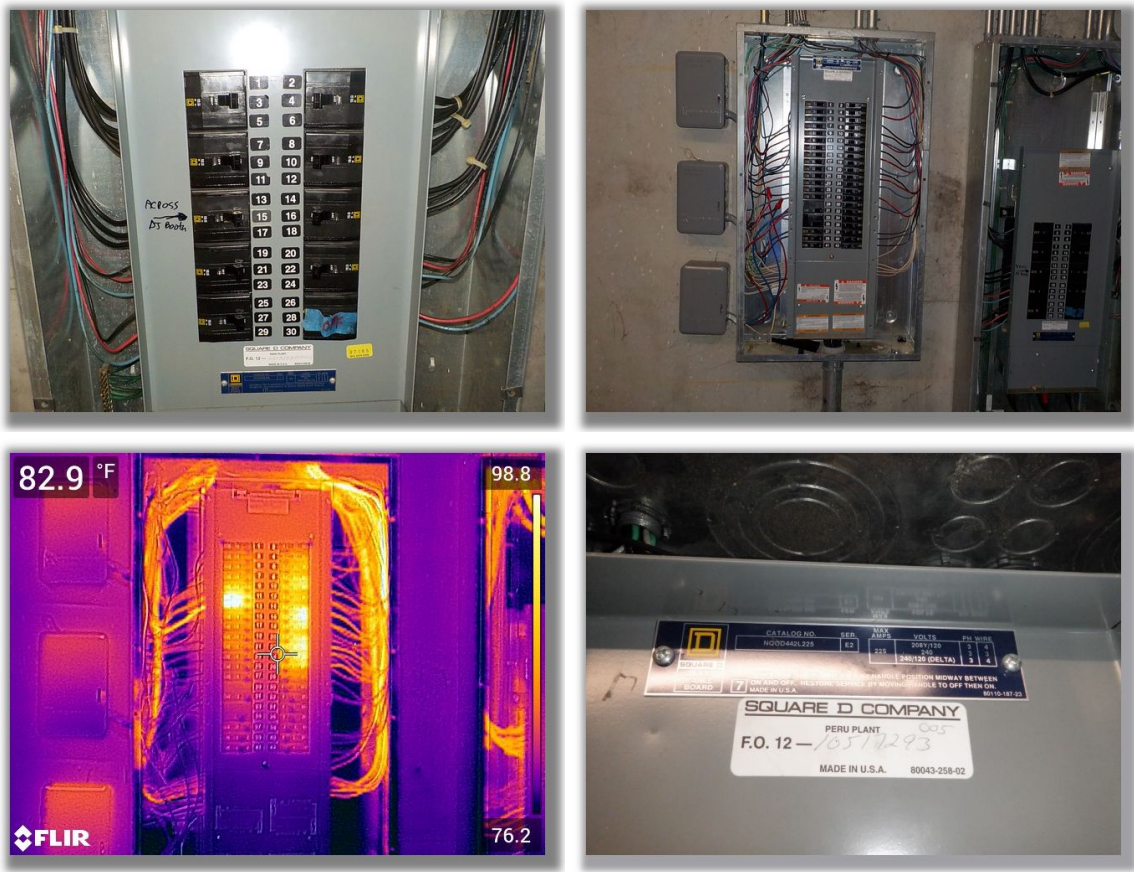
- The breakers (overcurrent devices) in the electrical panel are not properly labeled.

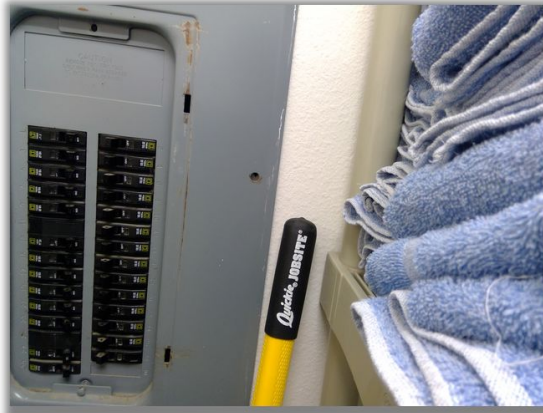
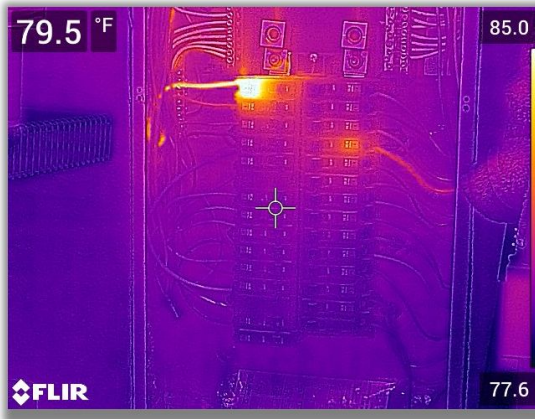
Box Location: Kitchen Storage Area

- The breakers (overcurrent devices) in the electrical panel are not properly labeled.
- One or more of the cabinet cover plate screws are missing and need to be replaced.
- The electrical cabinet cover plate door is missing. This should be corrected for reasons of safety.

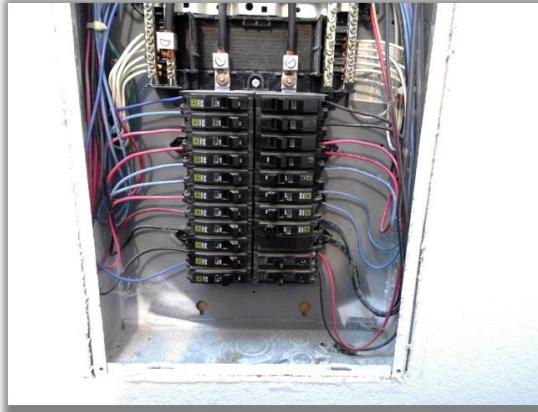
Box Location: Office Storage Area

- The breakers (overcurrent devices) in the electrical panel are not properly labeled.

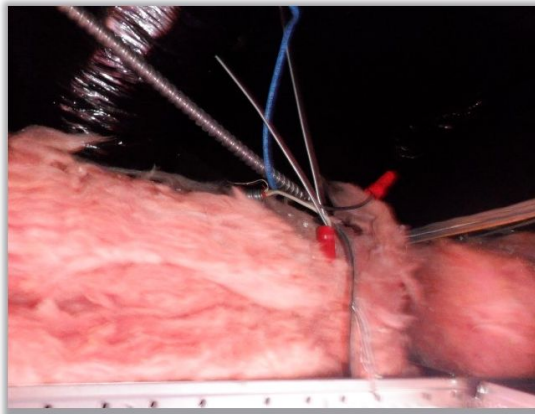
Distribution Wiring

- Open electrical junction box(es) and spliced wires were observed in the space above the drop ceiling tiles. All open junction box(es) and spliced wires should be properly enclosed. Open junction box(es) were located in various locations above the drop ceiling tiles.

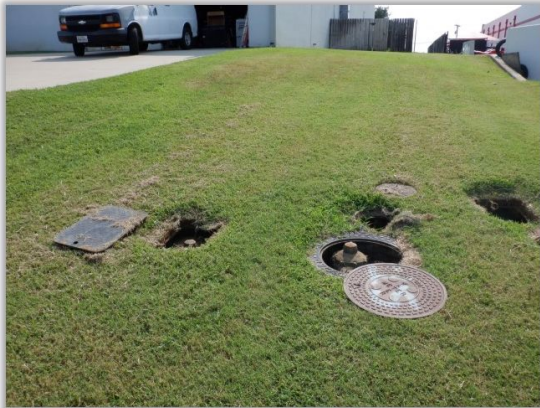
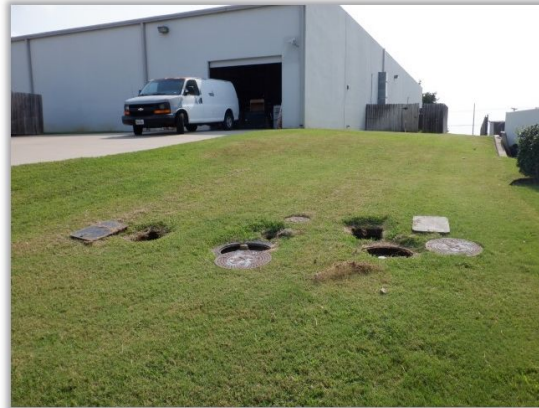
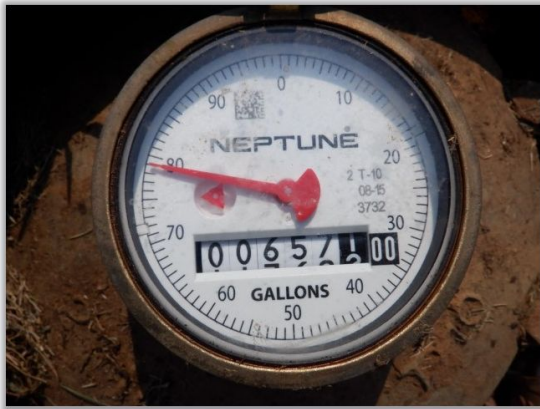
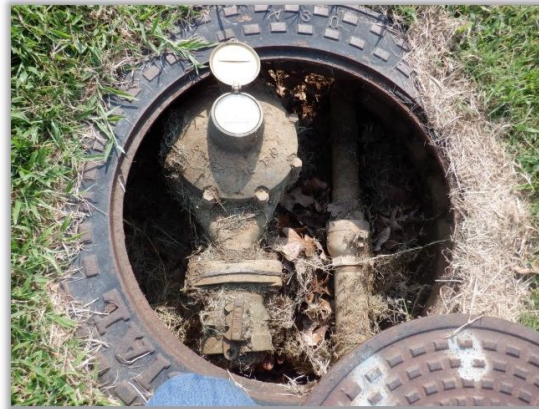
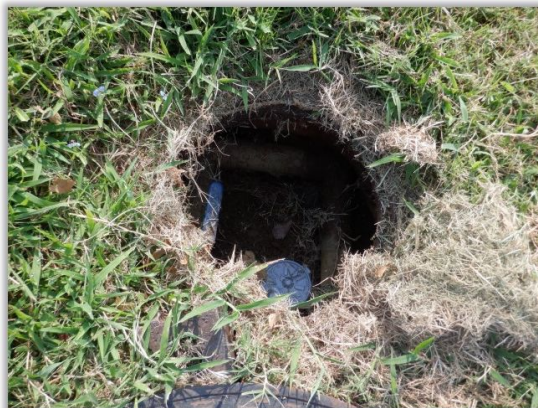
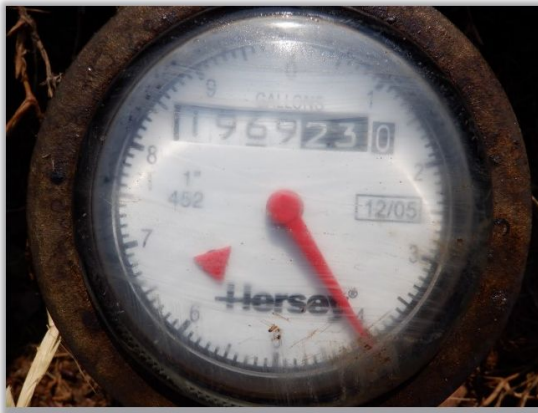
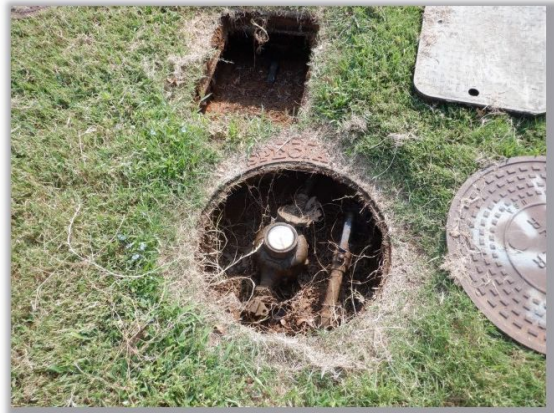
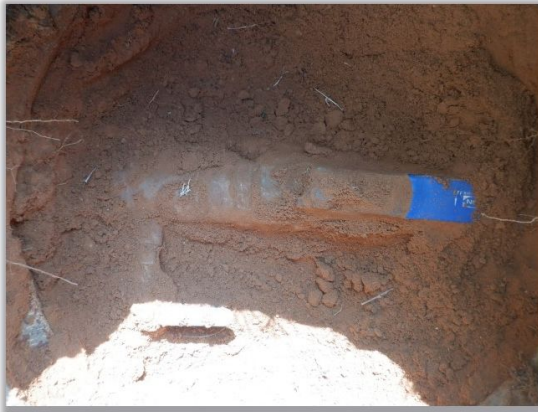
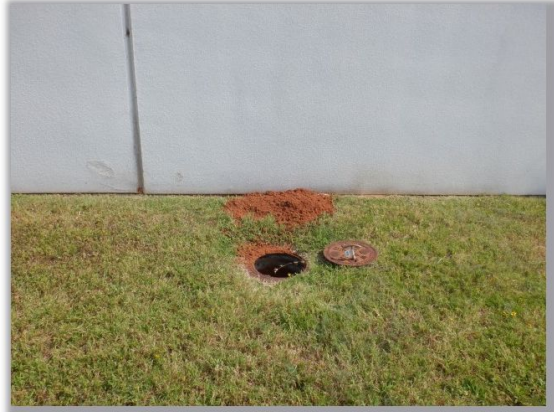
- Water meter component was in satisfactory condition on the day of the inspection.
There was no visible movement or changes in the meter reading at the time of this inspection.

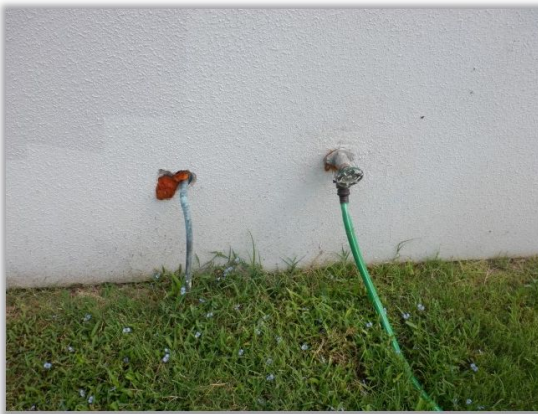
Exterior Faucets/Fixtures

- The exterior water hose bibb (faucet) is leaking at the handle when in the off position on the south side of the structure.

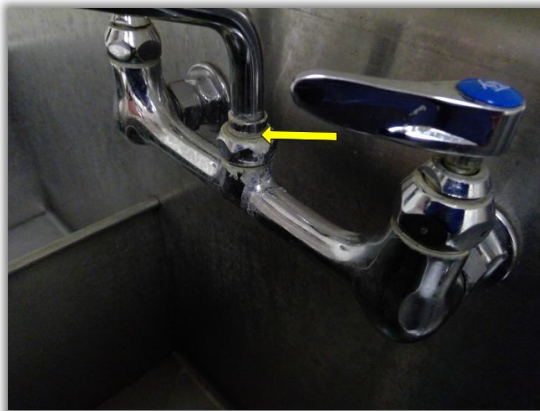
Kitchen Sink

- The faucet leaks at the base when operated.
- The sink is loose at the wall.

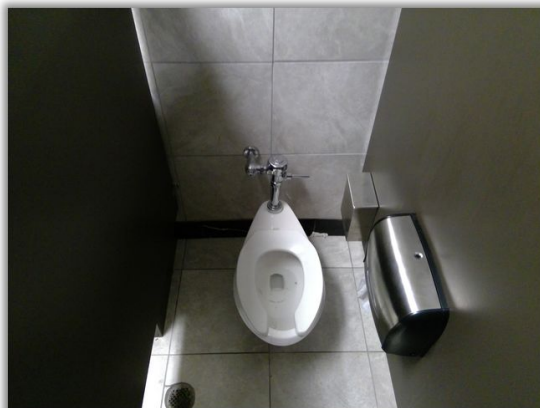
1st Commode / Toilet

- The commode is inoperative. The cause and remedy should be further evaluated and corrected as necessary.

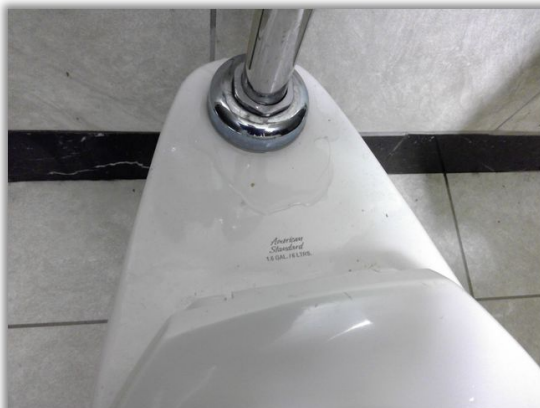
3rd Commode / Toilet

- The commode leaks between the bowl and tank when flushed. The cause and remedy should be further evaluated and corrected as necessary.

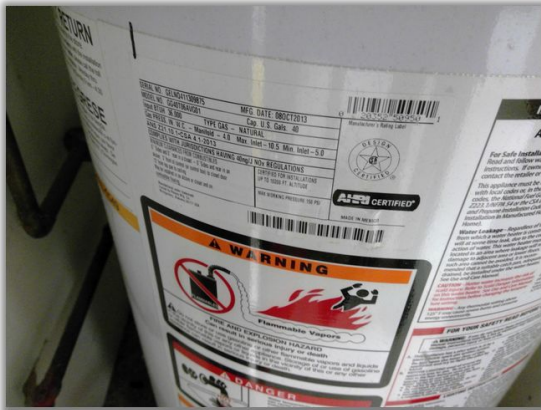
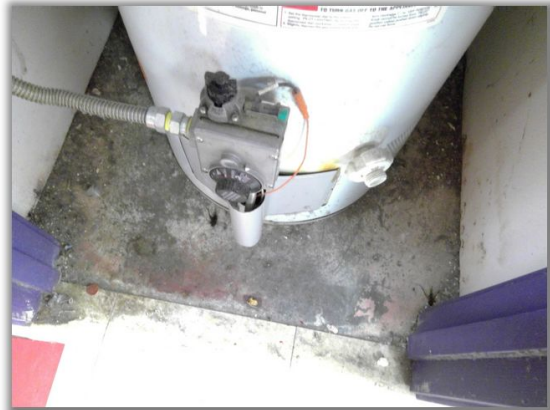
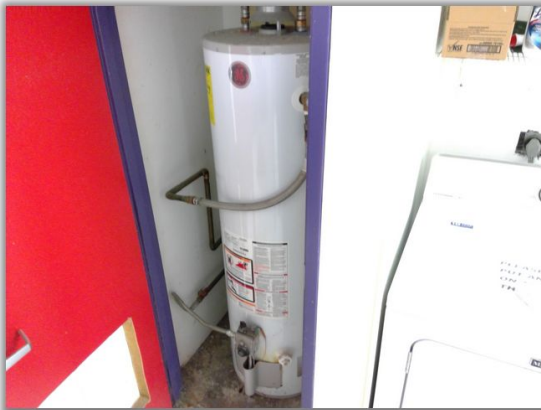
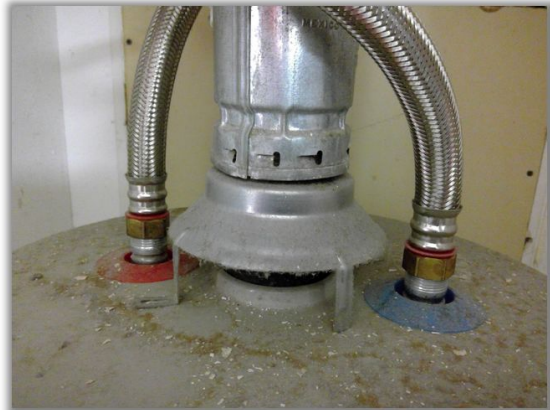
- The water heater flue connector should be mechanically attached to the draft hood with a minimum of three sheet metal screws.
- There is no pan installed under the water heater.
- The water heater flue connector should be mechanically attached to the draft hood with a minimum of three sheet metal screws.

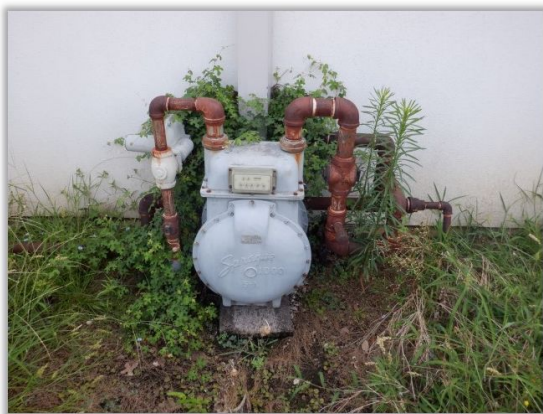
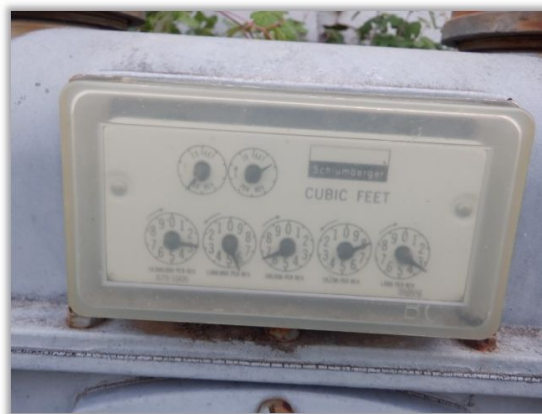
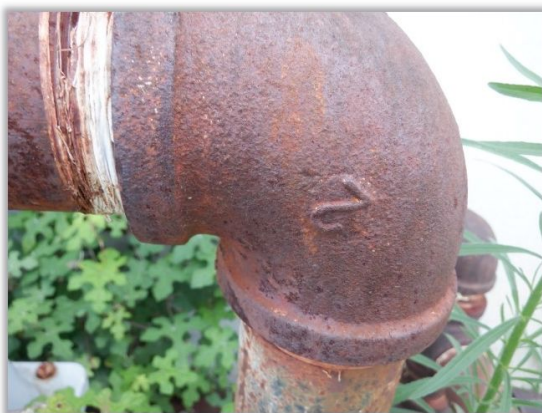
D. Gas Distribution System

This component appears to be performing adequately at the time of this inspection.

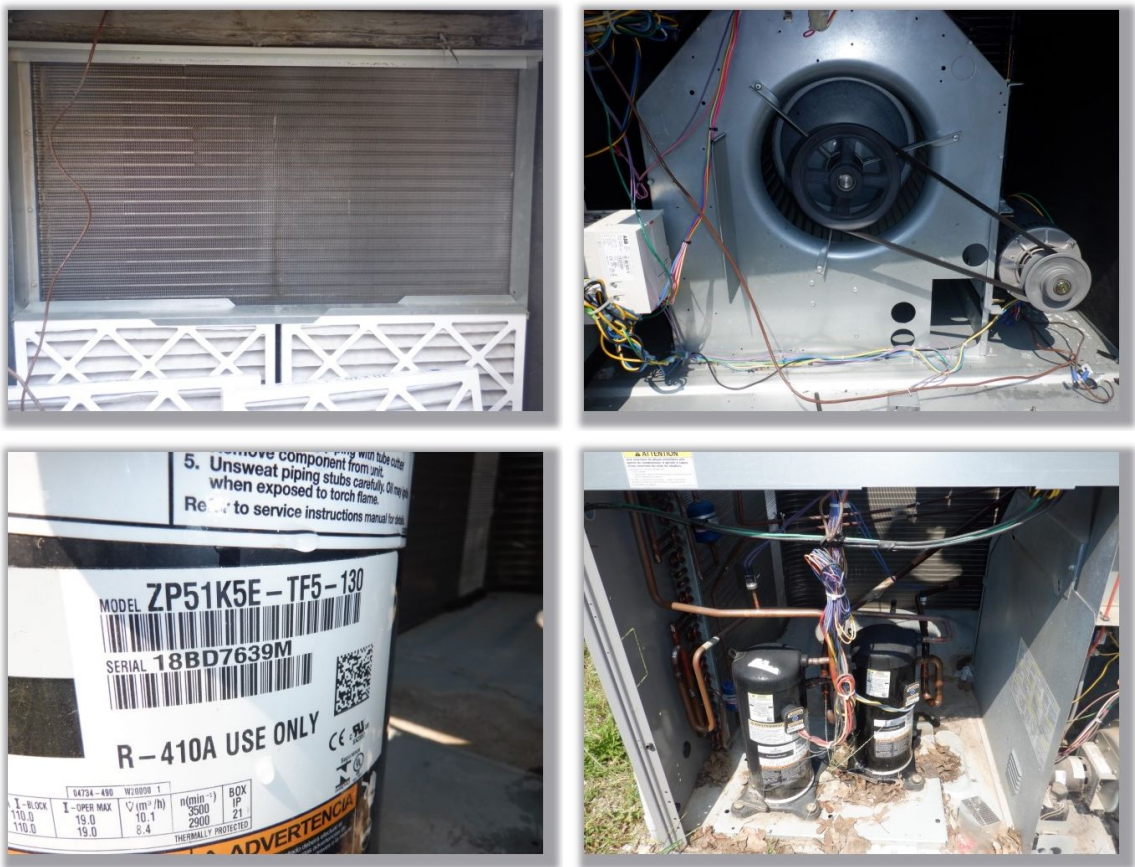
- The fins of the outdoor portion of the air conditioning system were observed to be damaged. This condition can reduce the efficiency of the system.

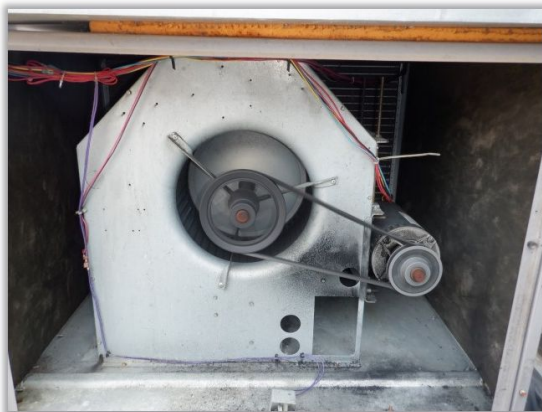
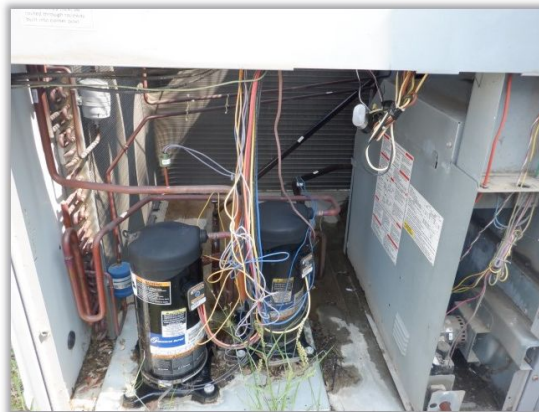
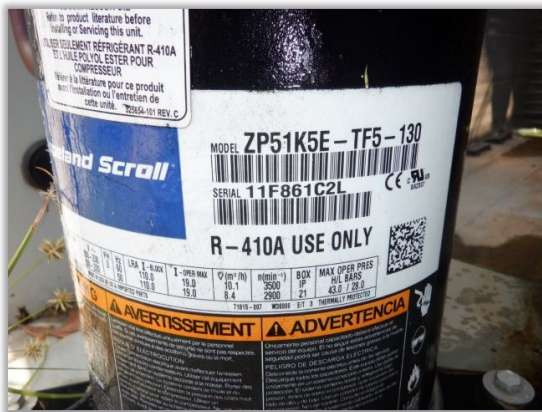
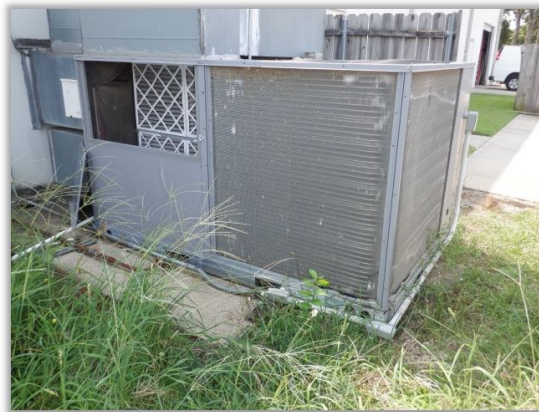
- The main blower belt was observed to be loose. The belt needs to be tightened to improve performance and air movement.
- The indoor blower observed to be dirty and should be cleaned to help improve the efficiency of the unit.
- The evaporator coils were observed to be dirty and require cleaning.
- The fins of the outdoor portion of the air conditioning system were observed to be damaged. This condition can reduce the efficiency of the system.

The HVAC system and equipment needs to be checked and serviced by a Qualified / Licensed HVAC Technician. The observations made to support the rendering of this opinion are listed but may not be limited to the following:

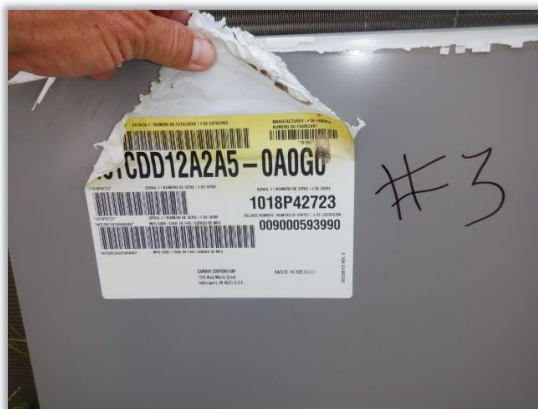
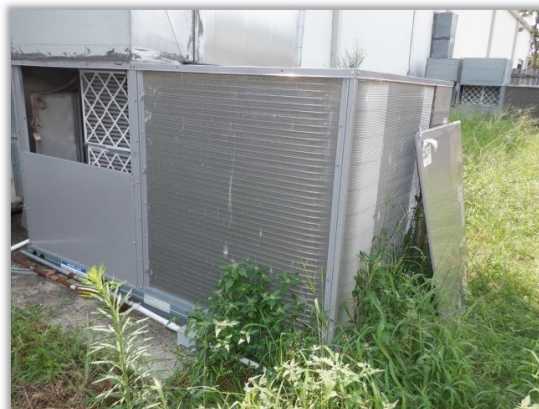
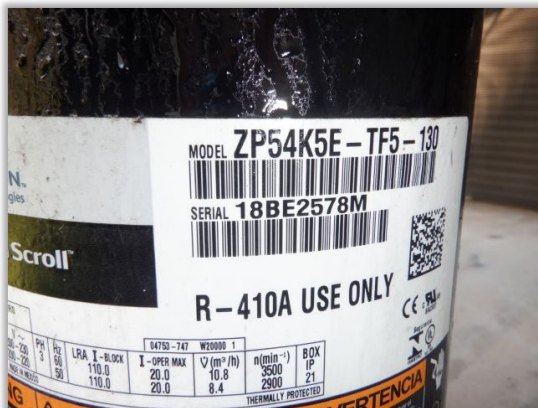
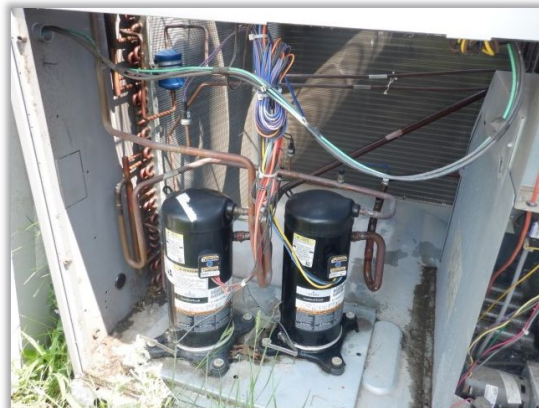
- The main blower belt was observed to be loose. The belt needs to be tightened to improve performance and air movement.

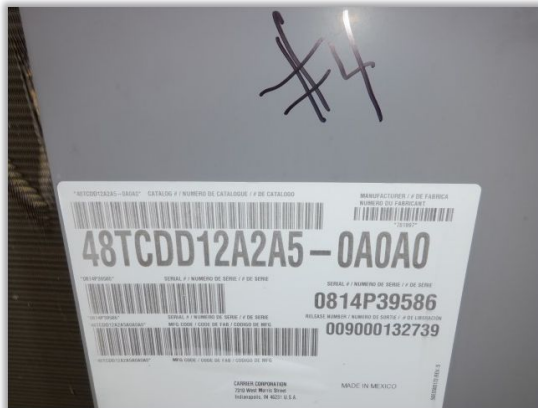
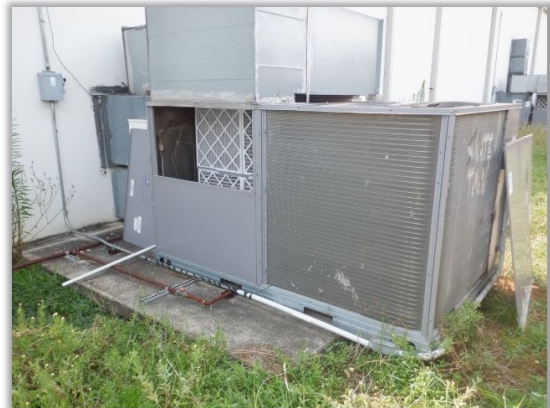
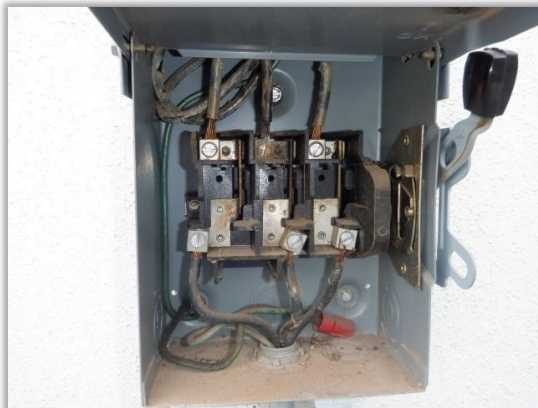
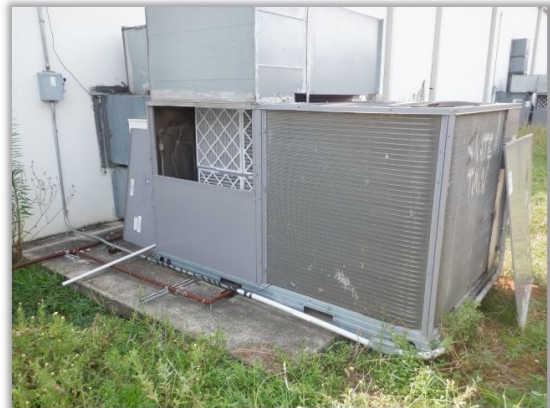
- **The temperature drop measured across the evaporative coils of the air conditioning system is lower than considered typical. The unit is not cooling properly and servicing is needed.**
- The evaporator coils were observed to be dirty and require cleaning.
- The indoor blower observed to be dirty and should be cleaned to help improve the efficiency of the unit.
- The fins of the outdoor portion of the air conditioning system were observed to be damaged. This condition can reduce the efficiency of the system.

The HVAC system and equipment needs to be checked and serviced by a Qualified / Licensed HVAC Technician. The observations made to support the rendering of this opinion are listed but may not be limited to the following:

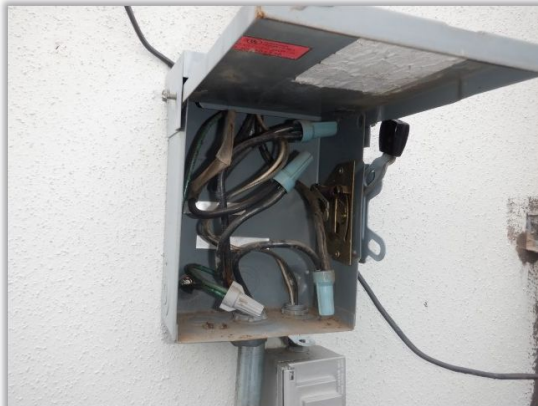
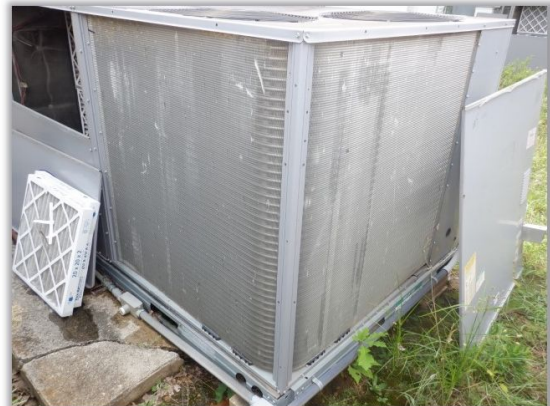
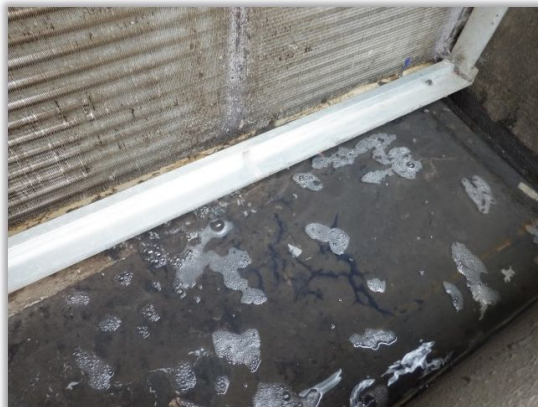
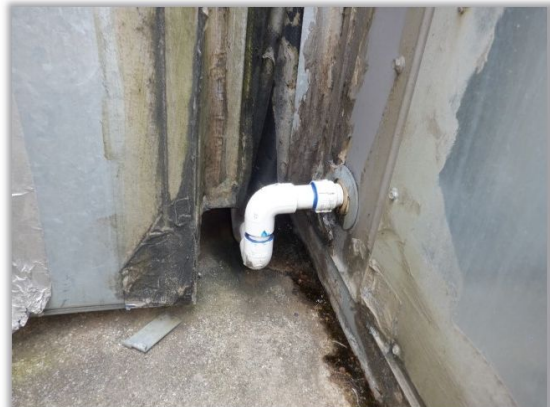
- The indoor blower observed to be dirty and should be cleaned to help improve the efficiency of the unit.
- The evaporator coils were observed to be dirty and require cleaning.
- There was no service disconnect observed within sight of the outside condenser/coils. The disconnect has been bypassed.
- The main blower belt was observed to be loose. The belt needs to be tightened to improve performance and air movement.
- The primary drain line is clogged and the interior of the housing is filling with water and leaking into the heater compartment. This condition needs to be corrected.

The HVAC system and equipment needs to be checked and serviced by a Qualified / Licensed HVAC Technician. The observations made to support the rendering of this opinion are listed but may not be limited to the following:

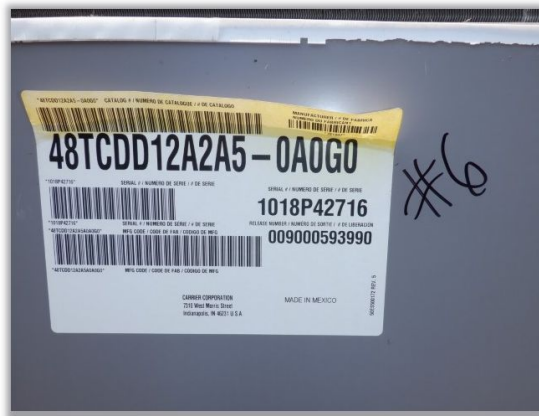
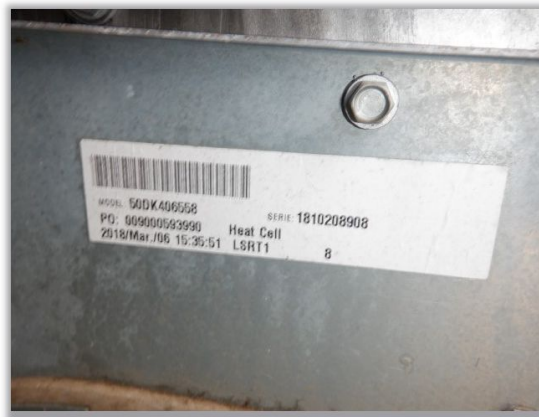
- **The temperature drop measured across the evaporative coils of the air conditioning system is lower than considered typical. The unit is not cooling properly and servicing is needed.**

The HVAC system and equipment needs to be checked and serviced by a Qualified / Licensed HVAC Technician. The observations made to support the rendering of this opinion are listed but may not be limited to the following:

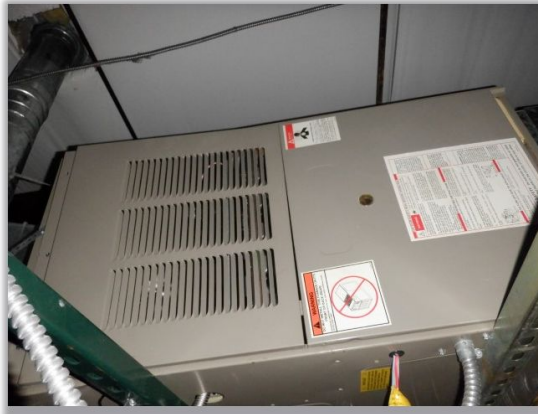
- The gas supply flex connector was observed to be passing through the heating unit cabinet. Under current mechanical installation standards, this is no longer an accepted practice. Only rigid black gas pipe is allowed to pass through the heating unit cabinet.
- The front cover panel plastic retention clips are damaged and the cover does not fasten in place / securely properly.
- Damaged, deteriorated (aged) and/or missing insulation on the refrigerant lines in the space above the drop ceiling tiles should be repaired or replaced as necessary. The old insulation is allowing condensation to drip onto the drop ceiling tiles causing water stains and damage.
- The indoor blower observed to be dirty and should be cleaned to help improve the efficiency of the unit.
- The evaporator coils were observed to be dirty and require cleaning.
- The dirty air filter should be replaced.

The HVAC system is older and replacement is necessary at this time. The approximate replacement cost for the HVAC system is \$10,000 to 12,500.

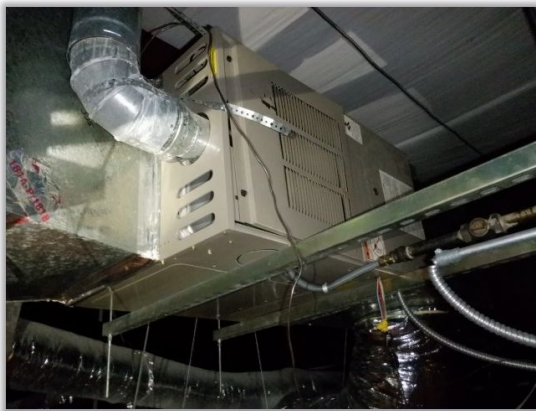
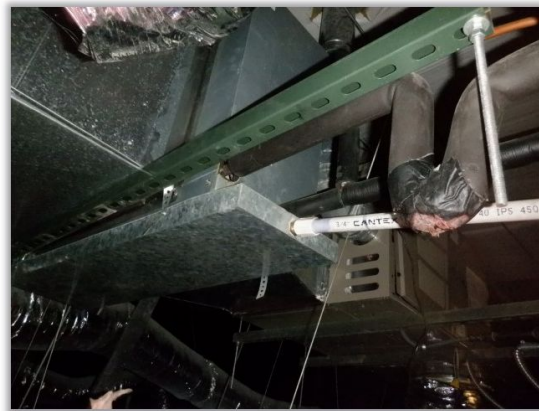
- The gas supply flex connector was observed to be passing through the heating unit cabinet. Under current mechanical installation standards, this is no longer an accepted practice. Only rigid black gas pipe is allowed to pass through the heating unit cabinet.

- The front cover panel plastic retention clips are damaged and the cover does not fasten in place / securely properly.
- Damaged, deteriorated (aged) and/or missing insulation on the refrigerant lines in the space above the drop ceiling tiles should be repaired or replaced as necessary. The old insulation is allowing condensation to drip onto the drop ceiling tiles causing water stains and damage.

- The indoor blower observed to be dirty and should be cleaned to help improve the efficiency of the unit.
- The evaporator coils were observed to be dirty and require cleaning.

- The dirty air filter should be replaced.
- The service receptacle was improperly wired to the service disconnect. This condition does not allow for overcurrent protection and should be corrected for reasons of safety.

- Damaged, deteriorated and/or missing insulation on the refrigerant lines should be repaired or replaced at the outside condenser.

The HVAC system is older and replacement is necessary at this time. The approximate replacement cost for the HVAC system is \$10,000 to 12,500.

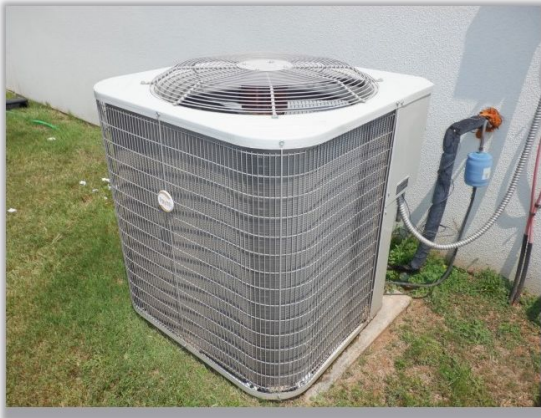
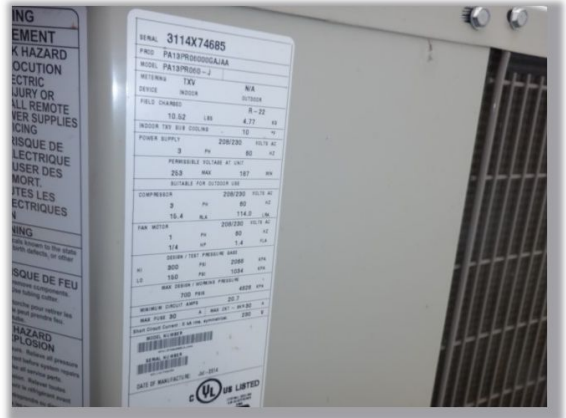
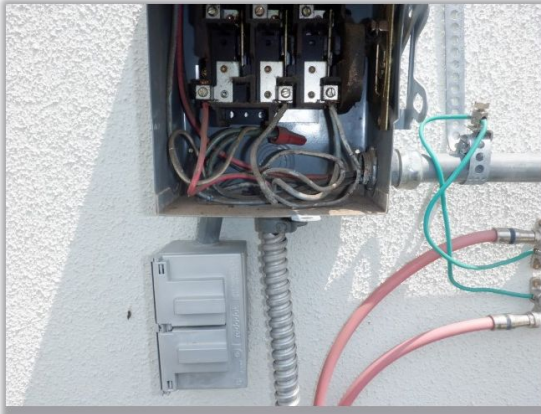
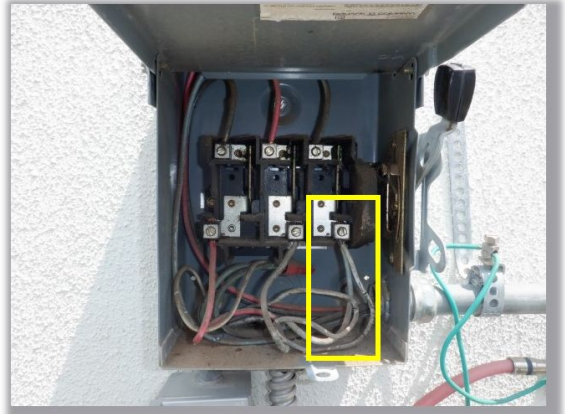
- The gas supply flex connector was observed to be passing through the heating unit cabinet. Under current mechanical installation standards, this is no longer an accepted practice. Only rigid black gas pipe is allowed to pass through the heating unit cabinet.

- The front cover panel plastic retention clips are damaged and the cover does not fasten in place / securely properly.
- Damaged, deteriorated (aged) and/or missing insulation on the refrigerant lines in the space above the drop ceiling tiles should be repaired or replaced as necessary. The old insulation is allowing condensation to drip onto the drop ceiling tiles causing water stains and damage.

- The evaporator coils were observed to be dirty and require cleaning.
- The indoor blower observed to be dirty and should be cleaned to help improve the efficiency of the unit.

- The dirty air filter should be replaced.
- There is a Teflon coated brass gas appliance connector in use for the heating equipment. Brass is no longer an acceptable material to be used as a gas supply connector and should be replaced with an approved gas appliance flexible connector.

- Damaged, deteriorated and/or missing insulation on the refrigerant lines should be repaired or replaced at the outside condenser.
- The fins of the outdoor portion of the air conditioning system were observed to be damaged. This condition can reduce the efficiency of the system.

The HVAC system is older and replacement is necessary at this time. The approximate replacement cost for the HVAC system is \$10,000 to 12,500.

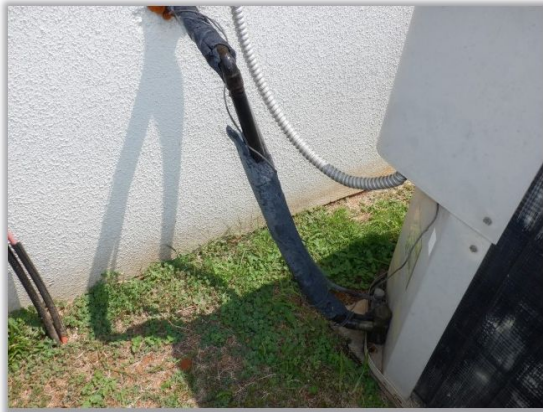
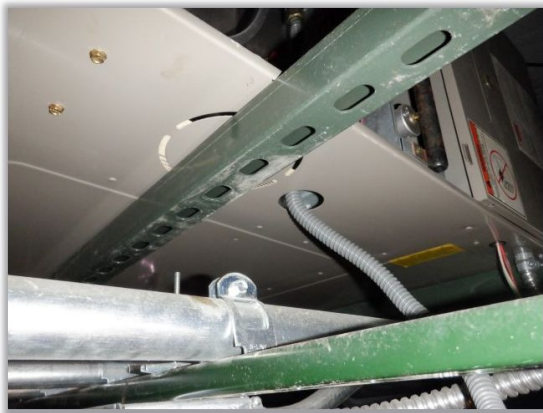
- Air leaks were detected at and around the ductwork connections and the distribution plenum(s).
- The duct system was observed to be dirty and needs to be cleaned for air quality purposes.

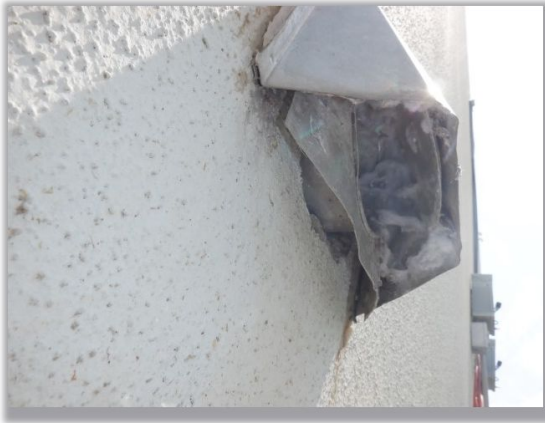
- The dryer exhaust duct (vent pipe) is dirty and needs to be cleaned.
- The damper at the dryer exhaust termination does not function properly. The damper does not reset to the closed position when not in use.
