April 11, 2022

PROPERTY INSPECTION REPORT FORM

Client Name Here	04/11/2022
<i>Name of Client</i>	<i>Date of Inspection</i>
AddressCity, TX 00000	
<i>Address of Inspected Property</i>	
Brian Murphy	3948
<i>Name of Inspector</i>	<i>TREC License #</i>

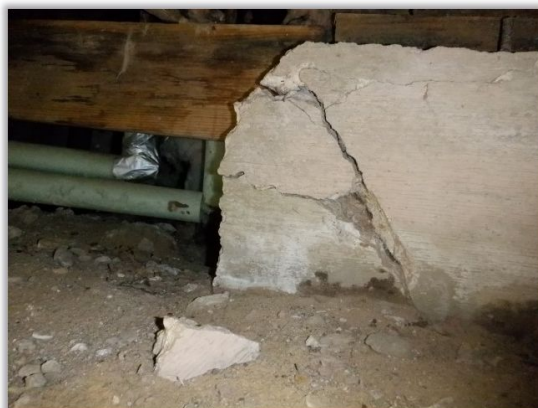
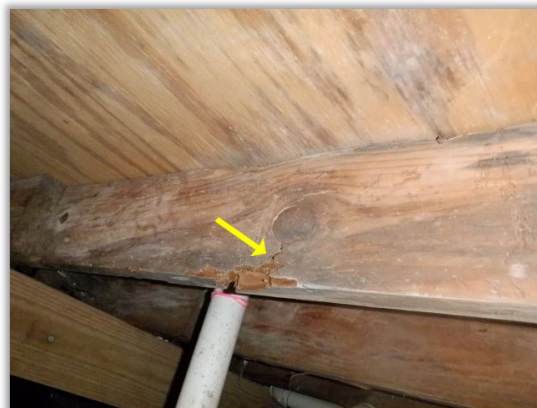
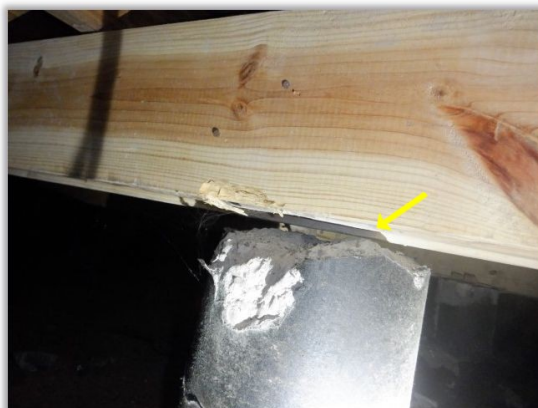
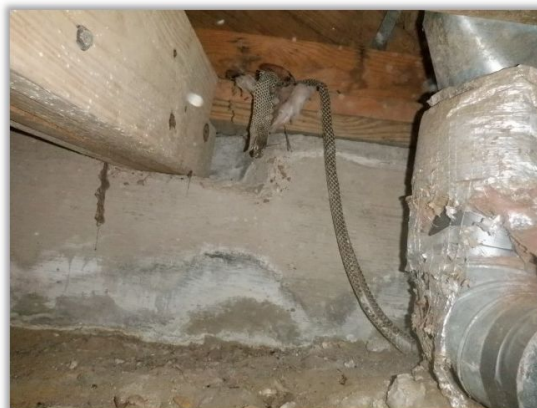
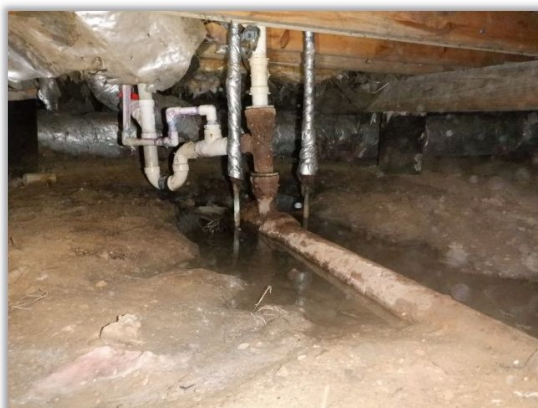
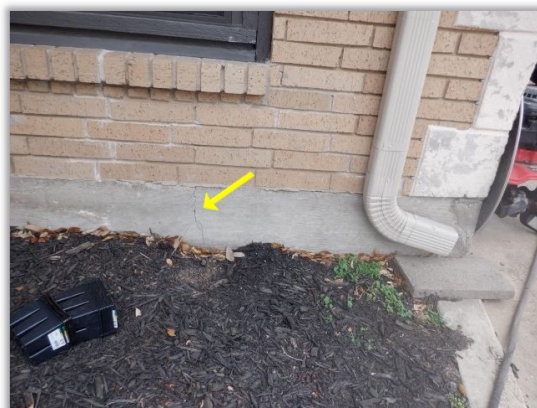
Some of the pier and beam foundation structural components appear to have deficiencies that are beyond normal. The Buyer should have the cause and remedy investigated by a foundation repair company familiar with pier and beam type structures. The observations made to support the rendering of this opinion are listed but may not be limited to the following:

- Floor slopes and/or unlevelness were observed.
- There is visible evidence of standing water in the crawl space in one or more locations. The crawl space drainage system does not appear to be performing properly and should be further evaluated by a drainage specialist familiar with pier and beam structures.

- There is standing water in the crawl space area under the laundry room. The cause and remedy should be further evaluated and corrected as necessary.
- There is a lot of dry rots related to the wood foundation components. This condition needs to be further evaluated.

- The crawl space does not appear to be adequately ventilated. Proper ventilation will help to control humidity and reduce the potential for rot. This condition should be further evaluated and corrected as necessary.

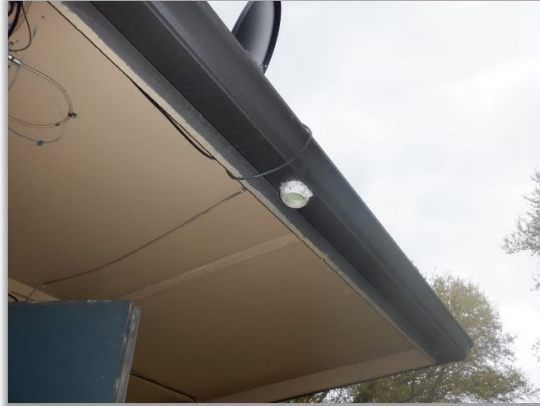
Gutter & Downspout System

- **Note:** The gutter downspouts should discharge water at least thirty-six inches (36") away from the foundation perimeter beam. Storm water should be encouraged to flow away from the structure at the points of discharge.
- Minor leaks in the gutter joints and seams should be repaired.
- The guttering system downspout is missing on the north side of the structure.

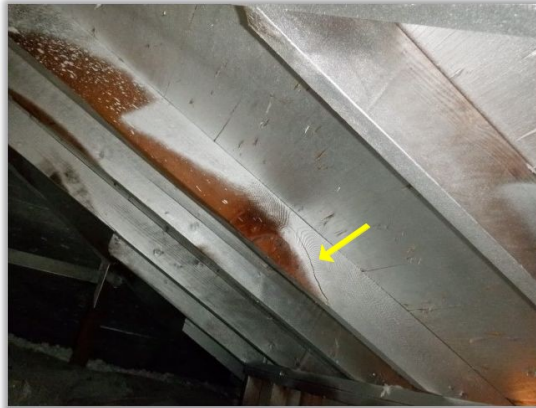
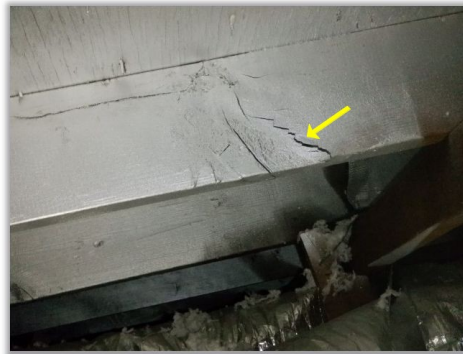
Roof Structure

- Split rafter(s) were observed in the attic area over master bedroom, master bathroom the area(s).
- **Note:** Visible evidence of rodent activity was observed in the attic area. It is recommended to have a Certified Pest Control Operator further evaluate this condition and make corrections as necessary.

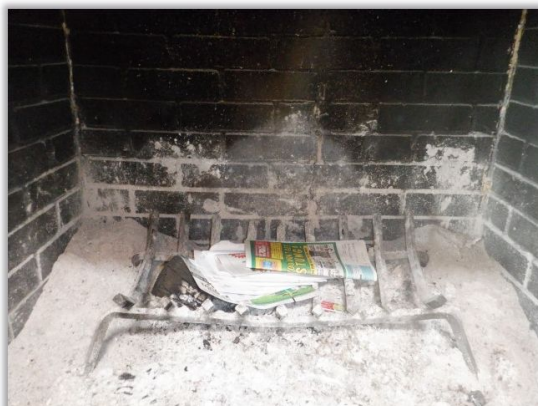
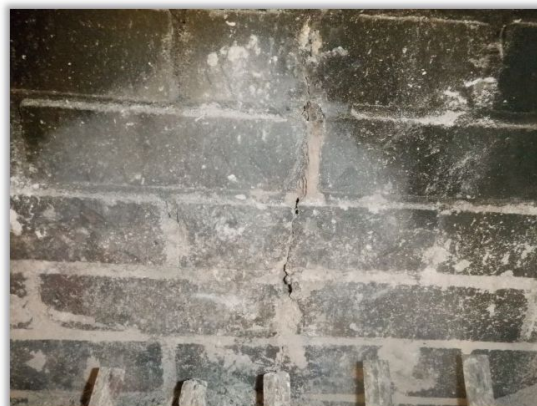
- The chimney flue needs to be cleaned by a Qualified Chimney Sweep. A creosote / soot build-up was observed in the visible flue area.
- Firebox brick mortar needs to be improved.
- **Note:** The floor of the firebox is dirty and needs to be cleaned. I was unable to view the floor of the firebox at the time of this inspection.

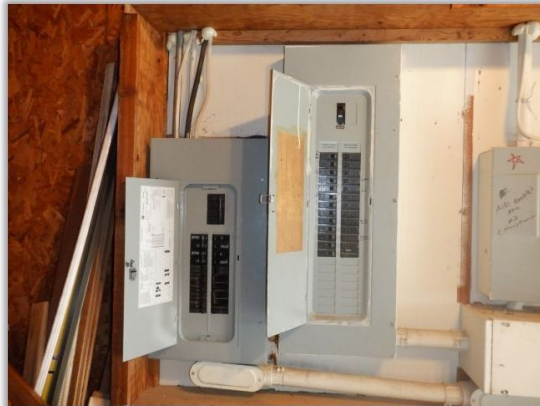
- One or more of the cabinet cover plate screws are missing and need to be replaced.
- All openings (missing knockouts) in the electrical cabinet cover plate (dead front) and /or cabinet need to have fillers.
- The breakers (overcurrent devices) in the electrical panel are not properly labeled.

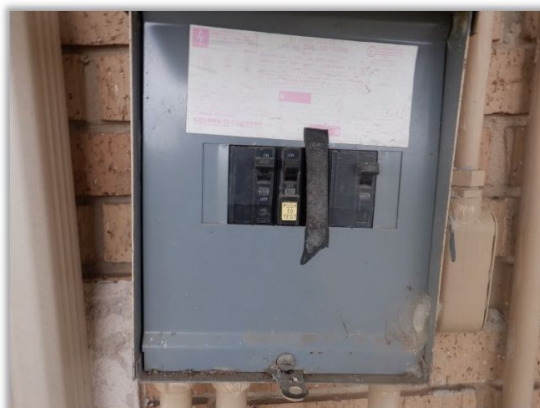
- All openings (missing knockouts) in the electrical cabinet cover plate (dead front) and /or cabinet need to have fillers.
- The sub-panel does not appear to have a four-wire service feed. Although the sub-panel is functional, it does not meet current National Electrical Code standards. This is an “as-built” condition but Per TREC standards of practice we are required to report this condition as a deficiency.

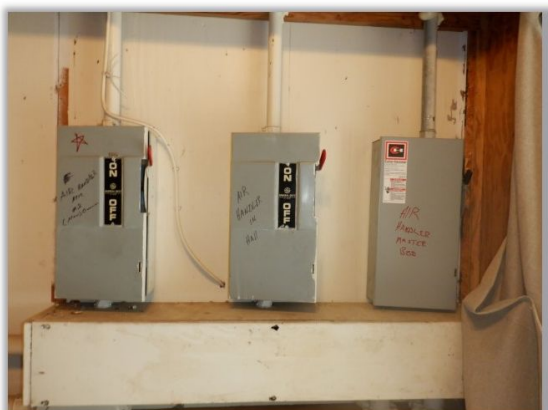
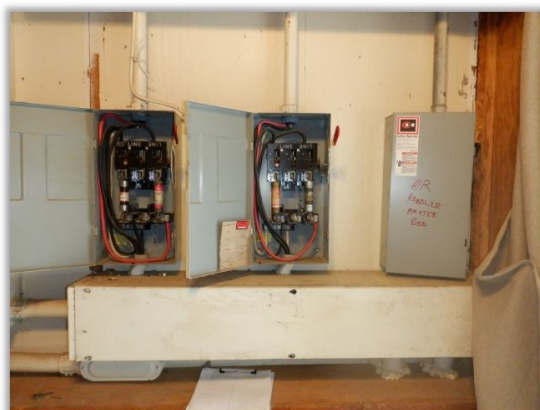
Service Disconnects for HVAC Units

- The fuse type service disconnects for the air handlers are oversized for the air handles.

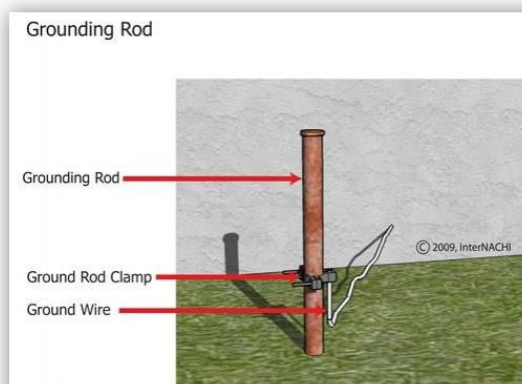
Grounding / Bonding

- I was unable to locate the electrical bond connection for the metal water piping to the grounding electrode system. All bond connections should be accessible for inspection, repair or replacement. This condition should be further investigated and corrected if necessary.
- I was unable to locate the electrical bond connection for the gas piping back to the grounding electrode system. All bond connections should be accessible for inspection, repair or replacement. This condition should be further investigated and corrected if necessary.
- I was unable to locate a grounding rod (Grounding Electrode) or supplement grounding source for the electrical system. This condition should be further investigated and corrected if necessary.

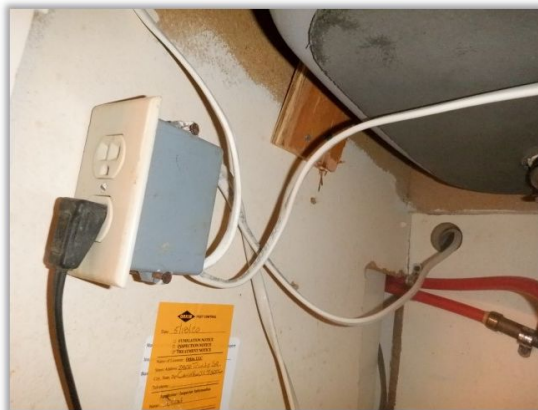
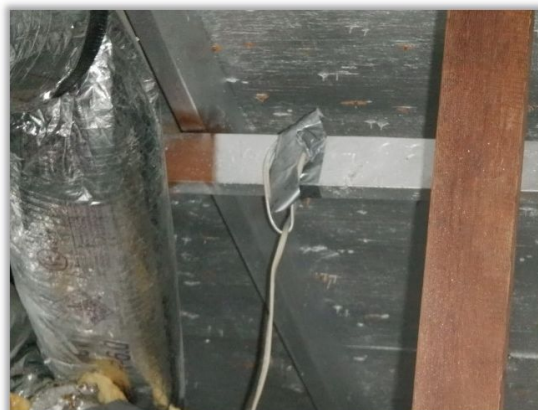
Distribution Wiring

- Spliced electrical wires were observed in the attic area. Spliced wires in the attic should be properly enclosed in junction box(es) and secured to the ceiling joist. Spliced wires were located over the bedroom hallway, master bedroom and master bathroom.
- Open end wires were observed master bedroom and master bathroom. The open ended wires need to be properly enclosed in an electrical junction box for reasons of safety.
- All exposed distribution wiring should be properly enclosed in conduit. Exposed wiring was observed in the kitchen cabinet below the sink.

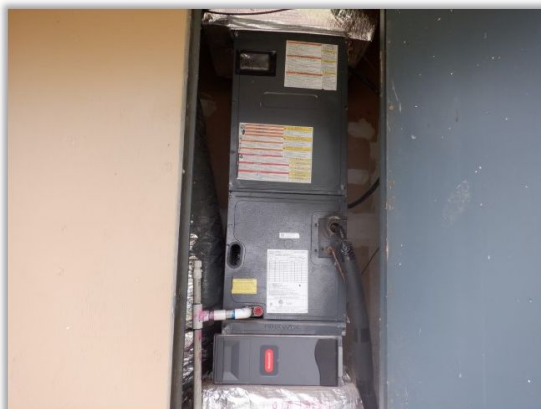
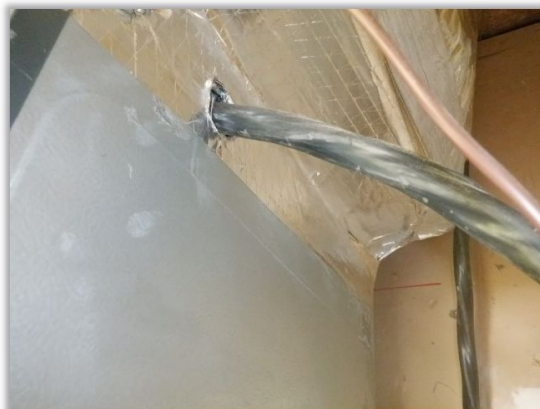
- The electrical branch wires are not properly secured to the heater housing.

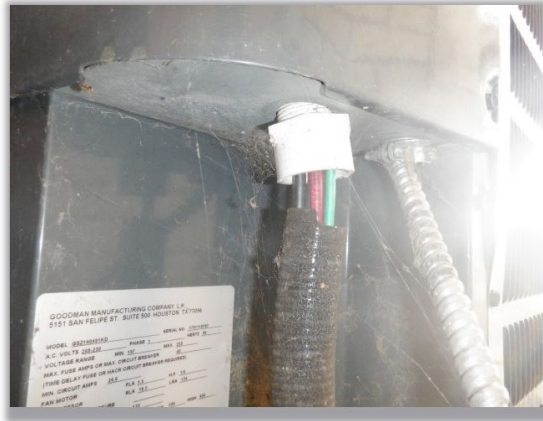
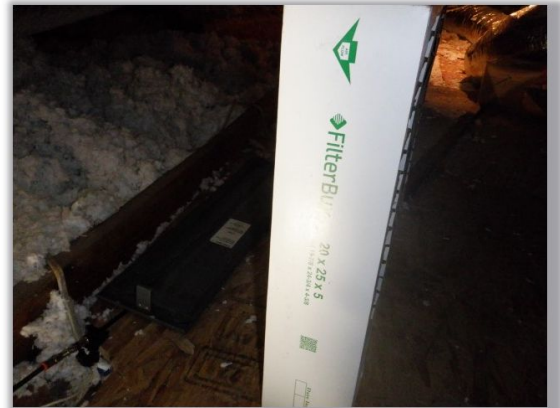
Bedroom Hallway Central Cooling System

Today's Temperature Differential (Delta-T): 0

- **The temperature drop measured across the evaporative coils of the air conditioning system is lower than considered typical. The unit is not cooling properly and servicing is needed.**
- Air leaks were detected at and around the indoor coil housing. The air leaks should be corrected for improved efficiency.
- The indoor blower observed to be dirty and should be cleaned to help improve the efficiency of the unit.
- The evaporator coils were observed to be dirty and require cleaning.
- The dirty air filter should be replaced.
- The outdoor unit of the air conditioning system requires cleaning.
- The electrical wire conduit has pulled loose at the outside condenser housing and/or service disconnect.
- Damaged, deteriorated and/or missing insulation on the refrigerant lines in the crawl space area should be repaired or replaced as necessary.

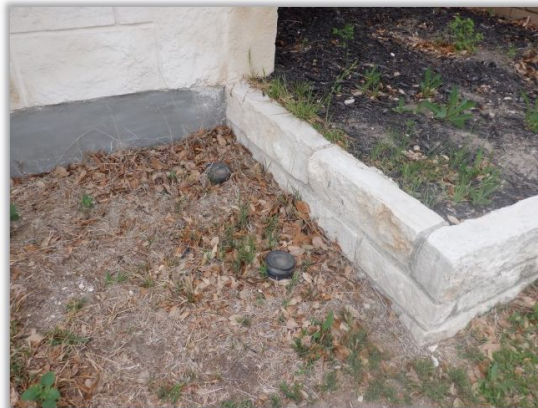
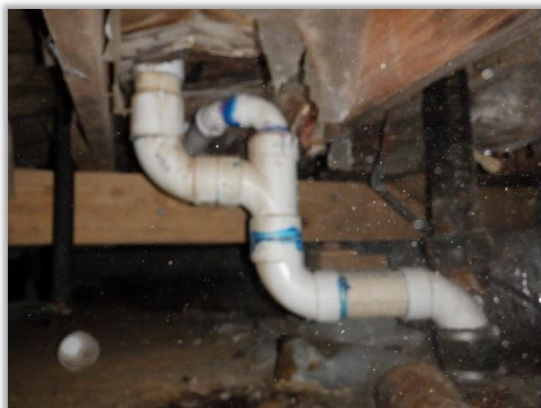
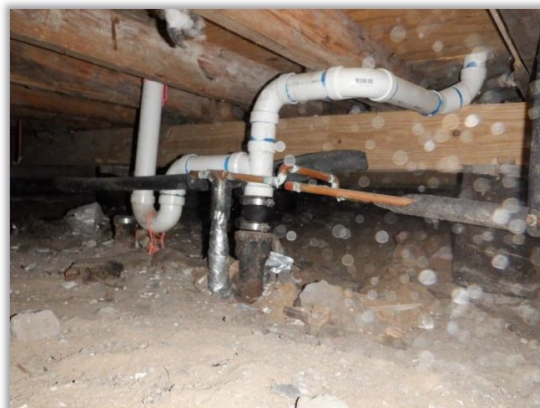
- Some of the crawl space area plumbing waste pipes were observed to be damaged and are leaking into the crawl space area under the laundry room.
- There are visible leaks in the cast iron piping system. Further evaluation of this condition is recommended.

- The cast iron plumbing system appears to have had some previous repairs performed. This is a good sign that additional failures may occur in the near future. Further evaluation of the cast iron plumbing system is recommended.

- The cast iron plumbing system has visible rust and corrosion on the exterior surfaces of the piping system. This is a good indicator that failures may occur in the near future. Further evaluation of the cast iron plumbing system is recommended.

- Cast iron material was observed to be present in the drains, wastes and vents system. Full evaluation of the integrity of this type of material is beyond the scope of this inspection. Due to the known latent defects that are associated with this type of older material, it is recommended to have the integrity of the drain system further evaluated by a qualified plumber. It is recommended to have a hydrostatic test and to have the inaccessible and buried pipes scoped with a camera as part of this evaluation. This evaluation should occur prior to the expiration of any time limitations such as option or warranty periods.

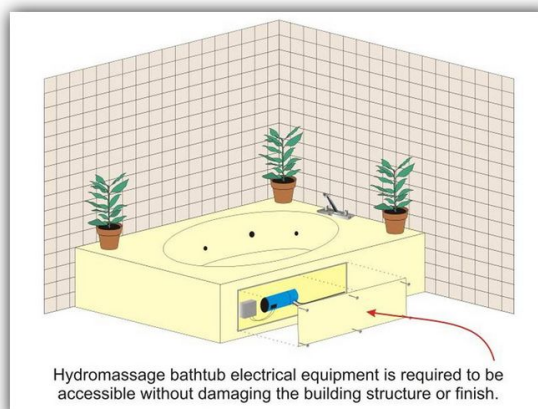
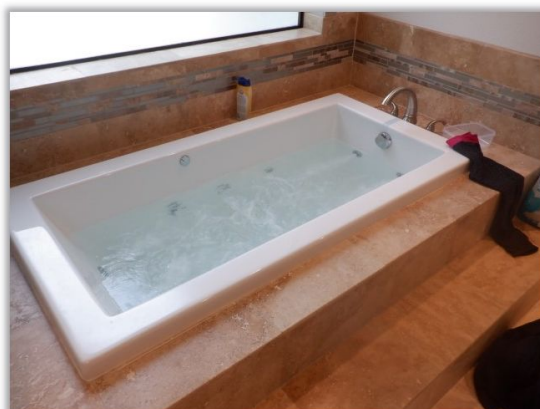
Location of GFCI: Unable to locate a GFCI for equipment.

- I was unable to locate a ground fault circuit interrupter (GFCI) receptacle or breaker for the hydro-massage therapy equipment. The homeowner should be consulted on the location of this GFCI device. If there is no GFCI device installed on the hydro-massage therapy equipment circuit, a GFCI receptacle or breaker should be installed for reasons of safety.
- The access to the hydro-massage therapy equipment motor is not readily accessible and inspection of the equipment lines and motor could not be performed. This does not meet current installation standards.

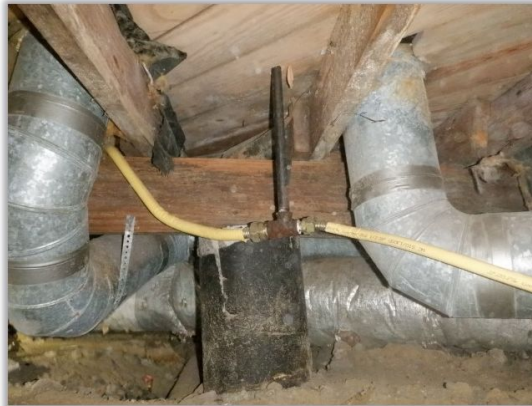
Corrugated Stainless Steel Tubing (CSST) was observed to be in use at the time of this inspection. This product is known to have various installation and grounding / bonding problems or deficiencies. Full evaluation of this product is beyond the scope of this inspection. You are strongly encouraged to have a licensed plumber evaluate the installation and a licensed electrician investigate for proper bonding and grounding of this component of the gas distribution system. **Such follow-up should take place prior to the expiration of any time limitations such as option or warranty periods.** Evaluations by qualified tradesmen may lead to the discovery of additional deficiencies which may involve additional repair costs.

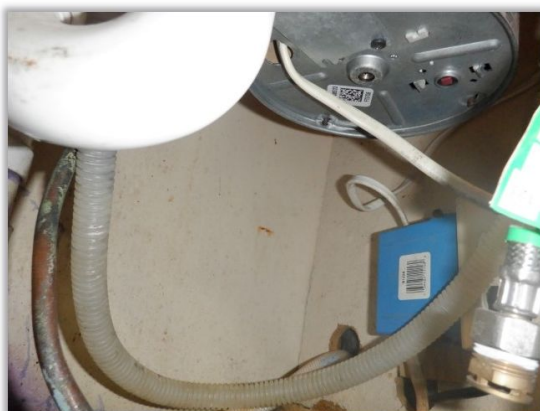
- The electrical wiring to the food waste disposer is not properly secured to the disposer housing.

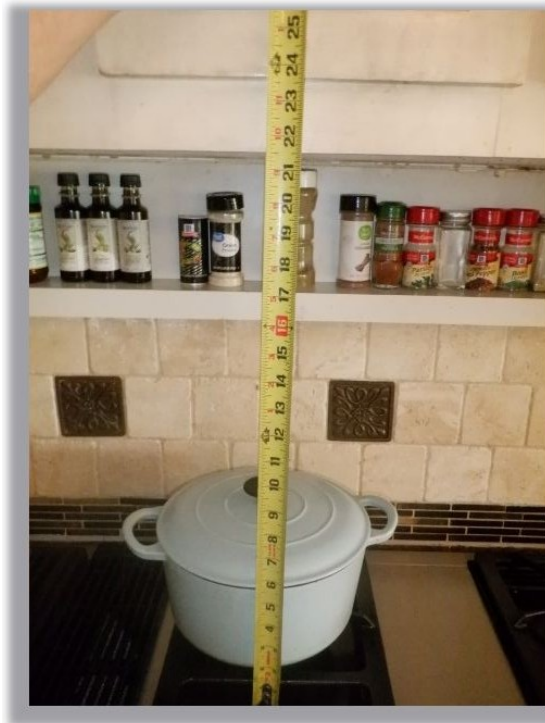
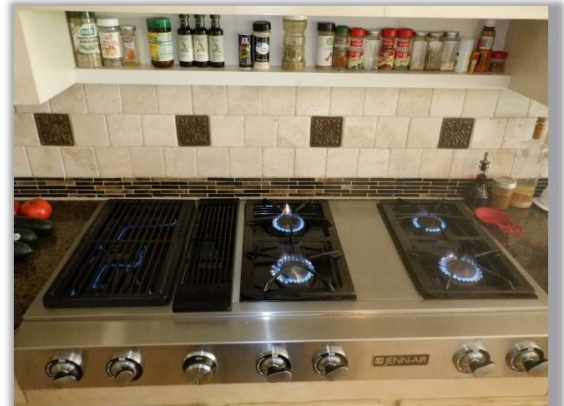
Brand Name: Jenn-Air

- There should be at least thirty inches (30") of free clearance above the cooktop to any combustible material.

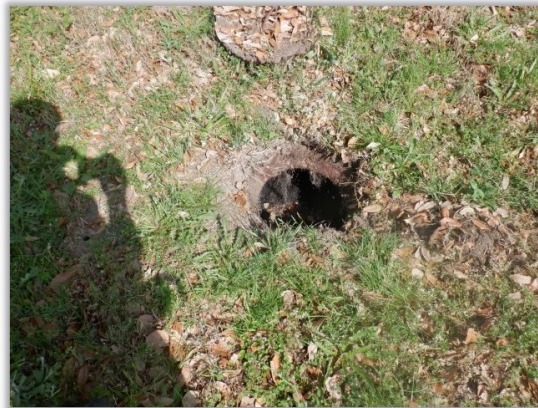
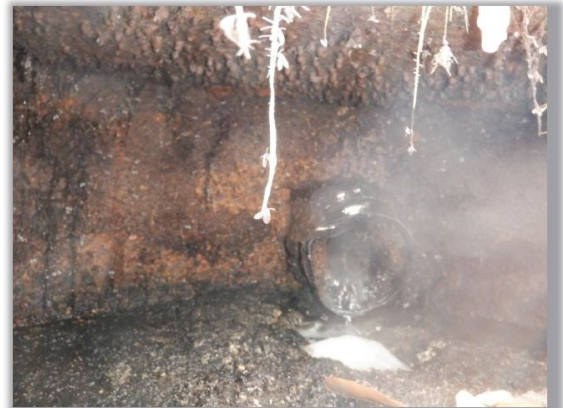
- One or more of the tank access lids are not secured into place.
- Note: I was unable to observe the interior baffles between tanks.
