INSPECTED FOR  
**Client Name Here**  
**Address**  
**City, TX 00000**  
**Date Here**

## PROPERTY INSPECTION REPORT FORM

<b>Client Name Here</b> <i>Name of Client</i>	<b>Date Here</b> <i>Date of Inspection</i>
<b>Address</b> City, TX 00000 <i>Address of Inspected Property</i>	
<b>Brian Murphy</b> <i>Name of Inspector</i>	<b>3948</b> <i>TREC License #</i>

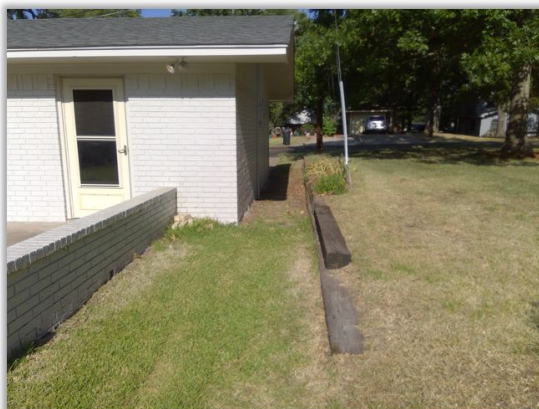
- Poor to negative site drainage was observed on the north side of the structure. Proper drainage is needed to help prevent water from standing and/or pooling next to the foundation beam. Corrective measures may be needed if the water stands within 10-feet of the foundation perimeter beam for more than 24-hours.
- The soil line is too high on the north side of the structure. Under current building standards there should be at least 4-inches of foundation visible below masonry veneer and 6-inches of foundation visible below wood type veneer.

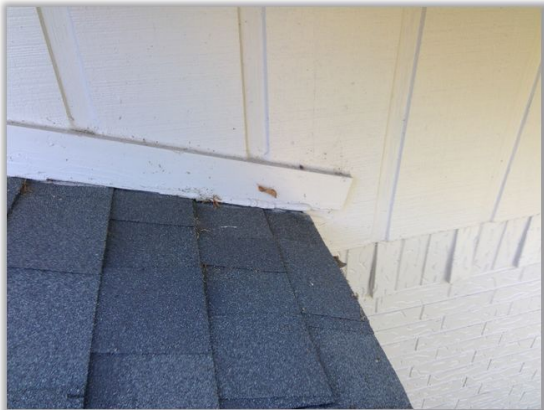
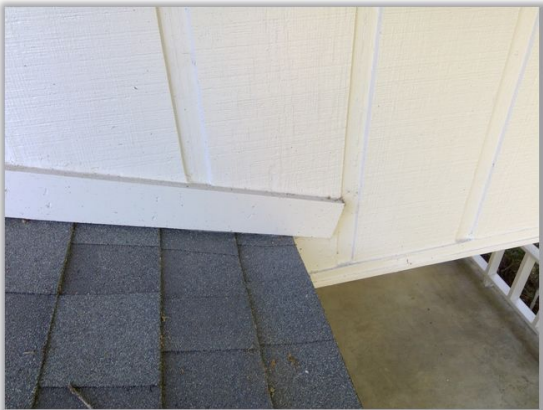
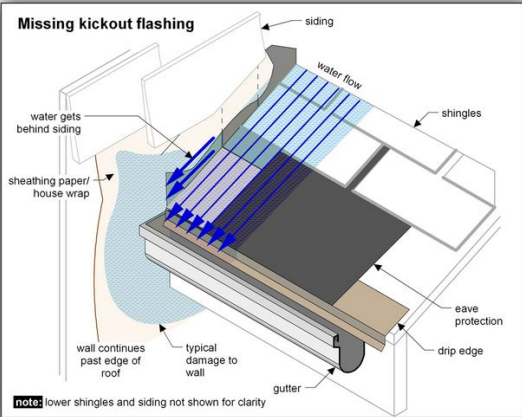
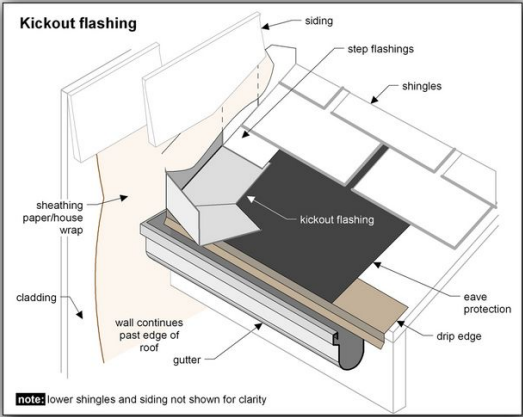
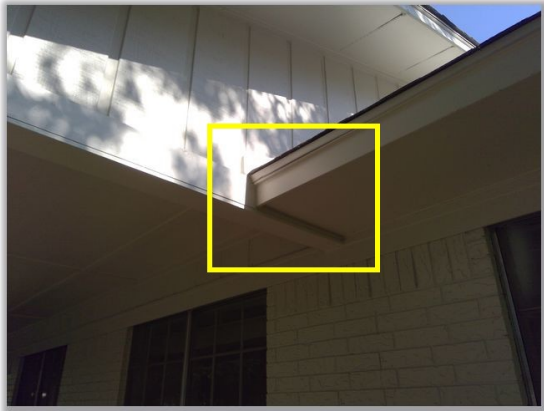
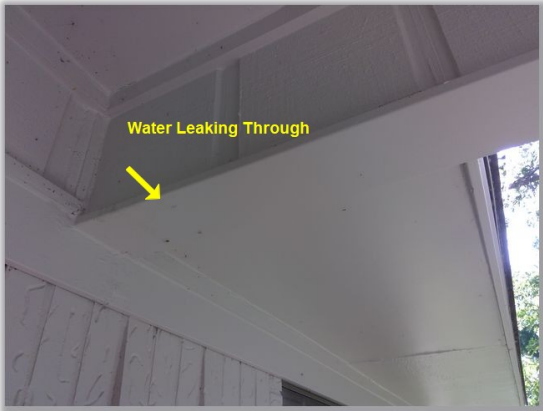
- There was no kickout flashing details observed at the lower bottom edge of the roof line interface and the sidewall that continues past the edge of the roof. The lack of this kickout flashing will allow water to penetrate at these points.
- There is no cricket / saddle in place behind the roof level chimney structure. Under current building standards, there should be a cricket or saddle installed behind the ridge side of any chimney greater than 30-inches wide.

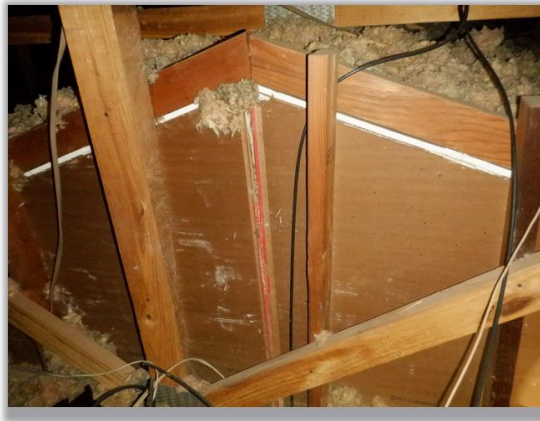
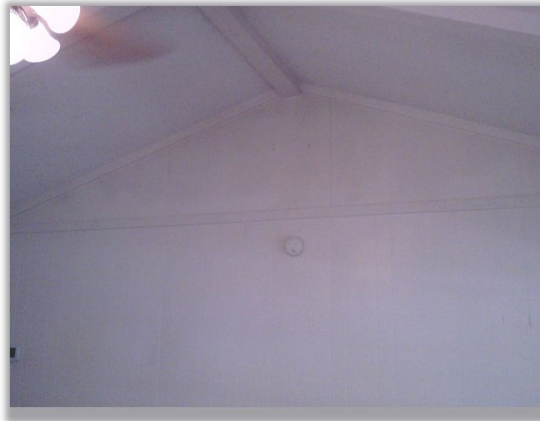
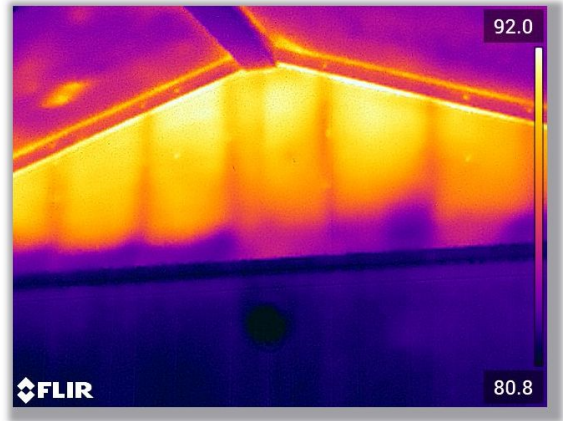
- Some noticeable sags and/or depressions were observed in the roof sheathing (decking).
- Some roof sheathing (decking) deterioration and/or damage was observed in one or more locations.
- **Note:** There are visible water stains on the roof sheathing (decking) in one or more locations.

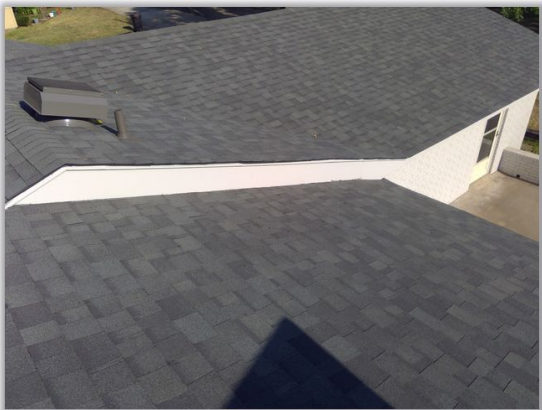
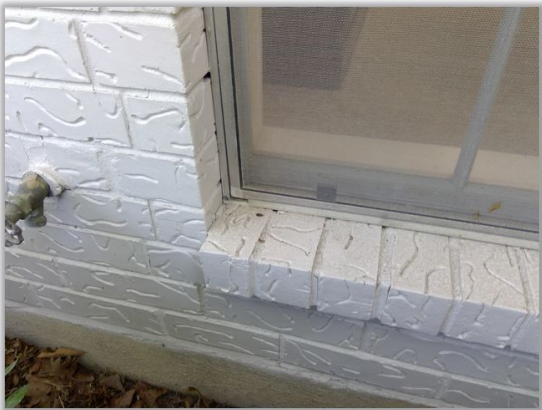
- The sidewall veneer / cladding is in contact with the roofing material. Under current building standards, there should be at least 2-inch of clearance between the roofing material and the sidewall veneer / cladding.
- The garage door trim has some deterioration and/or damage at the bottom.
- Caulking improvements are recommended for the area between the exterior veneer and the window frames. It is recommended to use an industry approved low-modulus elastomeric sealant.
- The wood veneer trim has some deterioration or damage on the south side of the structure.
- Caulking improvements are recommended for the area between the exterior veneer and the exterior door frames. It is recommended to use an industry approved low-modulus elastomeric sealant.

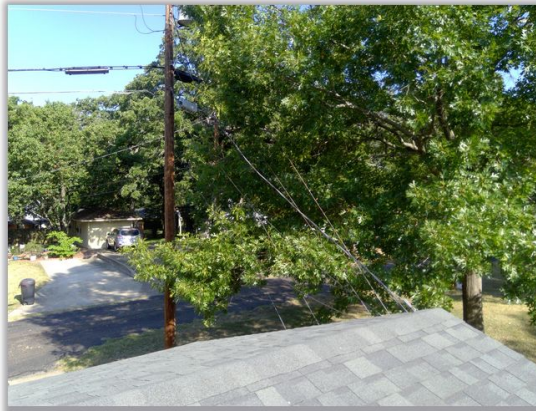
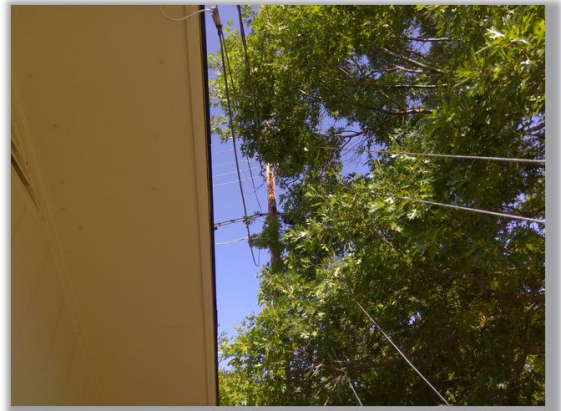
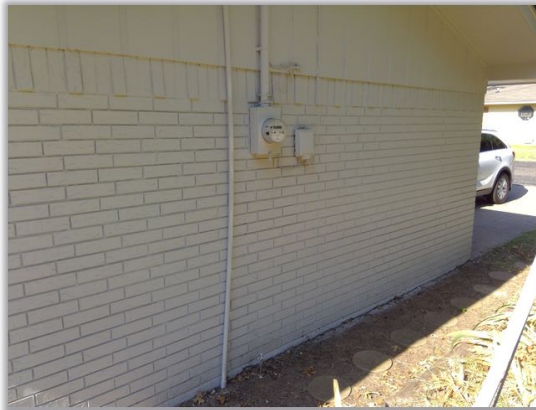
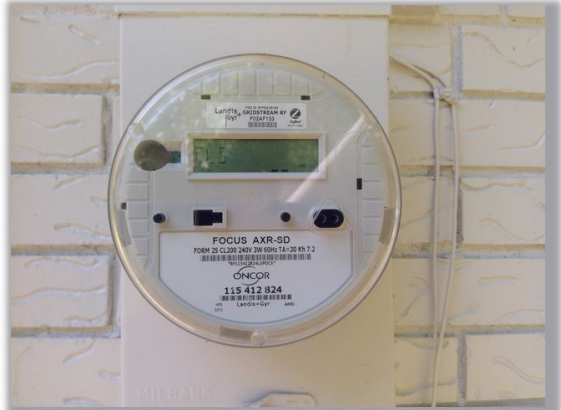
- The tree branches should be trimmed away from the overhead service wires.

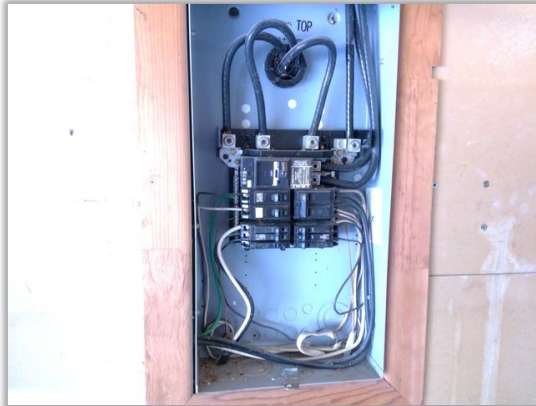
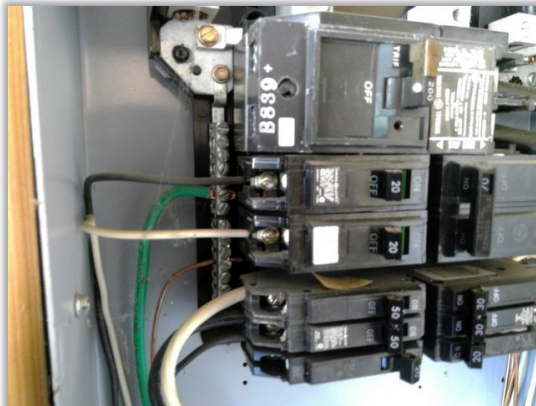
- The breakers (overcurrent devices) in the electrical panel are not properly labeled.
- There was no main disconnect observed in the panel box.
- The electrical cabinet cover plate (dead front) should be installed with blunt tip screws and not sharp wood type screws for reasons of safety.
- All openings (missing knockouts) in the electrical cabinet cover plate (dead front) and /or cabinet need to have fillers.
- The wires entering the electrical cabinet are not properly secured or protected from the sharp edges of the cabinet.
- One or more of the breaker trip-ties appear to be missing. The split overcurrent devices (breakers) servicing 240V appliances should be connected together by trip-ties.

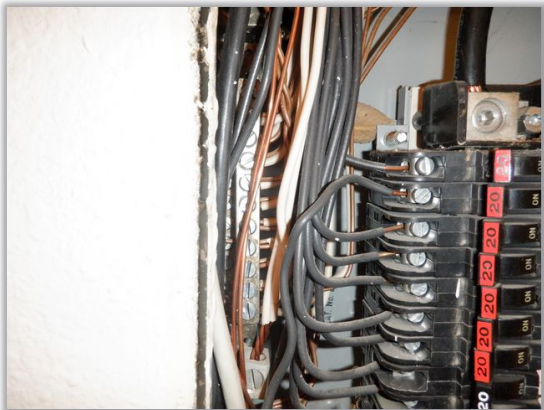
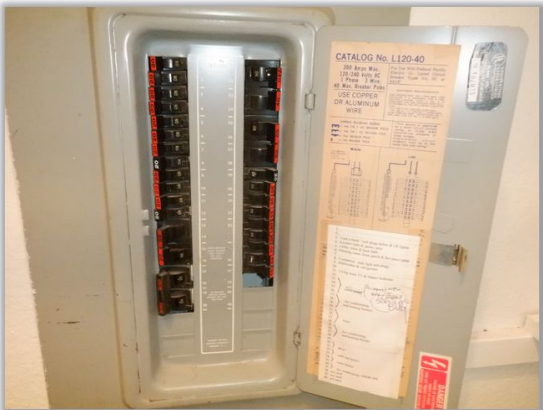
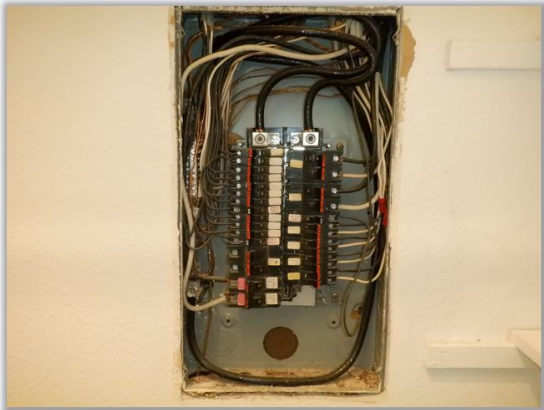
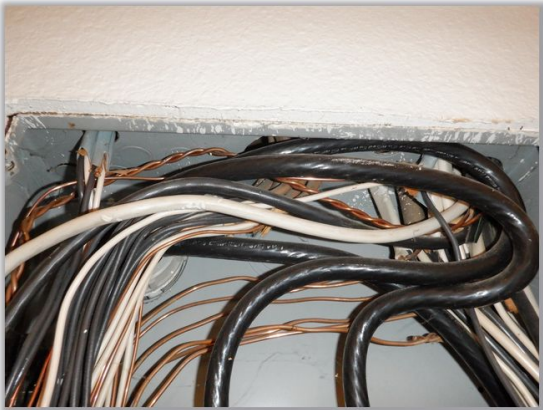
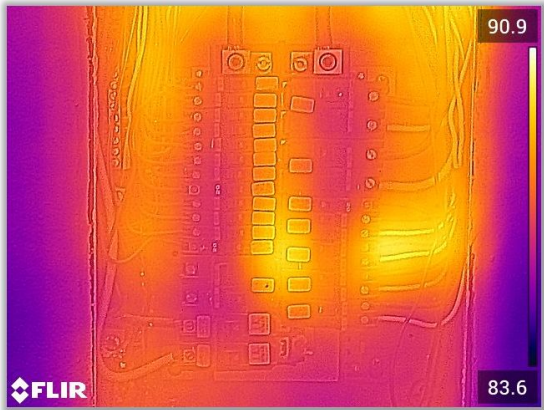
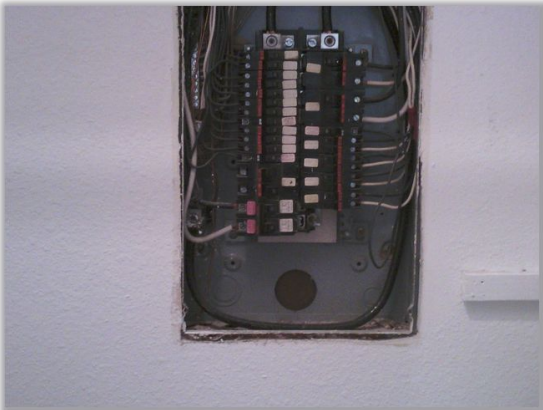
- The electrical panel is located in a clothes closet. Under current electrical standards, this is no longer an accepted practice. This is an “as-built” condition but Per TREC standards of practice we are required to report this condition as a deficiency.

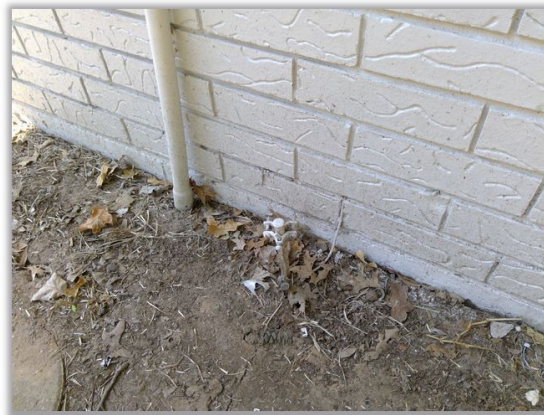
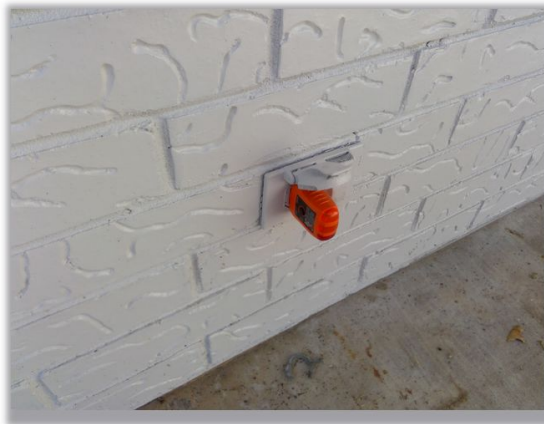
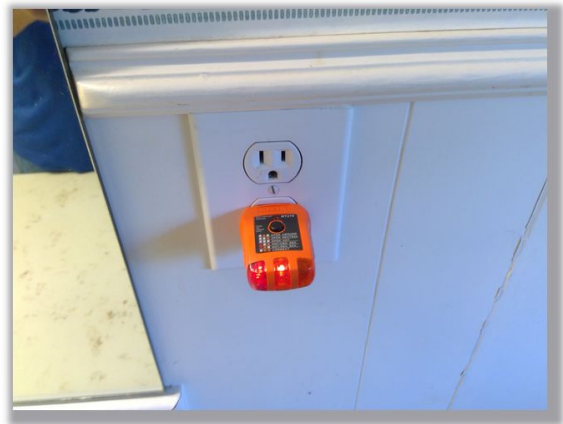
- One or more of the receptacles is missing its cover plate in the garage ceiling.
- Wires cross connected at the receptacles on the back porch north wall. This circuit needs to be further evaluated.
- One or more of the receptacles appear to have reversed polarity (i.e. it is wired backwards). This receptacle(s) and the circuit should be investigated and improved as necessary. The receptacle(s) in question are located in the 2nd master bathroom.
- **Note:** Several of the receptacles have been painted over.
- The receptacles in the wet/damp areas do not appear to have ground fault circuit interrupter (GFCI) protection.

- The receptacles in place are not listed as tamper-resistant type receptacles. Under current building standards all 15- and 20-ampere, 125- and 250-volt nonlocking-type receptacles located less than 5.5 feet above the floor should be listed tamper-resistant type receptacles.

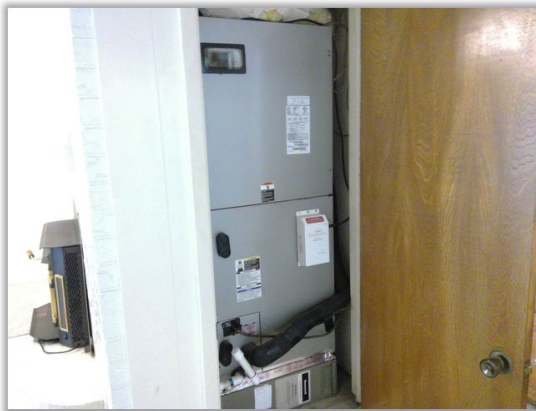
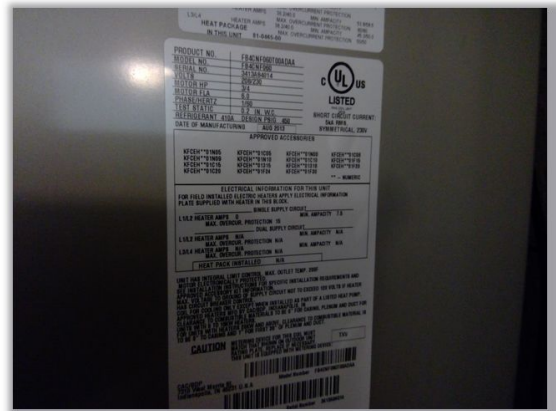
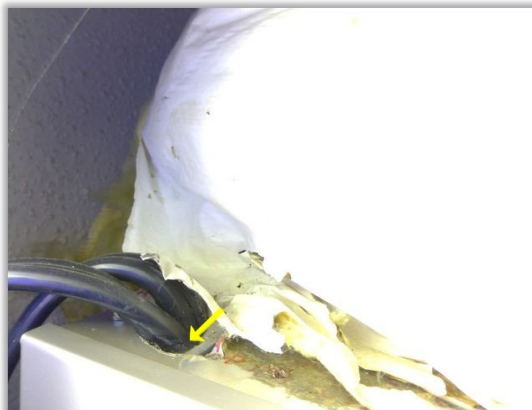
- The electrical branch wires are not properly secured to the heater housing.
- The exposed electrical service wires to the heating equipment should be enclosed in conduit.

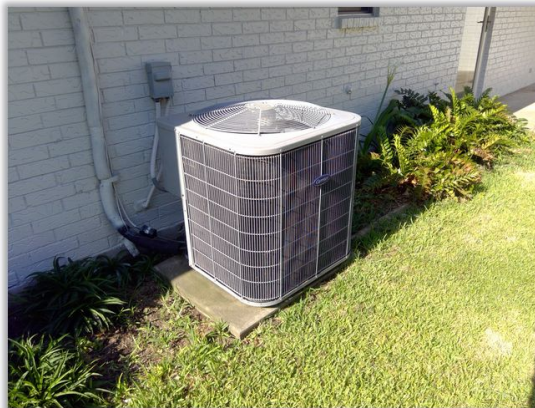
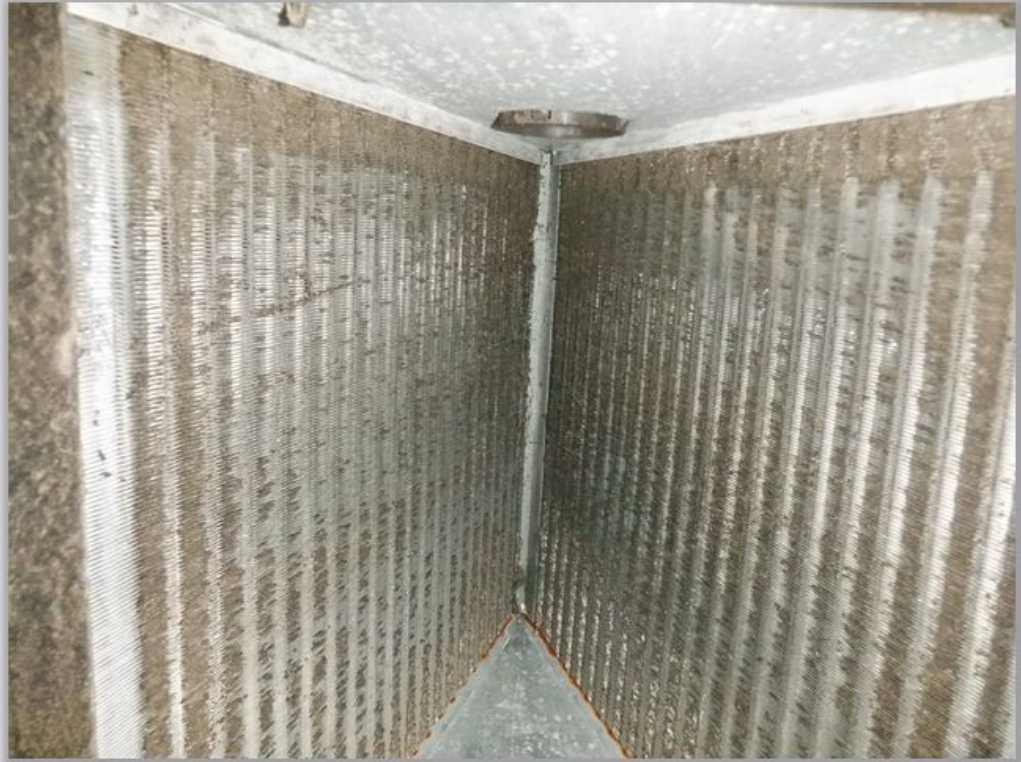
- **The temperature drop measured across the evaporative coils of the air conditioning system is lower than considered typical. The unit is not cooling properly and servicing is needed.**
- The evaporator coils were observed to be dirty and require cleaning.
- The electrical service disconnect is installed behind the outside condenser/coil. This does not meet the clearance requirements of the National Electrical Code or the International Residential Code and should be corrected as necessary.
- The manufacturers listing plate on the outside condenser/coil list that the maximum over current device (breaker) to be used should not exceed 40-amp. There is a 50-amp breaker in place at this time. This breaker in place does not meet the manufacturers listing plate requirements.

The HVAC system and equipment needs to be checked and serviced by a Qualified / Licensed HVAC Technician. The observations made to support the rendering of this opinion are listed but may not be limited to the following:

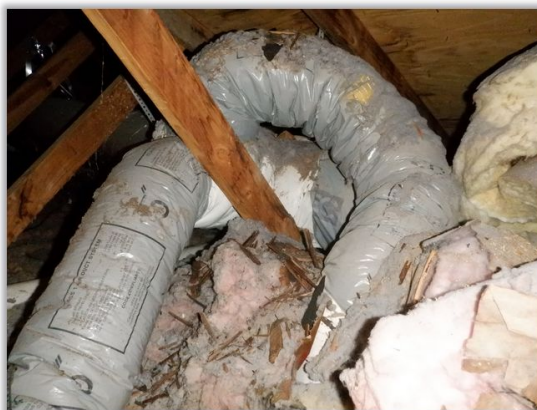
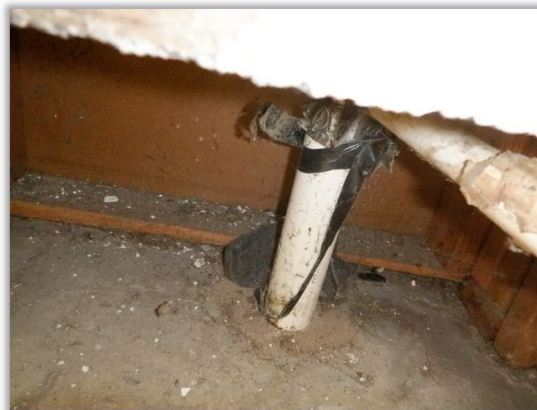
- The duct system was observed to be dirty and needs to be cleaned for air quality purposes.
- Air leaks were detected at and around the ductwork connections and the distribution plenum(s).

- Ductwork insulated covering was observed to be damaged and/or pulling loose.
- Some of the ductwork in the attic area has been turned to sharply. This will restrict the airflow through the duct system and affect the airflow balance in some areas of the house.

- The ducts in the attic space are not properly stretched out and supported. This will restrict the airflow through the duct system and affect the airflow balance in some areas of the house.

- **Note:** The air-return chase for the HVAC system is dirty and should be cleaned to help maintain good air quality.
- **Note:** The covering on the ductwork that is in place has been known to deteriorate with direct and/or indirect UV light. This item should be closely monitored and corrected as necessary.

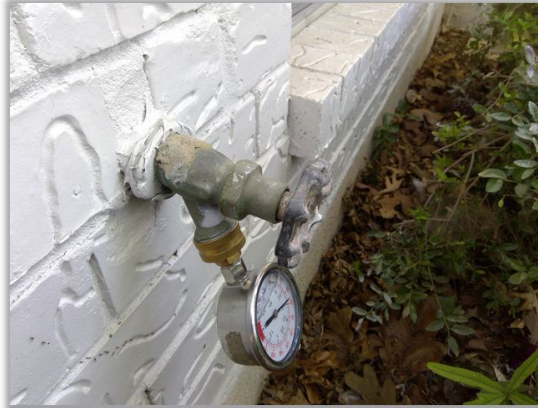
**Exterior Faucets/Fixtures**

- The exterior water hose bibb (faucet) is leaking at the handle when operated on the north and south sides of the structure.

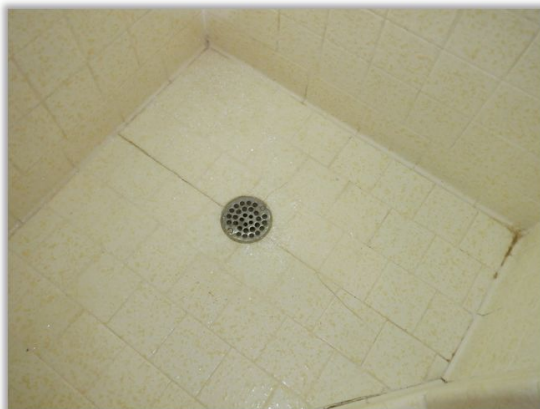
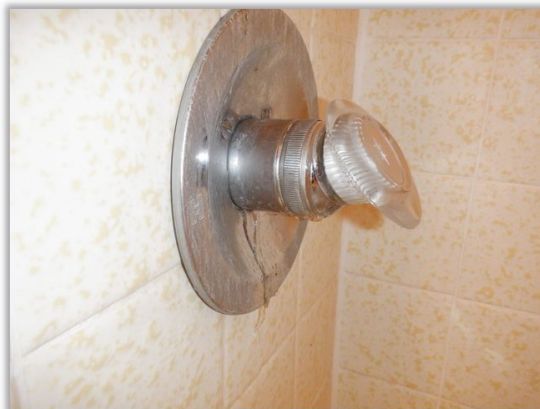
##### *Shower*

- Cracked, deteriorated and/or missing shower stall grout and/or caulking should be repaired or replaced as necessary.
- Some of the shower enclosure tiles were observed to be cracked.
- The faucet leaks at the handle when on.

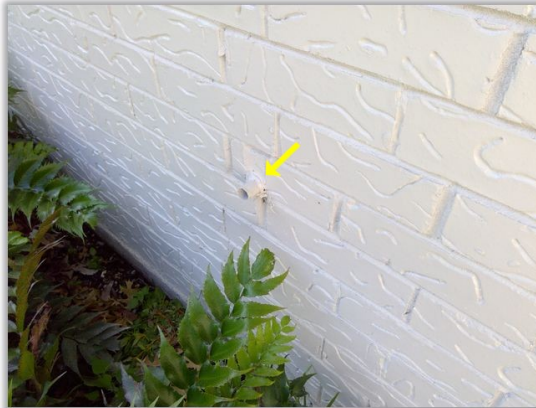
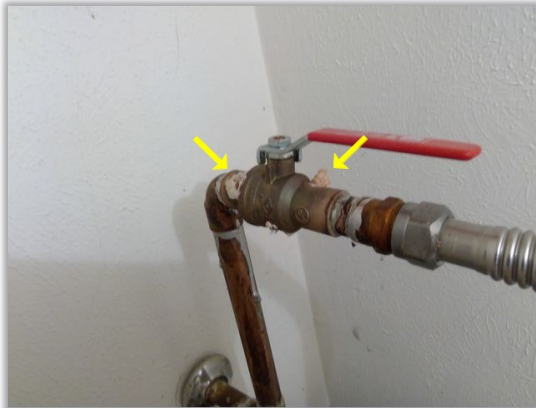
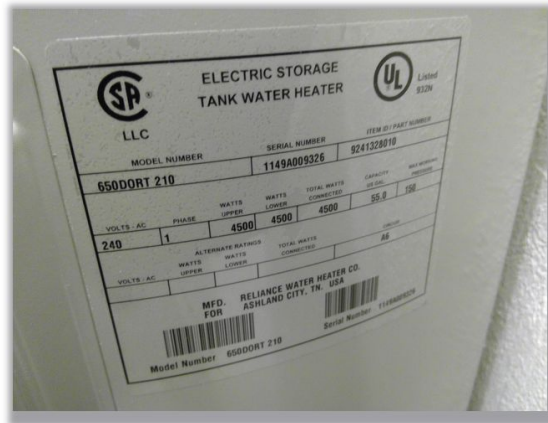
- The electrical wiring to the water heater is exposed and should be enclosed in conduit.
- There is no pan installed under the water heater.
- The exterior temperature and pressure relief (TPR) discharge pipe does not terminate at the proper height over the finished grade (ground). The TPR should terminate not more than 6 inches and not less than two times the discharge pipe diameter above the floor or waste receptor flood level rim.
- The exterior termination point of the temperature and pressure relief (TPR) valve discharge pipe is missing its 90-degree elbow. The TPR discharge pipe should turn 90-degrees downward and terminate within 6-inches of the ground.
- Some corrosion was observed on the water supply shutoff valve.

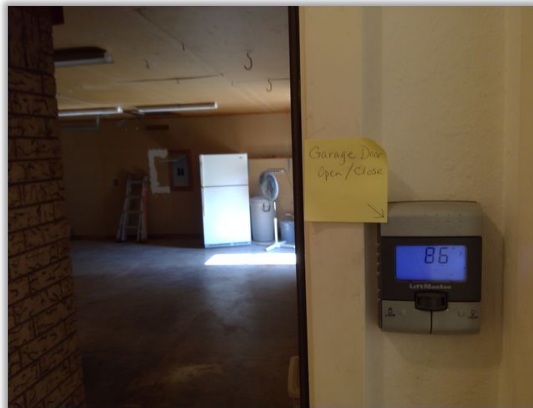
- The garage door opener button is poorly located. The garage door opener button should be installed on the opener side of the wall and within unobstructed view of the garage door.
- The garage door opener button should be installed at least 5-feet the floor of the garage, so to be out of the reach of children.
- When an automatic garage door opener is in use, the manual lock should be disabled or removed.
- The garage door reverse sensors are not properly installed. The garage door reverse sensors should be installed within 6-inches of the garage floor.

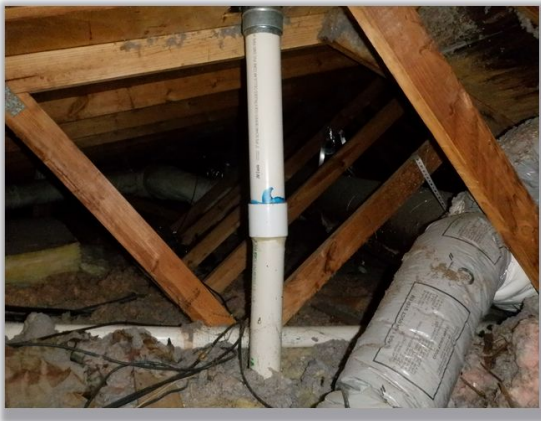
- The dryer exhaust duct (vent pipe) is dirty and needs to be cleaned.
- The material used for the dryer duct is not listed or labeled for this type of installation. The duct material should be metal with a smooth interior surface.

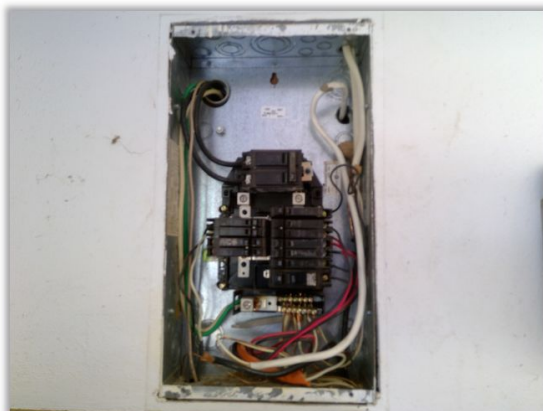
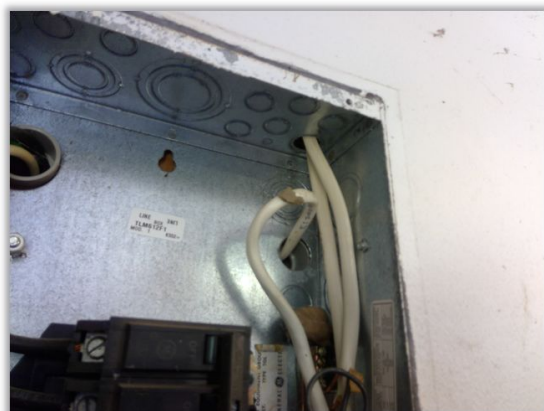
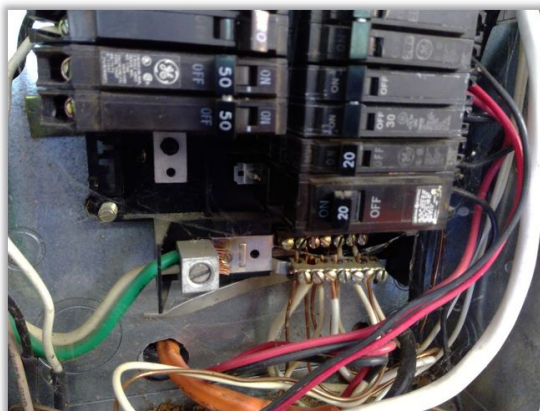
- The wires entering the electrical cabinet are not properly secured or protected from the sharp edges of the cabinet.
- The ground wires and the neutral wires are not properly separated in the sub-panel electrical cabinet. The neutral wires should be on their own isolated bus bar and the ground wires should be connected to the sub-panel cabinet. Although the sub-panel is functional, it does not meet current National Electrical Code standards.

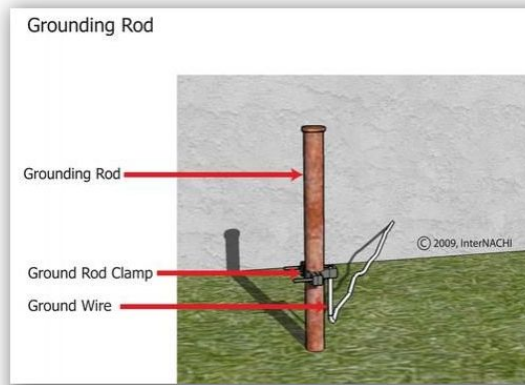
### Grounding / Bonding

- I was unable to locate a grounding rod (Grounding Electrode) or supplement grounding source for the electrical system. This condition should be further investigated and corrected if necessary.
