CLADDING MOISTURE REPORT

Cladding Inspection Report

Subject Property : Address, City, TX 00000

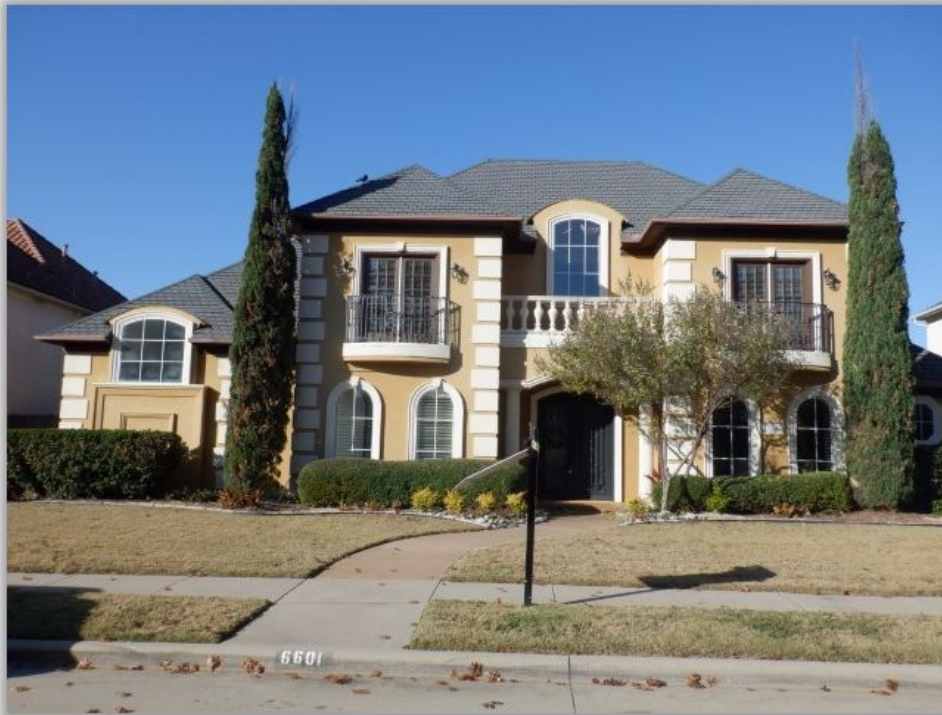
Front Side of Structure

- There is foliage in contact with the exterior stucco finishes. It is recommended to trim the foliage at least 18-inches off the exterior walls.
- All sprinkler heads within 12-inches of the exterior walls should be relocated a minimum of 12-inches away from the walls and directed so that water does not spray directly onto the walls.

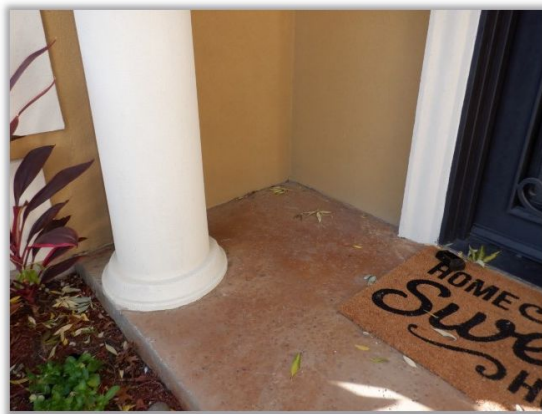
Balcony Over Front Door

- There is no visible end dam at the balcony interface with the stucco system. It is recommended to install end dams at this locations to help prevent water intrusion within the wall system.

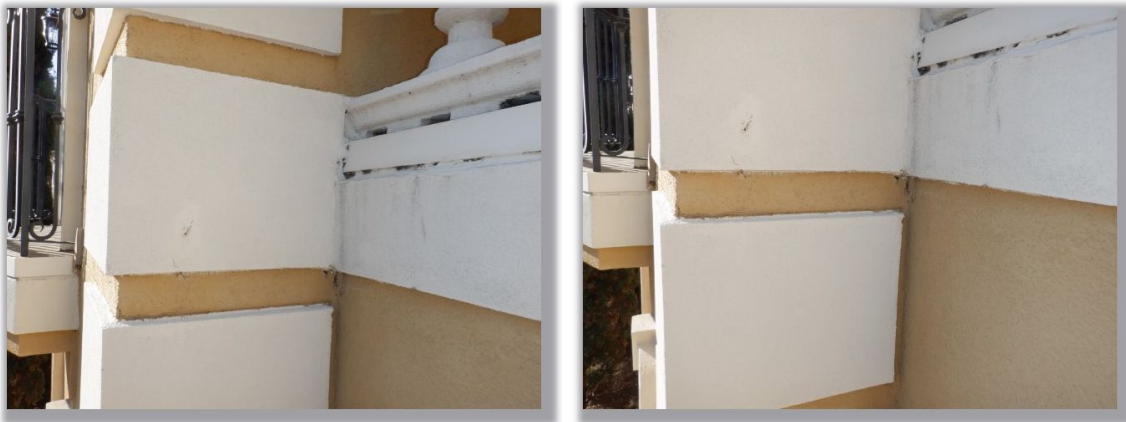
Balcony Over Master Bedroom Closet

- There is no visible end dam at the balcony interface with the stucco system. It is recommended to install end dams at this locations to help prevent water intrusion within the wall system.

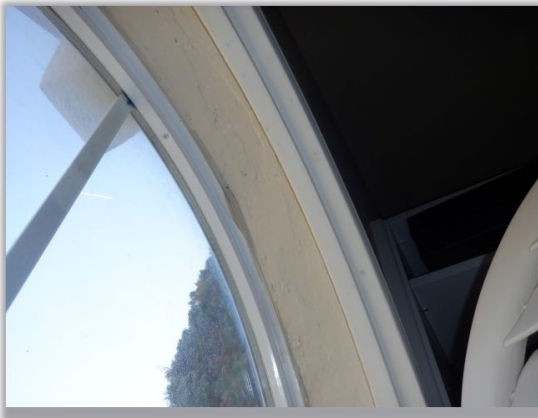
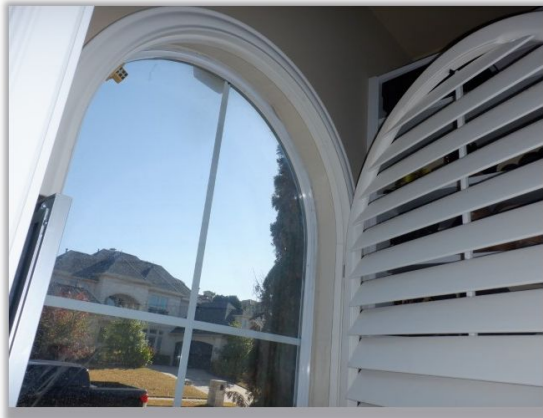
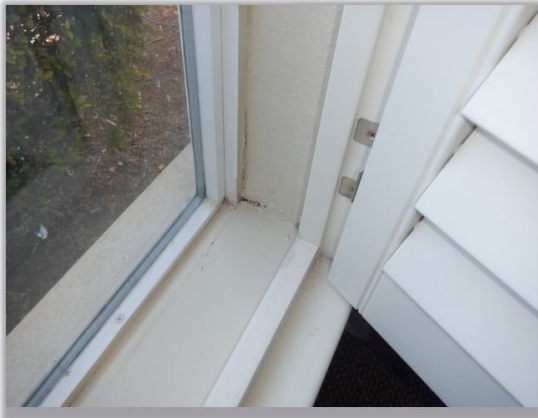
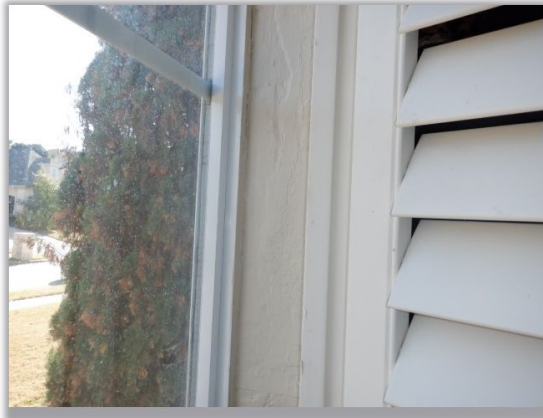
Balcony Over Dining Area

- There is no visible end dam at the balcony interface with the stucco system. It is recommended to install end dams at this locations to help prevent water intrusion within the wall system.

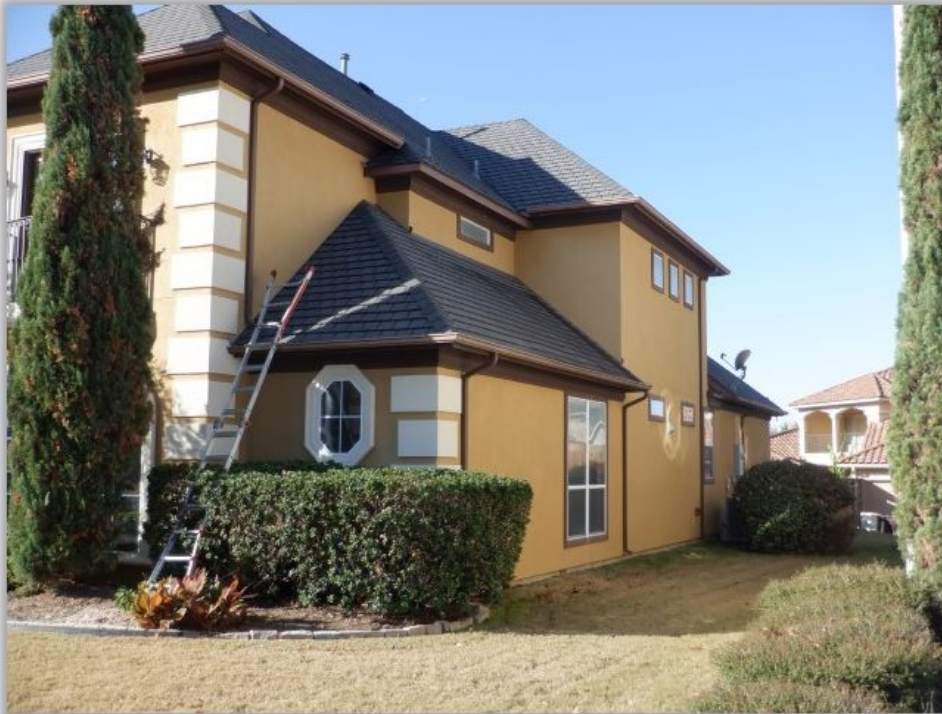
Right Side of Structure

- The EPS decorative bands do not have a proper 6/12 slope away from the structures walls. Under current installation standards the EPS bands should have a 6/12 slope so water does not stand on top of the bands. There are no visible defects related to this application at this time and no remedial repairs are recommended.
- All sprinkler heads within 12-inched of the exterior walls should be relocated a minimum of 12-inches away from the walls and directed so that water does not spray directly onto the walls.
- The area between the exterior cladding / veneer and all of the wall penetrations / openings need to be properly sealed. Areas such as utility connections, downspouts, hose bibbs, lighting fixtures, receptacles etc. It is recommended to use an industry approved low-modulus elastomeric sealant.

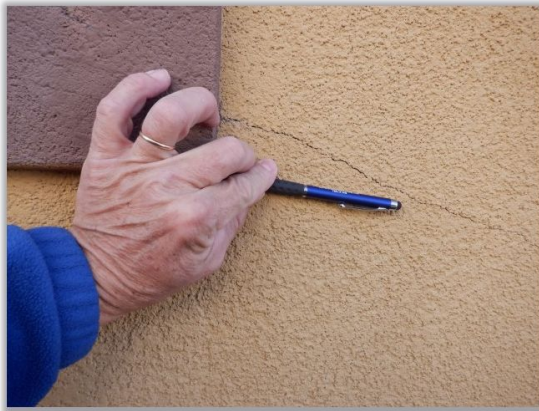
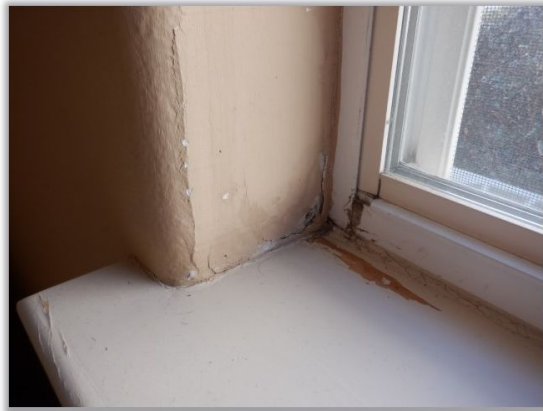
- Some minor cracking of the stucco finish was observed in one or more locations at the time of this inspection. The cracks observed were less than 1/16-inch and are consistent to be within accepted industry standards and no remedial repairs are recommended.

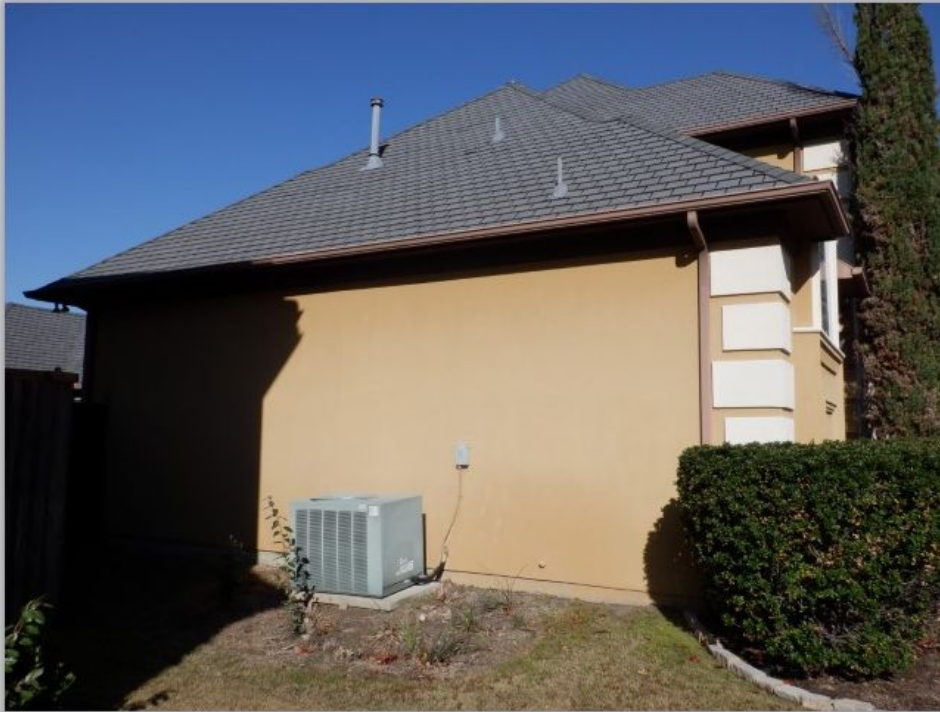
Left Side of Structure

- The area between the exterior cladding / veneer and all of the wall penetrations / openings need to be properly sealed. Areas such as utility connections, downspouts, hose bibbs, lighting fixtures, receptacles etc. It is recommended to use an industry approved low-modulus elastomeric sealant.

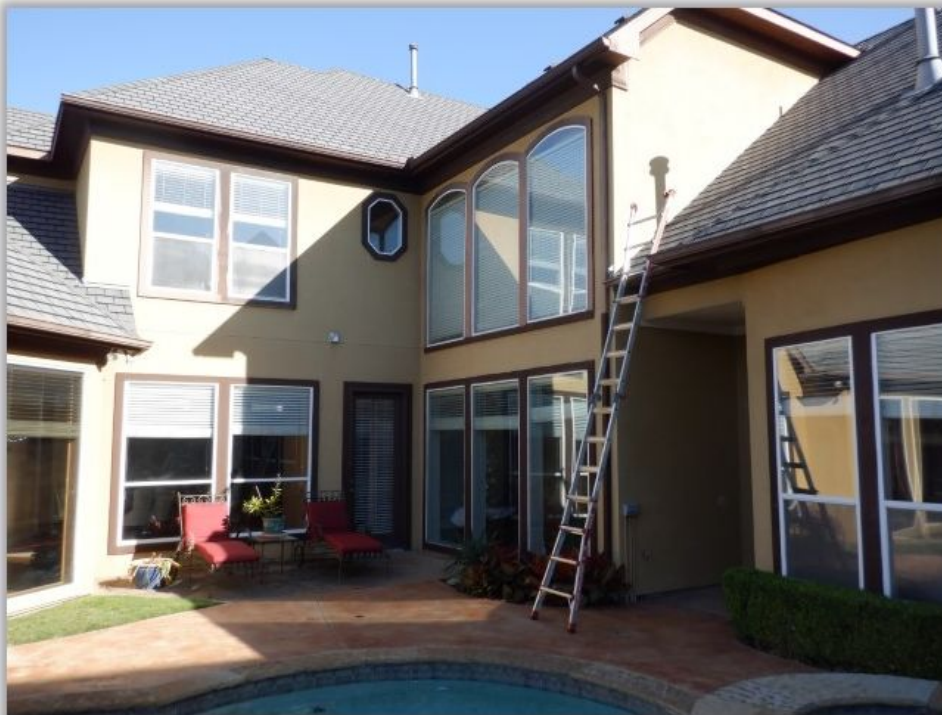
Back Side of Structure

- The EPS decorative bands do not have a proper 6/12 slope away from the structures walls. Under current installation standards the EPS bands should have a 6/12 slope so water does not stand on top of the bands. There are no visible defects related to this application at this time and no remedial repairs are recommended.

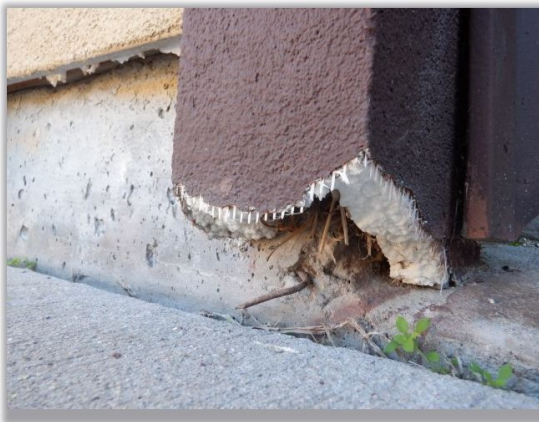
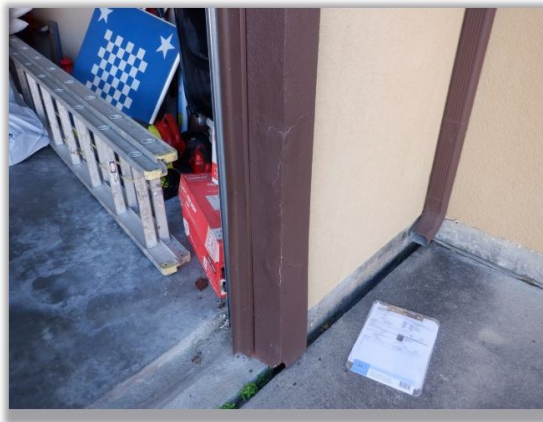
Breakfast Area Windows / Back Door

- There is no visible through wall flashing (head flashing) above the door openings. Under current stucco installation standards, there should be through wall flashing continuously above all doors to help prevent water intrusion at these locations. The lack of this flashing detail has allowed water into the wall cavity and leak to the interior of the structure.

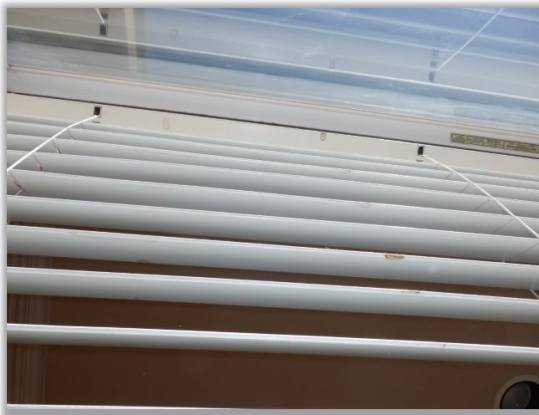
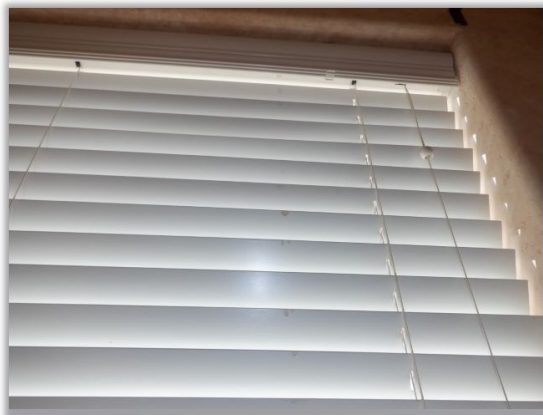
Living Area Windows

- Visible evidence of water intrusion was observed at and/or around the window(s) in the living room.
- There is no visible through wall flashing (head flashing) above the windows. Under current stucco installation standards, there should be through wall flashing continuously above all windows to help prevent water intrusion at these locations.
- There is visible evidence of water intrusion through the stucco cladding system on the back side of the structure at and around the living area windows. This condition has caused some visible damage to the stucco cladding. This condition should be further evaluated and corrected as necessary.
- There are larger than typical cracks observed in the stucco finishes. The cause of the cracking needs to be further evaluated and repairs by a qualified stucco specialist. Further moisture testing recommended.

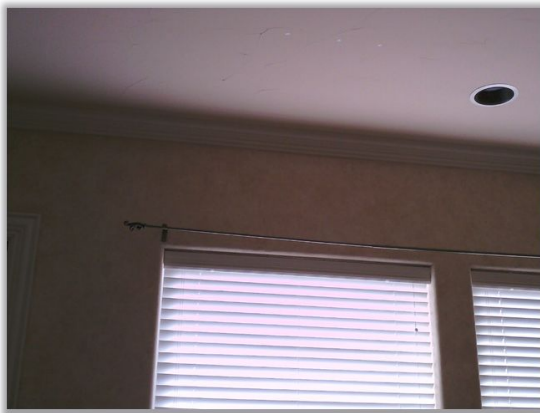
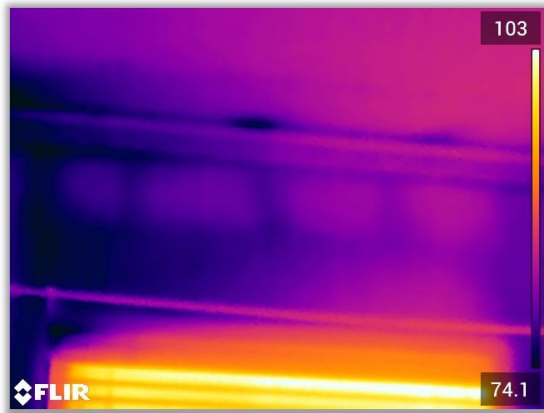
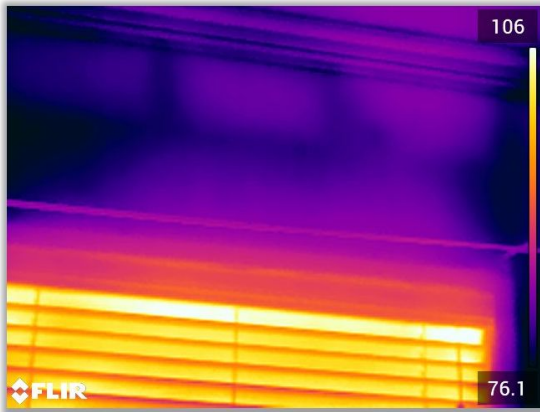
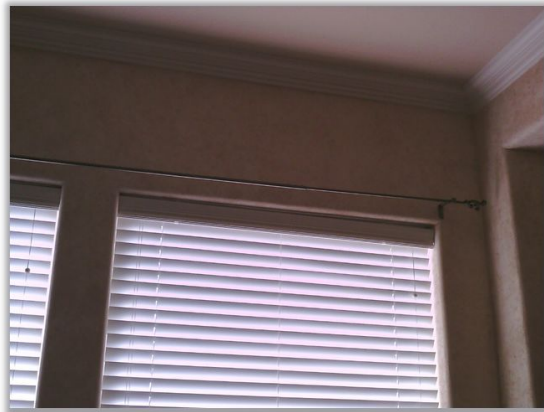
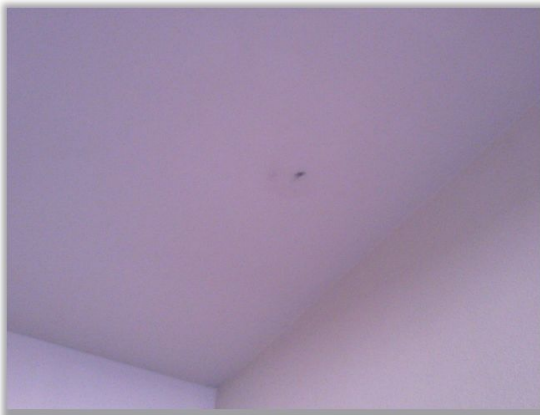
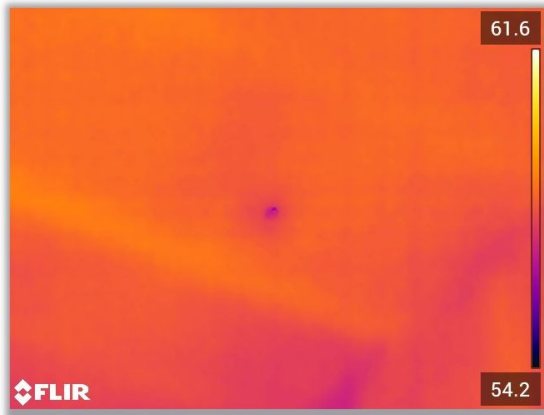
- The stucco finish coat or sealant was observed to be installed over the window weepholes / tracks. It is recommended to clear all of the window weepholes / tracks to help prevent further water intrusion within the wall cavity.

- The substrate (sheathing) behind the stucco finishes appear to be compromised. The stucco is bulging and very spongy to the touch. This condition needs to be further evaluated and repaired as necessary. It is my professional opinion that the stucco in the affected areas will need to be removed, the substrate replaced and the stucco finishes replaced.
